SECTION 14 INCIDENT REPORT (*Waste Management and Pollution Control Act*)

Date and Time of Notification:	Tuesday 18 July 2023 1325hrs
Person / Company:	Power and Water Corporation
Incident:	Discharge of raw sewage from Overflow Relief Gully (ORG) at Karnte camp, Mparntwe (Alice Springs)

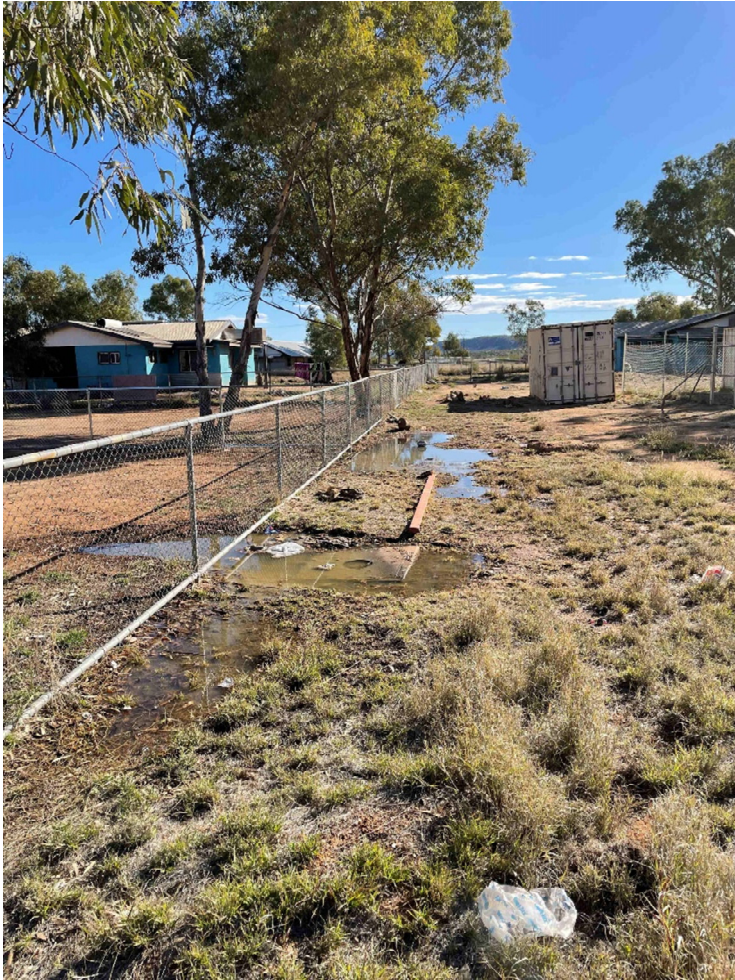
<p>Please see photo in Appendix B that was provided by a Power and Water staff member (Technical Coordinator).</p> <p><i>iii. Indicate any locations nearby to the discharge point where public can gain ready-access, such as public open spaces through which the discharge moves.</i></p> <p>The discharge was via an ORG and discharge pooled in the immediate area that was accessible by the public.</p> <p>Signed fencing was erected to inhibit public access.</p> <p>The ponding water was sucked up via a sucker truck.</p>

(c) the date and time of the incident	<p><i>i. The time and date of commencement and cessation of the discharge.</i></p> <p>The overflow was first reported at approximately 3:00pm Monday 17 July. At around 5:00pm that same day (Monday 17 July) the blockage was cleared, discharge stopped from the ORG and affected areas fenced off (with signage) and cleaned.</p> <p><i>ii. How PWC were notified, or became aware of the discharge.</i></p> <p>Power and Water was first alerted via online monitoring when low inflow trends alluded to a problem at the Karnte camp sewer pump station. Discharge was confirmed shortly after when Power and Water staff travelled to site (Karnte camp) to undertake a follow-up visual check.</p> <p><i>iii. The process by which the discharge occurred.</i></p> <p>Blockage at the inlet to pump station caused sewage to back up and discharge from a nearby ORG. It is believed foreign objects such as rocks have been disposed of into the sewer system causing the blockage.</p> <p><i>iv. The reason why the discharge occurred.</i></p> <p>As per (c) iii</p>

Appendix B – Photo of pooled discharge from an ORG in Karnte camp (pre-clean up)

<p>Ponding water was sucked up via sucker truck.</p> <p>Signed fencing was erected and the area was cleaned before safe access by the public was permitted.</p> <p><i>iii. Attempts made to prevent, reduce or control the discharge</i></p> <p>Blockage has been cleared, which has stopped the overflow to the environment. The sewage main is operating as per normal specifications again.</p>
<p>(f) the identity of the person notifying the NT EPA</p>	<p>PWC Environmental Team on behalf of Water Services</p>
