**SECTION 14 INCIDENT REPORT (*Waste Management and  
Pollution Control Act*)**

| <b>Incident:</b> | The death of more than 1000 small fish believed to be Oxeye Herring ( <i>Megalops cyprinoides</i> ~50 mm long) in Pond E North, an internal pond within East Arm Wharf. The incident appears species-specific, with no observable impacts to other fish. |

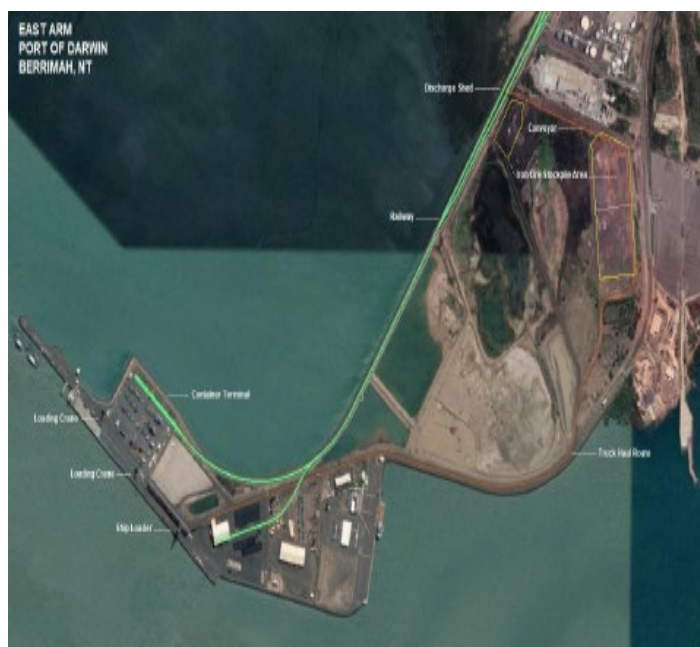
Figure 1 – Map showing facilities at East Arm Wharf including the iron ore stockpile area

- from an iron ore stockpile area bordering the landward boundary of East Arm Wharf contiguous to Berrimah road sub-leased and controlled by Ag-River Energy Pty Ltd (**AGRE**) depicted in Figure 1 below
- into drainage channels around the perimeter of the stockpile area and directed to containment ponds located to the south and west of the stockpile area
- flowing through to Pond E (the large green pond to the south east of the stockpile area) into Pond E North bordering the harbour depicted in Figure 2 below.

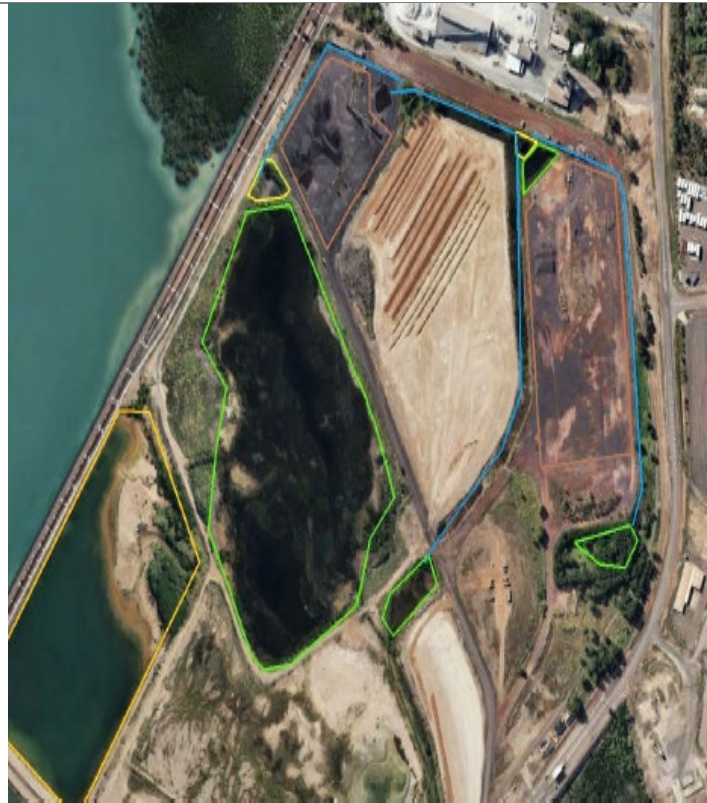
Figure 2 - East Arm Wharf stockpile areas (brown), channel drains (blue), sumps (yellow) and containment ponds (green).

| <p><b>(d) how the pollution has occurred, is occurring or may occur</b></p> | <p>Based on the independent water testing conducted by DPO to date, DPO considers the pollution most likely occurred by recent large downpours of rain washing water run-off from the iron ore stockpiles, managed by AGRE, into the drainage channels around the perimeter of the stockpile area which were directed to containment ponds located to the south and west of the stockpile area through to Pond E (the large green pond to the south east of the stockpile area) into Pond E North bordering the harbour depicted in Figure 2 above.</p> |

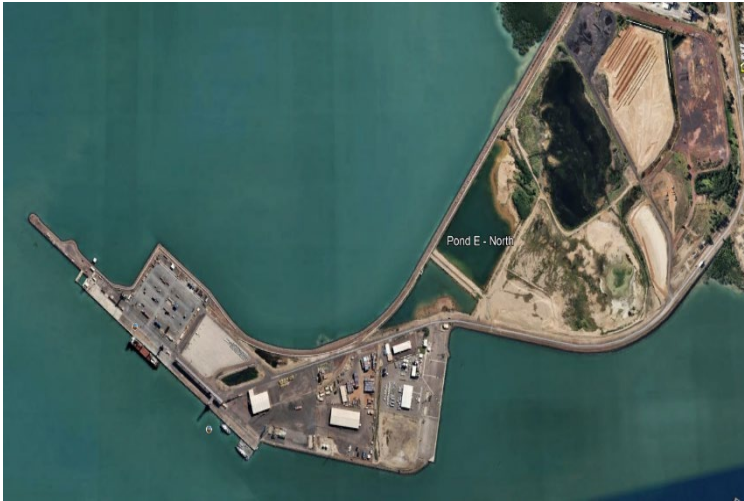
| <p><b>(b) the place where the incident occurred</b></p> | <p>Pond E North, an internal pond within East Arm Wharf depicted in Figure 3 below.</p> <p>Figure 3 Pond E North, East Arm Wharf</p> |
