SECTION 14 INCIDENT REPORT (*Waste Management and Pollution Control Act*)

Date and Time of Notification:	Thursday 23rd May 2019, 15:30pm
Person / Company:	Power and Water Corporation (PWC)
Incident:	Controlled discharge of treated effluent from Papunya Waste Stabilisation Ponds (WSPs).

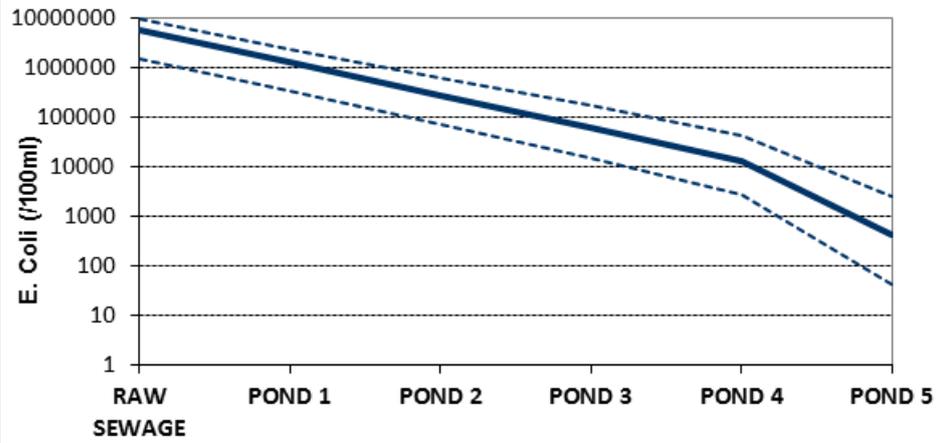
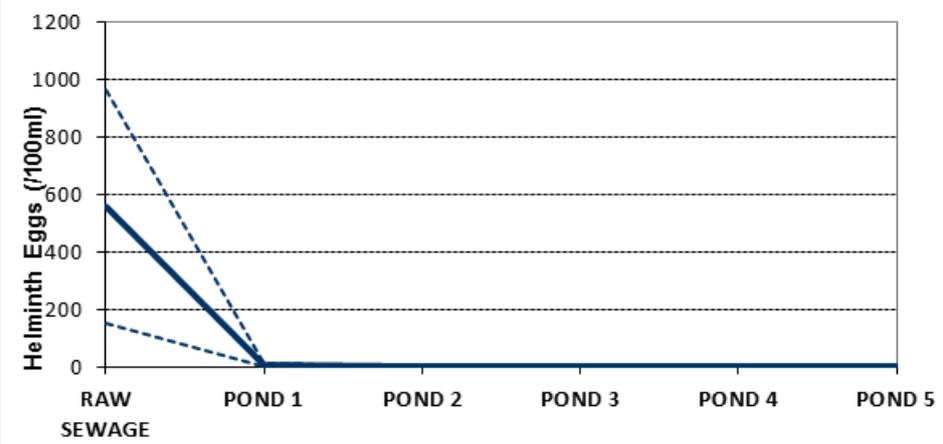
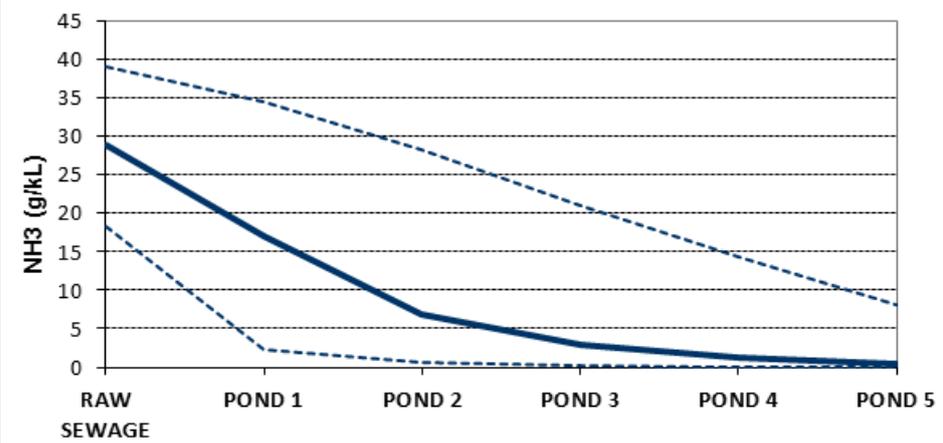
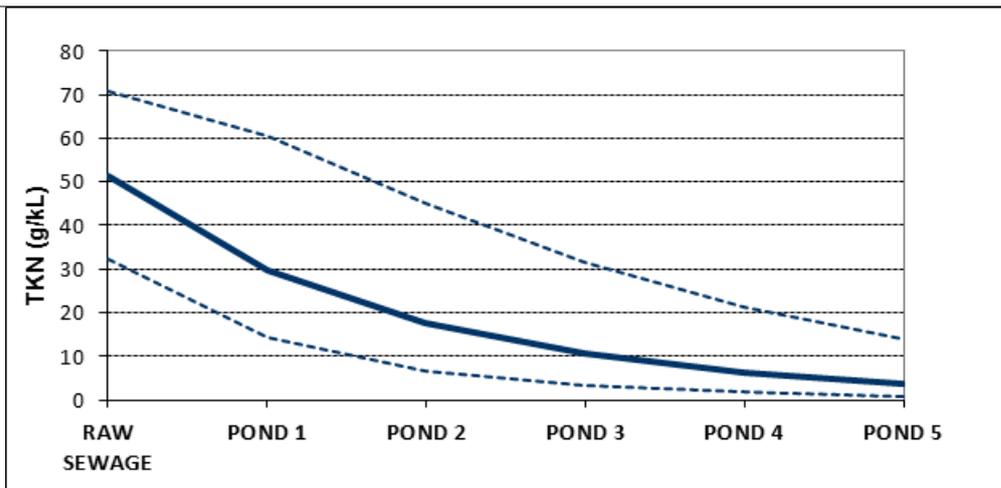
<p>(a) the incident causing or threatening to cause pollution</p>	<p><i>i. Description of the waste that was discharged.</i></p> <p>Treated effluent.</p> <p><i>ii. Indicative wastewater quality for the discharge.</i></p> <p>We do not have any analysis results from the site for treated wastewater quality, estimates from modelling are attached below. However, due to the large amount of dilution of the sewage, treated wastewater quality may be significantly better than these estimates.</p> <p>Indicative wastewater quality for this overflow can be found in the graphs below. This is based off modelled data.</p> <div data-bbox="427 1256 1433 1747" data-label="Figure">

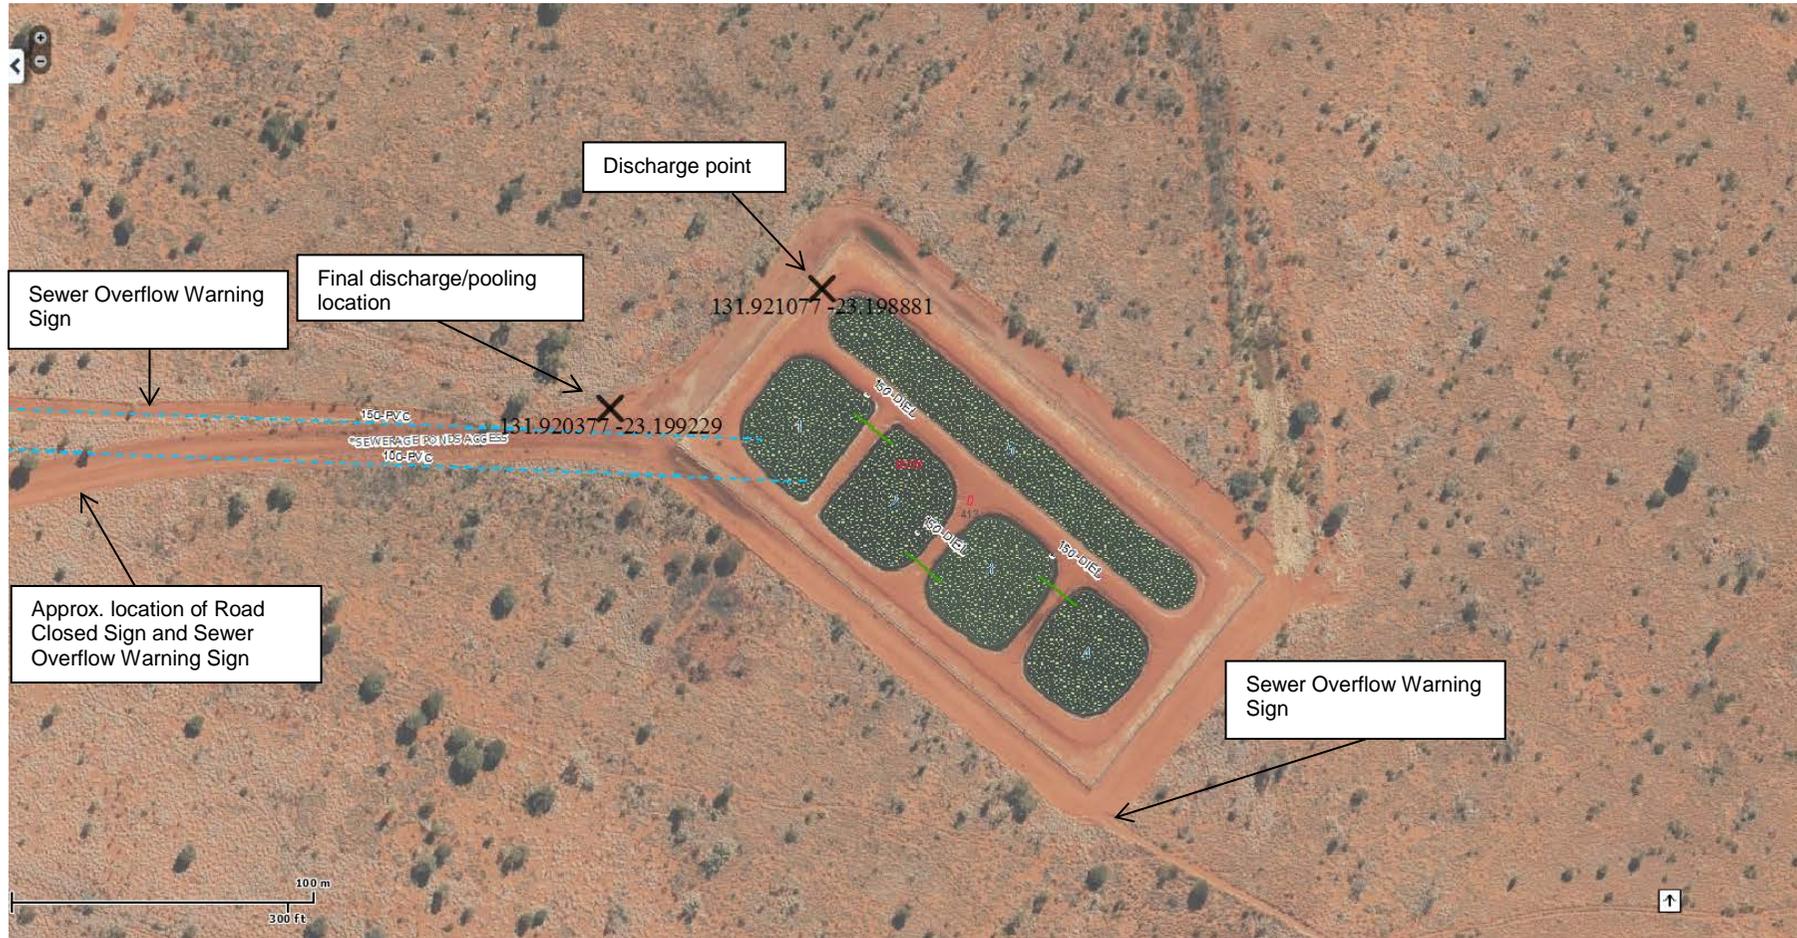
Papunya Waste Stabilisation Ponds (see map below).

Papunya Waste Stabilisation Ponds (see map below). The discharge will occur from the final (evaporation) pond, and will impact on the area shown in the map below and attached. A road closed sign and sewer overflow warning sign will be erected to deter public access.
