SECTION 14 INCIDENT REPORT (Waste Management and Pollution Control Act)

Date and Time of Notification:	Tuesday 19/11/2019 13:00hrs
Person / Company:	Power and Water Corporation (PWC)
Incident:	Leaking power transformers

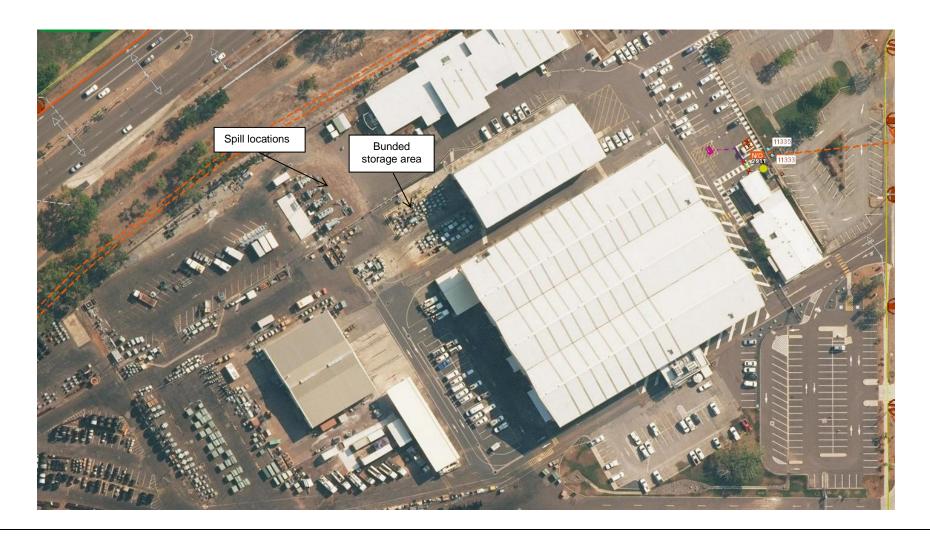
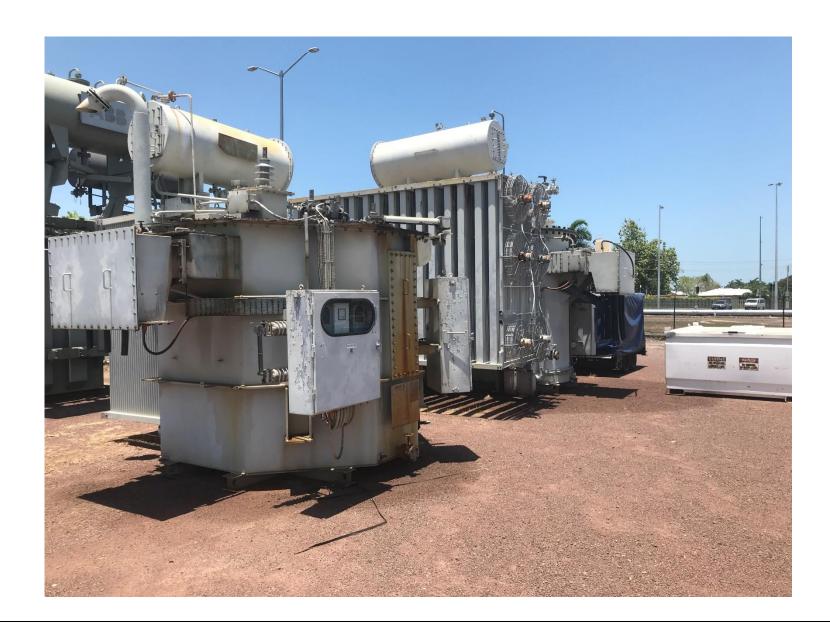
(a) the incident causing or threatening to cause pollution	Two large power transformers that are leaking transformer oil, stored outside of the facilities bunded storage area.

(d) how the pollution has occurred, is occurring or may occur	Transformer oil is leaking from two power transformers brought in from the field that were incorrectly placed outside the bunded storage compound, where they have leaked an unknown quantity of transformer oil onto an engineered hardstand surface

(e) the attempts made to prevent, reduce, control, rectify or clean up the pollution or resultant environmental harm caused or threatening to be caused by the incident	The area of the spill will be covered with plastic sheeting to prevent rain from further spreading any contamination and leaking oil will be captured by placing tubs underneath to capture any additional leaking oil. Discussions with management to determine what additional actions need to be taken are underway. At present, we are looking at increasing the size of the bunded area and mobilising a crane to move these assets to this area of containment, prior to undertaking remediation works.
