## SECTION 14 INCIDENT REPORT (*Waste Management and Pollution Control Act*)

<b>Date and Time of Notification:</b>	Tuesday 10/03/2020 15:15hrs
<b>Person / Company:</b>	Power and Water Corporation ( <b>PWC</b> )
<b>Incident:</b>	Discharge of diluted sewage from sewerage network (no gross pollutants)

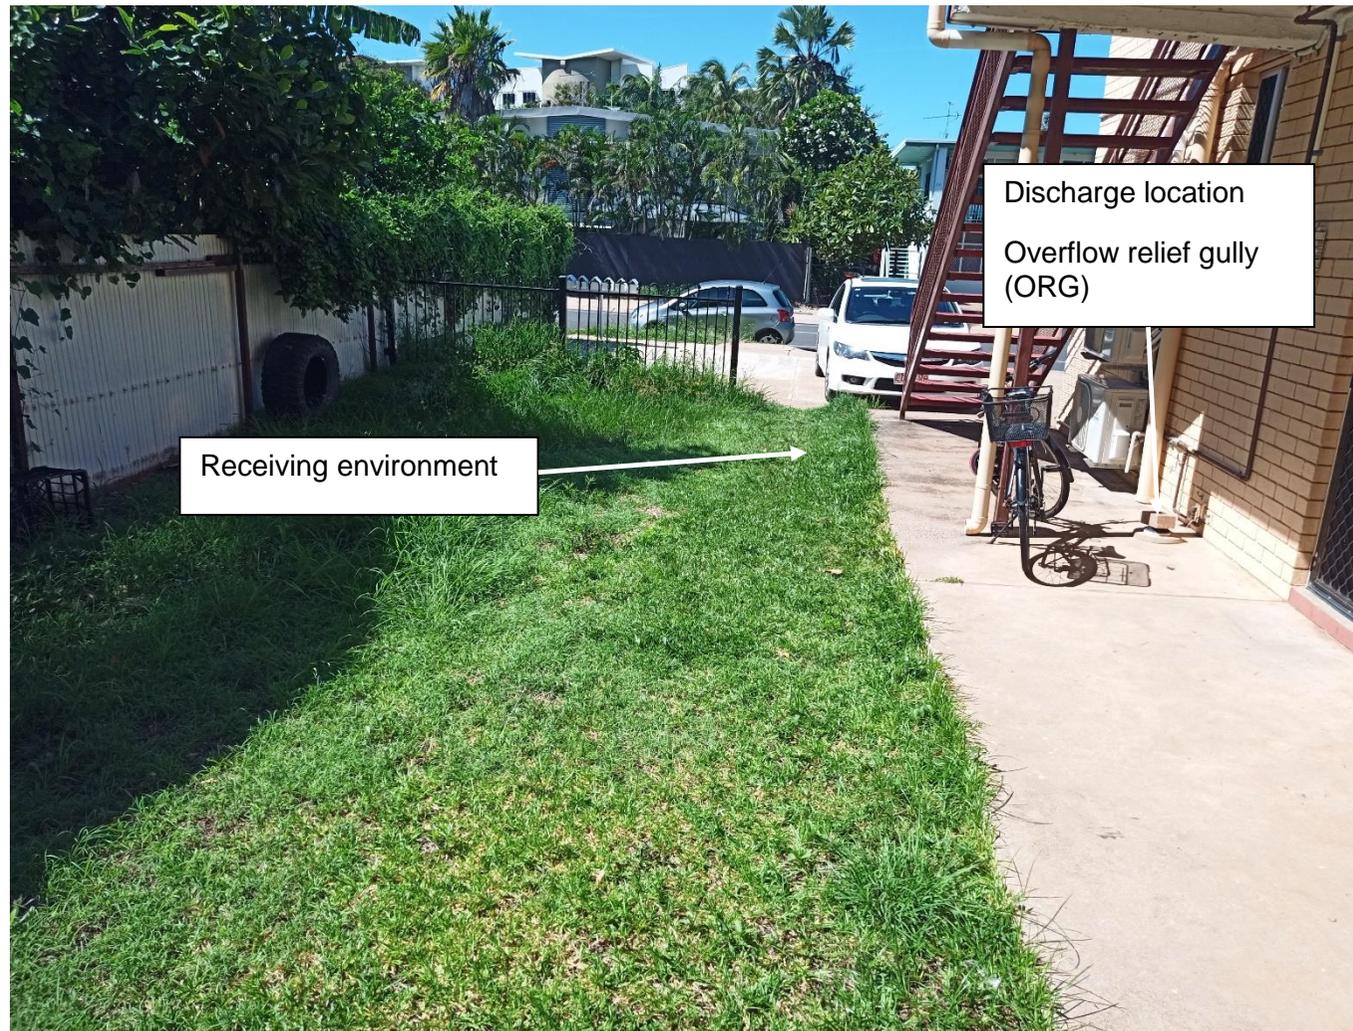
Appendix B – Photographs of the spill source and receiving environment

<p>Final discharge point was concrete and grass surrounding the overflow relief gully at the above co-ordinates.</p> <p><i>iii. Indicate any locations nearby to the discharge point where public can gain ready-access, such as public open spaces through which the discharge moves.</i></p> <p>Access to the public is possible, as the ORG is within a private residential property. Residents and visitors would have access. The affected area has been thoroughly cleaned and disinfected as per the PWC Sewage Spills/Overflow Response Work Instruction, allowing safe access by residents.</p>
<b>(c) the date and time of the incident</b>	<p><i>i. The time and date of commencement and cessation of the discharge.</i></p> <p>The commencement time of the overflow is unknown. The overflow was observed at approximately 12:30hrs by PWC staff on 10/03/2020 and the spill stopped by 12:40hrs 10/03/2020.</p> <p><i>ii. How PWC were notified, or became aware of the discharge.</i></p> <p>This overflow was reported by one of the residents to the PWC call centre, after being advised by a private plumber that the blockage was not within their property boundary. This information was then relayed to the on-call PWC operations staff. PWC personnel attended the site at 12:30hrs (10/03/20) and undertook action to resolve the situation and make it safe.</p> <p><i>iii. The process by which the discharge occurred.</i></p> <p>The cause of the spill was due to a blockage in the main line, because of rags and fat build-up in the gas trap. Fat and other substances have been incorrectly disposed of into the sewer network by customers, resulting in the blockage and the overflow. When fats, oils and meat juices are put down the sink it is usually as a liquid, but as it cools it can become more solid and cause build-up, resulting in bad odours and blockages in the sewerage system. This can lead to the sewage overflows into the environment, households and businesses.</p> <p>Public education about what can be disposed in sewer/is flushable: <a href="https://www.powerwater.com.au/about/what-we-do/wastewater/sewer-blockages-and-overflows/think-before-you-put-it-down-the-sink">https://www.powerwater.com.au/about/what-we-do/wastewater/sewer-blockages-and-overflows/think-before-you-put-it-down-the-sink</a> In the aim of prevention, this material is available on the PWC website and is used as an educational tool for customers.</p> <p><i>iv. The reason why the discharge occurred.</i></p> <p>As per (c) iii. Sewerage network infrastructure has been designed to overflow with the best public health and environmental outcomes possible. Design focuses on not overflowing directly inside houses/businesses; rather discharge is designed to occur in a controlled manner at locations that can be accessed for infrastructure repair and clean up and with minimal public health or environmental impacts, such as overflow relief gullies.</p>

<b>(d) how the pollution has occurred, is occurring or may occur</b>	<p>As per (c) iii &amp; (c) iv.</p> <p>Sewer overflow from property overflow relief gully, caused by tenants in property continuing to use plumbing even after their private plumber had</p>

<p>informed them not to. The sewer blockage was determined not to be within the bounds of their property, hence PWC was notified, who cleared the blockage shortly after arriving.</p>
<p><b>(e) the attempts made to prevent, reduce, control, rectify or clean up the pollution or resultant environmental harm caused or threatening to be caused by the incident</b></p>	<p><i>i. Confirmation signage and fencing has been erected, as appropriate.</i></p> <p>The spill, which was mostly on concrete, had been thoroughly cleaned up using a pressure washer and vacuum truck and disinfected as per Sewage Spills/Overflow Response Work Instruction; as such the area was deemed unlikely to pose a health risk to the tenants and barricading or signage was not erected.</p> <p><i>ii. Decontamination of the site as appropriate.</i></p> <p>Clean up consistent with Sewage Spills/Overflow Response Work Instruction as appropriate to the location, and to minimise risk to public health and the environment. The crew contracted to conduct the unblocking of the sewer network and the clean-up and disinfection on behalf of PWC was Alawa Plumbing. All waste from the clean up was taken to Hudson Creek facility – Wishart.</p> <p>No impact to mangroves, as they are around 150 meters away and any contamination was cleaned up on site.</p> <p>Further targeted education campaigns on inappropriate items being disposed of into the sewer system is currently being contemplated by PWC.</p>
