## SECTION 14 INCIDENT REPORT (*Waste Management and Pollution Control Act*)

<b>Date and Time of Notification:</b>	Thursday 13 <sup>th</sup> January 2022, 13:00hrs
<b>Person / Company:</b>	Power and Water Corporation ( <b>PWC</b> )
<b>Incident:</b>	Discharge of sewage from sewerage network (ORG)

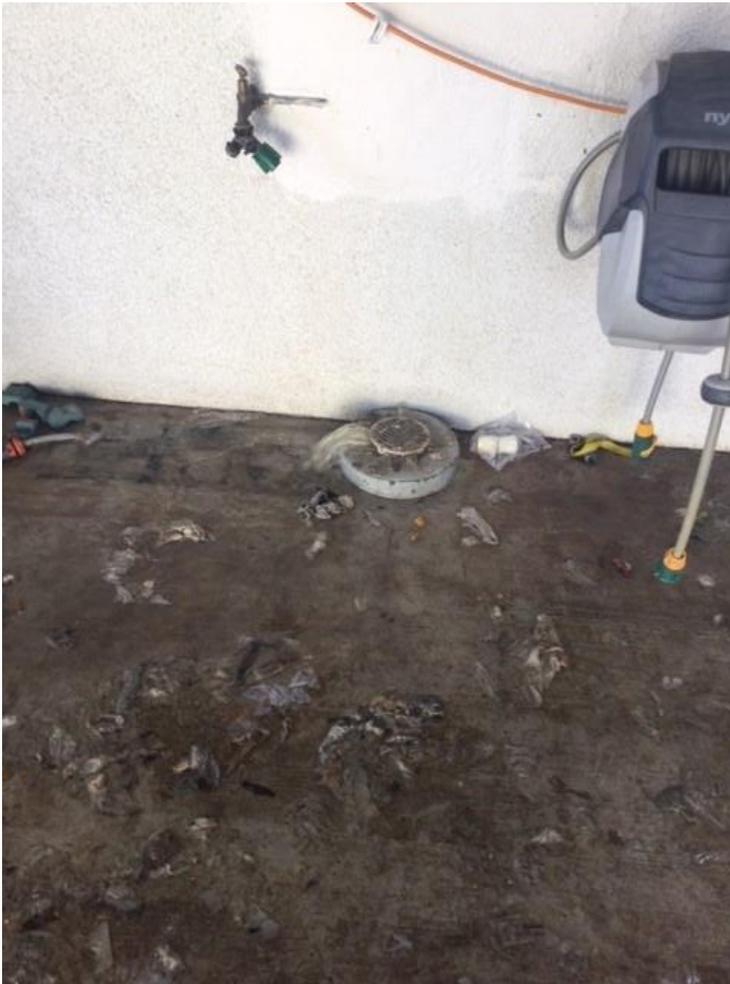
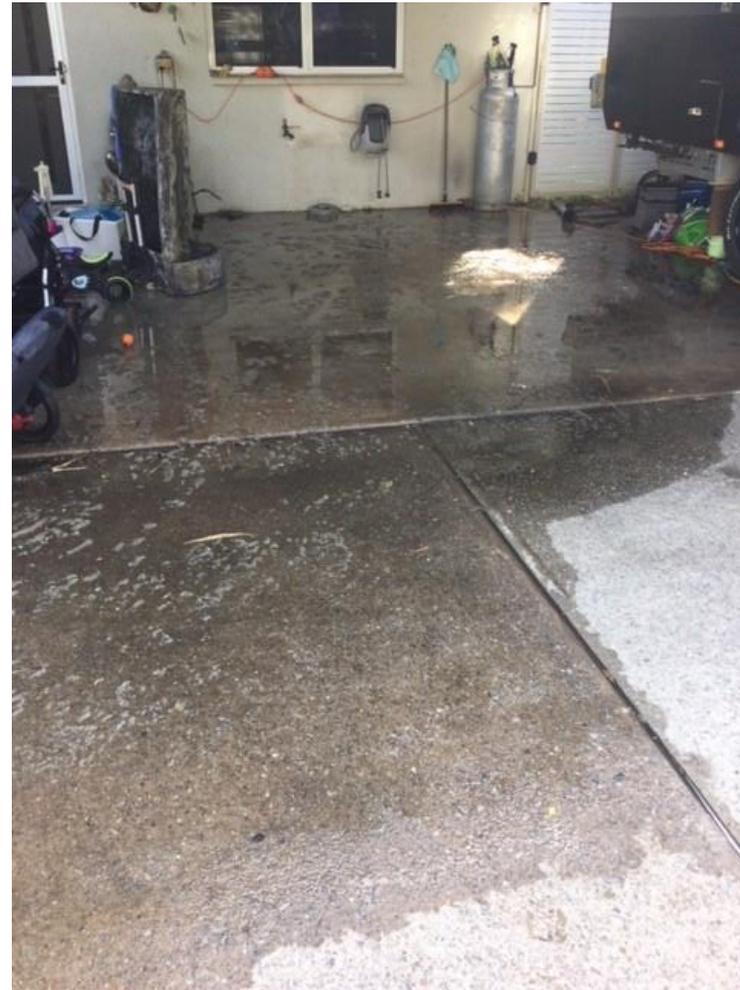
Appendix B – Photographs of the spill site. First one showing the overflowing ORG and the large amount of non-degradable paper/wipes in the system.

<b>(d) how the pollution has occurred, is occurring or may occur</b>	As per (c) iii & (c) iv.
<b>(e) the attempts made to prevent, reduce, control, rectify or clean up the pollution or resultant environmental harm caused or threatening to be caused by the incident</b>	<p><i>i. Confirmation signage and fencing has been erected, as appropriate.</i></p> <p>No fencing or signage was erected in this instance, as the scene was disinfected and cleaned thoroughly; and the residents who know about the spill are the only ones able to access the spill area.</p> <p><i>ii. Decontamination of the site as appropriate.</i></p> <p>Clean up consistent with Sewage Spills/Overflow Response Work Instruction as appropriate to the location, and to minimise risk to the Environment. Blockage was cleared and upon resolution of the blockage, the site was left in a clean state, free from any gross pollutants and the surrounding surface was cleaned and disinfected.</p>
