## SECTION 14 INCIDENT REPORT (*Waste Management and Pollution Control Act*)

<b>Date and Time of Notification:</b>	Wednesday 10 <sup>th</sup> August 2022, 13:10hrs
<b>Person / Company:</b>	Power and Water Corporation ( <b>PWC</b> )
<b>Incident:</b>	Discharge of sewage from sewerage network (ORG) & Inside residence

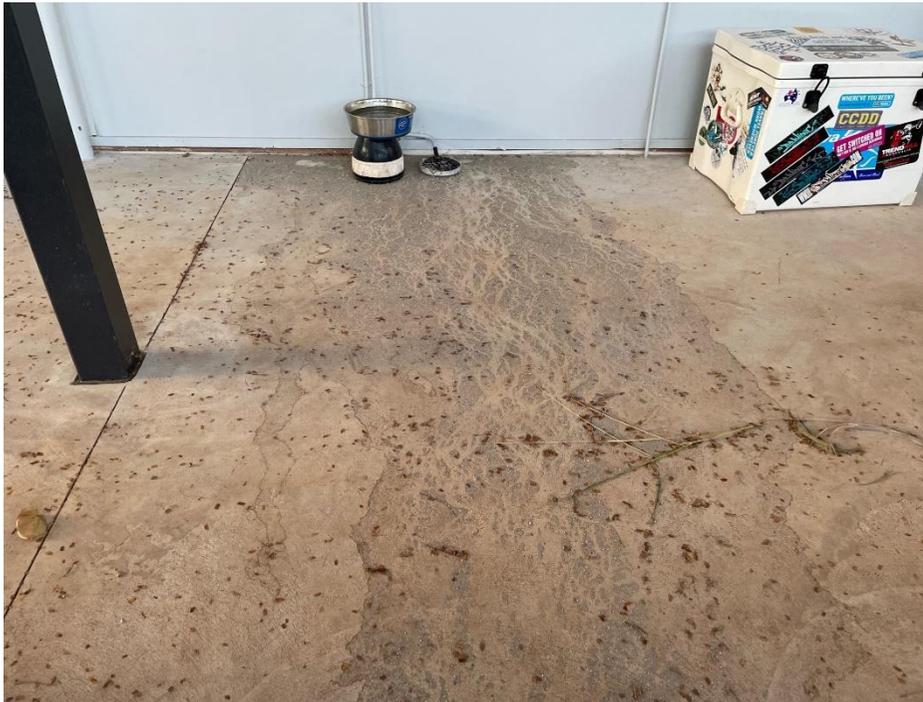
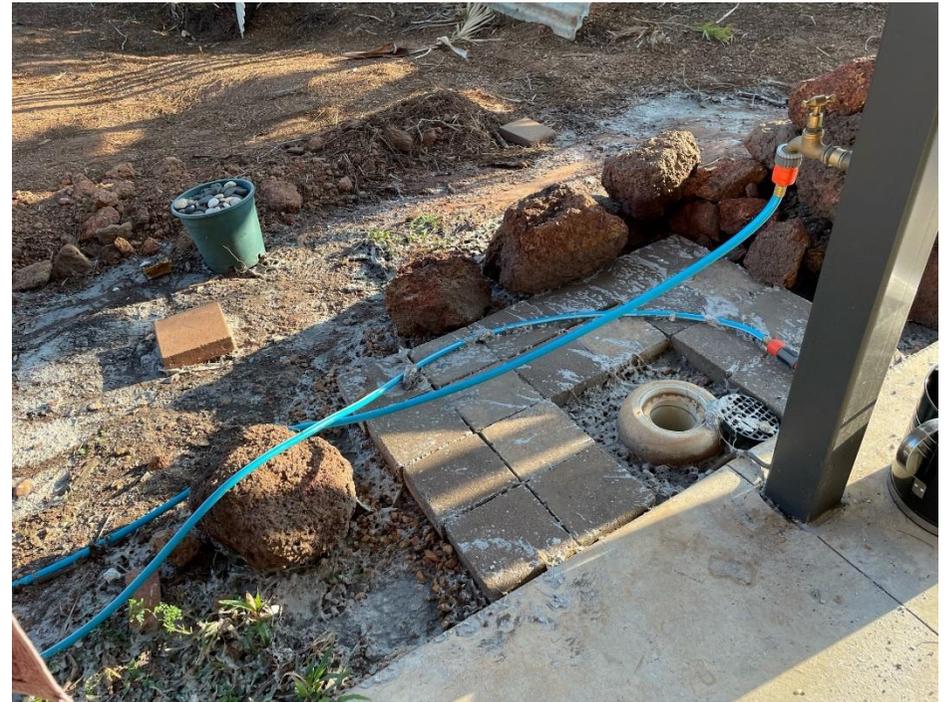
Appendix B – Photographs of both property's ORGs.

<p><i>Approximate locations are as follows;</i>  22 Tiwi Gardens Road, Tiwi:  1) Discharge Point: 130.8756809E, -12.3637348S (ORG)  2) Second Discharge Point: 130.8756198E, -12.3637279S (bathroom Un-numbered) Final discharge point: 130.8755656E, -12.3638570S (garden)</p> <p>6 Calvert Street, Tiwi;  4) Discharge Point: 130.8756255E, -12.3640886S (ORG)  5) Second Discharge Point: 130.8756071E, -12.3639342S (bathroom)</p> <p><i>iii. Indicate any locations nearby to the discharge point where public can gain ready-access, such as public open spaces through which the discharge moves.</i></p> <p>Access to the public is not possible as both overflows occurred on fenced private properties. The residents of both properties were made aware of the hazard, and kept away until all areas were thoroughly cleaned and disinfected.</p>
<p><b>(c) the date and time of the incident</b></p>	<p><i>i. The time and date of commencement and cessation of the discharge.</i></p> <p>6 Calvert Street - The commencement time of the overflow was approximately 08:00hrs and it ceased at approximately 09:00hrs, 09/08/2022.</p> <p>22 Tiwi Gardens Road - This overflow was observed at 14:30hrs by PWC staff 09/08/2022, and was stopped a short time later.</p> <p><i>ii. How PWC were notified, or became aware of the discharge.</i></p> <p>The residents of both properties called the PWC call centre, who then relayed the information to the PWC sewer reticulation team that attended the properties at around 08:00 and 14:30hrs 09/08/2022 and undertook action to resolve the situation and make it safe.</p> <p><i>iii. The process by which the discharge occurred.</i></p> <p>The cause of the overflows was due to multiple blockages in the sewer line, which resulted from a build-up of what most likely was fats. Fat and other non-disintegrating items like wet wipes and kitchen paper towels have been incorrectly disposed of into the sewer network by customers, resulting in the blockage and these overflows.</p> <p>When fats and oils are poured down the sink it is usually as a liquid, but as they cool they become more solid and build-up, resulting in bad odours and blockages in the sewerage system. This can lead to the sewage overflows into the environment, households and businesses.</p> <p>PWC provides ongoing periodic public education campaigns through various media, to remind residents of the three P's, in the aim of reducing these types of events.</p> <p><i>iv. The reason why the discharge occurred.</i></p> <p>As per (c) iii. Sewerage network infrastructure is designed to overflow with the best public health and environmental outcomes possible. Design focuses on not overflowing directly inside houses; rather discharge is designed to occur in a controlled manner at locations</p>

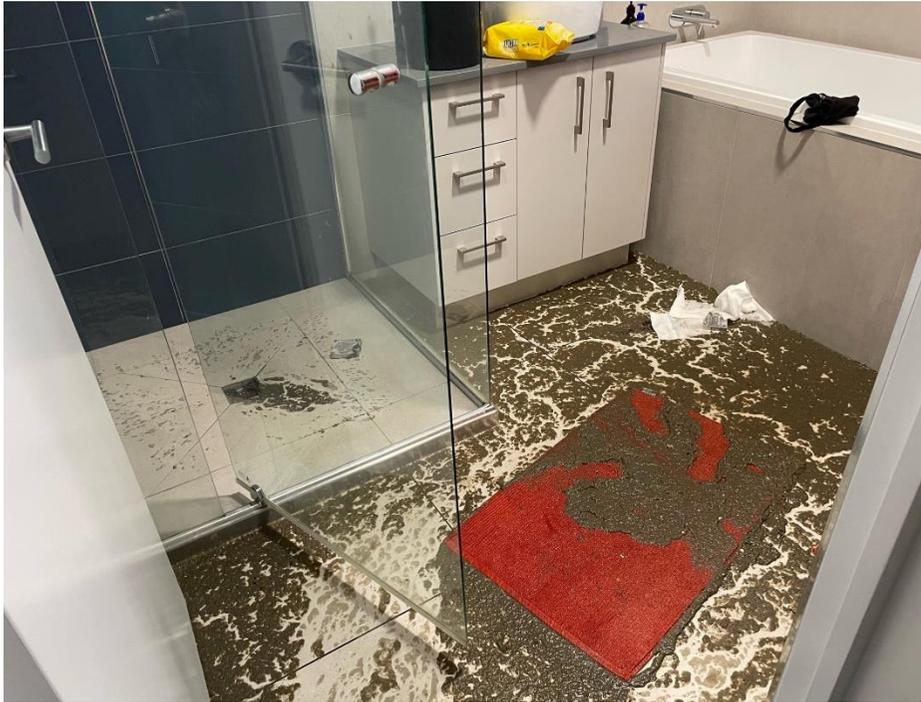
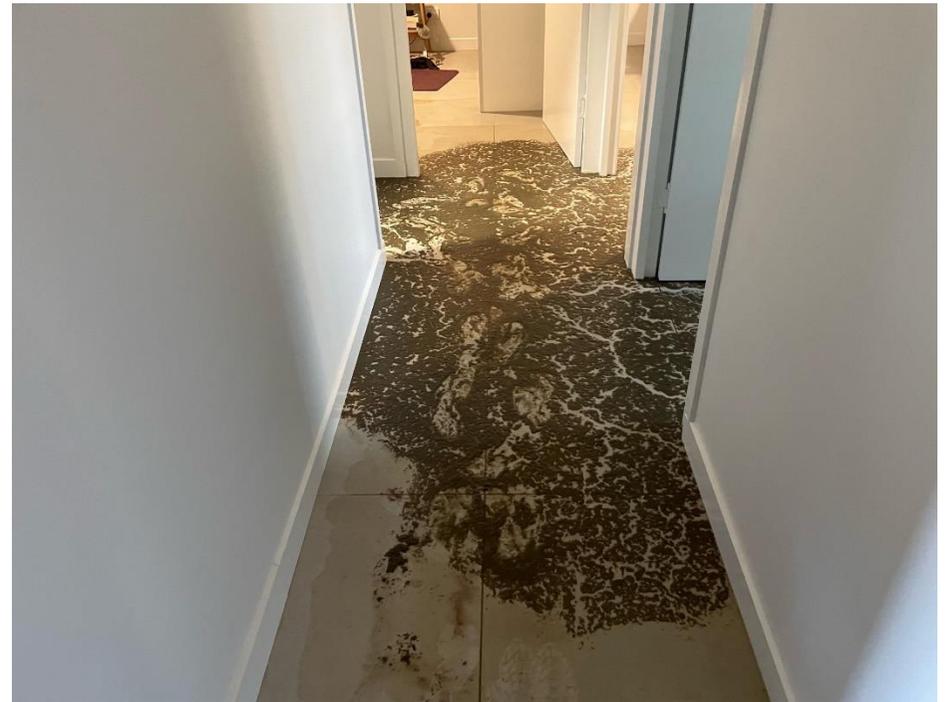
Appendix C – Photographs of overflow inside the buildings.

<p>which can be accessed for infrastructure repair and clean up, such as property ORGs; this reduces public health or environmental impacts.</p> <p>In this instance however, both properties have had recent renovations to their bathrooms, in which the levels of the floor level drains in relation to the ORGs were not installed as per design; hence the sewerage overflowed from both the ORG and inside the bathrooms at both properties.</p>
<b>(d) how the pollution has occurred, is occurring or may occur</b>	As per (c) iii & (c) iv, or blocking the overflow relief gully (ORG).
<b>(e) the attempts made to prevent, reduce, control, rectify or clean up the pollution or resultant environmental harm caused or threatening to be caused by the incident</b>	<p><i>i. Confirmation signage and fencing has been erected, as appropriate.</i></p> <p>Fencing and signage was not erected in this instance, as the spill was contained within the property boundaries of the private residence, which is fenced off.</p> <p><i>ii. Decontamination of the site as appropriate.</i></p> <p>Clean up consistent with Sewage Spills/Overflow Response Work Instruction as appropriate to the location. Blockages were cleared, and upon resolution of the blockages, the site was left in a clean state; free from any gross pollutants, and all surrounding surfaces were thoroughly cleaned and disinfected.</p>
