## SECTION 14 INCIDENT REPORT (*Waste Management and Pollution Control Act*)

<b>Date and Time of Notification:</b>	Tuesday 16 <sup>th</sup> August 2022. 10:30am
<b>Person / Company:</b>	Power and Water Corporation ( <b>PWC</b> )
<b>Incident:</b>	Discharge of raw effluent from manhole at 4 Harper Court, Larapinta, 0875

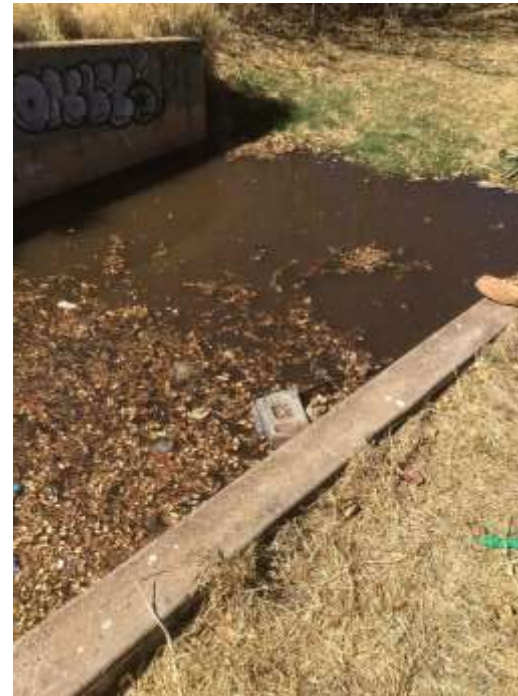
*Figure 4: Stormwater Pit*

<p><i>iii. Volume of the waste that was discharged.</i></p> <p>The volume of waste discharged is unknown as manholes are not telemetered. Approximate volumes are not known at this time.</p>	Sample Date	Description	E. Coli (MPN/100mL)	9/08/2022	SAA001 ALICE INLET SEWER	15,650,000	3/08/2022	SAA001 ALICE INLET SEWER	19,350,000	26/07/2022	SAA001 ALICE INLET SEWER	11,620,000	19/07/2022	SAA001 ALICE INLET SEWER	12,500,000	11/07/2022	SAA001 ALICE INLET SEWER	10,710,000
Sample Date	Description	E. Coli (MPN/100mL)																	
9/08/2022	SAA001 ALICE INLET SEWER	15,650,000																	
3/08/2022	SAA001 ALICE INLET SEWER	19,350,000																	
26/07/2022	SAA001 ALICE INLET SEWER	11,620,000																	
19/07/2022	SAA001 ALICE INLET SEWER	12,500,000																	
11/07/2022	SAA001 ALICE INLET SEWER	10,710,000																	
<p><b>(b) the place where the incident occurred</b></p>	<p><i>i. Description of the PWC asset from which the discharge occurred.</i></p> <p>Sewer 150mm manhole.</p> <p><i>ii. GPS coordinates of the discharge point from the PWC asset, and the final coordinates of the final discharge point.</i></p> <p>Discharge Point: 23.6948191S 133.8417976E Final discharge location: 23.6946659S 133.8419675E</p> <p><i>iii. Indicate any locations nearby to the discharge point where public can gain ready-access, such as public open spaces through which the discharge moves.</i></p> <p>The discharge is via manhole in public accessible location. Sewer flowed across public footpath and into storm water drain, collecting into a stormwater pit. Fencing and signage erected as per PWC Sewage</p>
