SECTION 14 INCIDENT REPORT (*Waste Management and Pollution Control Act*)

Date and Time of Notification:	Initial Notification: Friday 19 September 2025 @ 12:30pm Update: Tuesday 7 October 2025
Person / Company:	Power and Water Corporation
Incident:	Discharge of raw sewage effluent from sewerage network at Lakeside Drive Sewage Pump Station

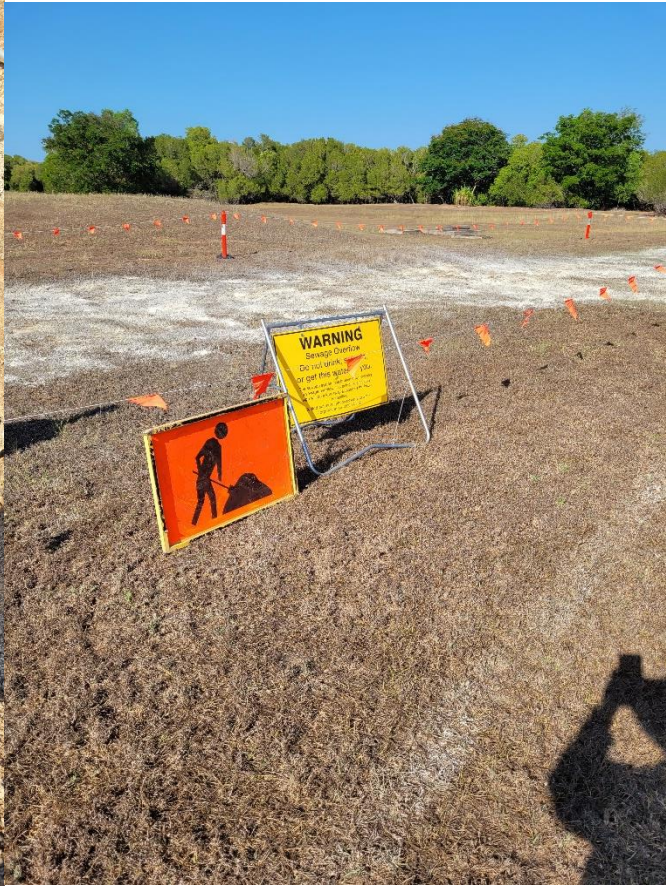
Photo 2 Signage and Flagging (Photo taken 19/09/2025)

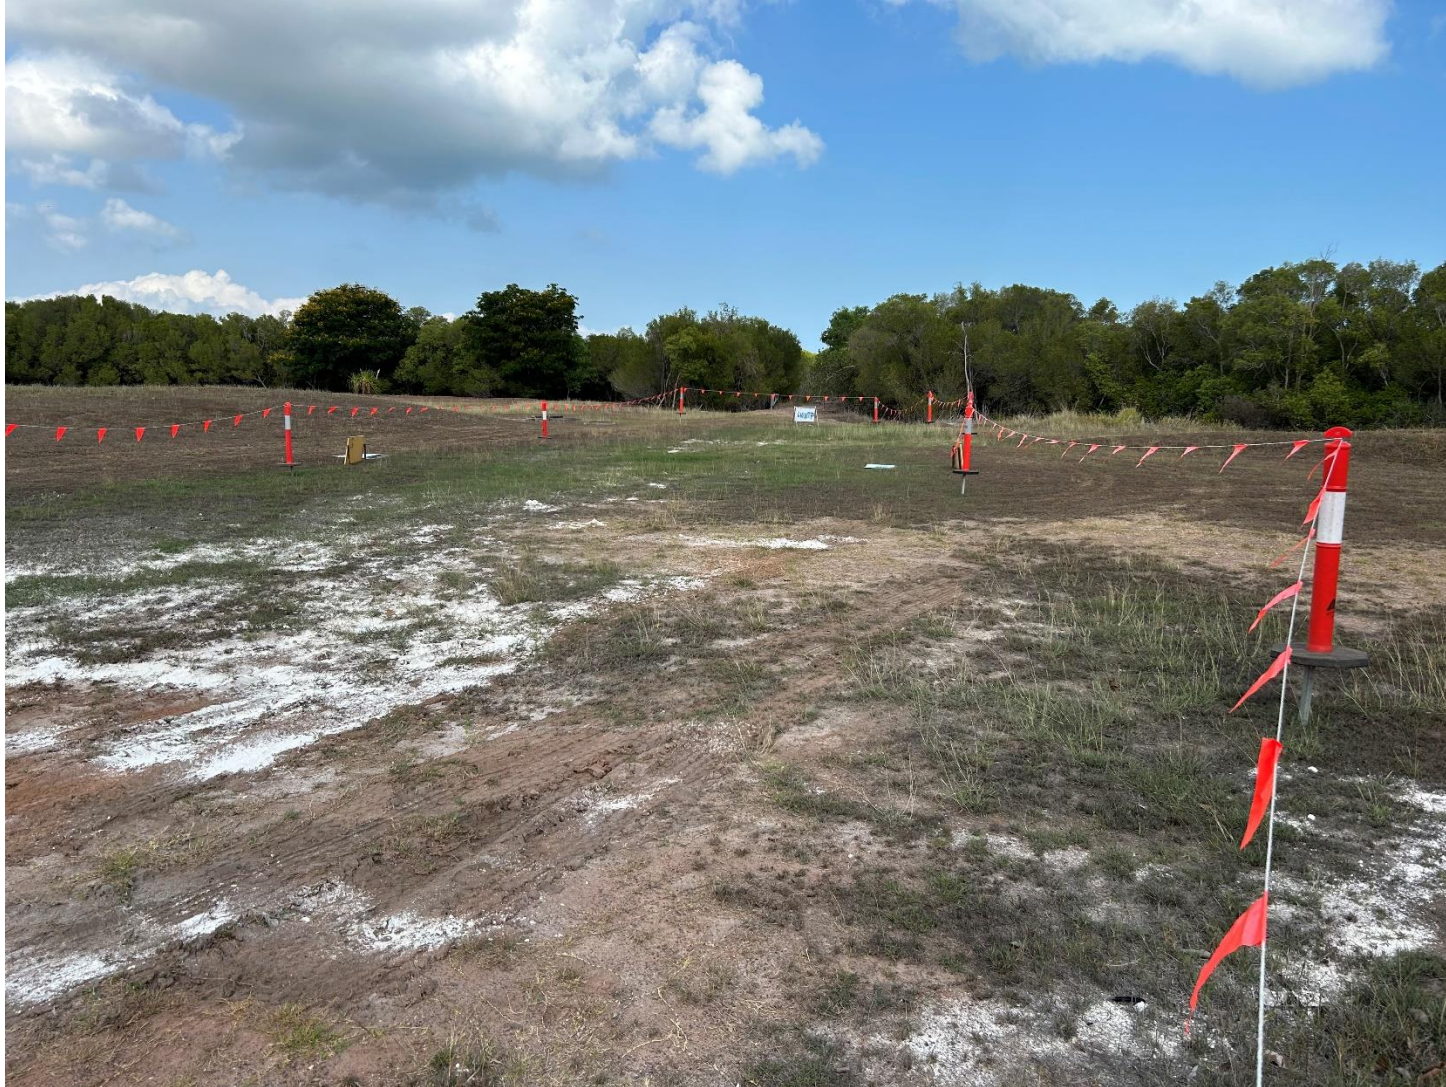
Photo 3 Extent of Spill with Lime (photo taken 06/10/2025)

(d) how the pollution has occurred, is occurring or may occur	<p>As per (c) iii & (c) iv.</p>
(e) the attempts made to prevent, reduce, control, rectify or clean up the pollution or resultant environmental harm caused or threatening to be caused by the incident	<p><i>i. Confirmation signage and fencing has been erected, as appropriate.</i></p> <p>Signage and flagging was erected (see attached photos).</p> <p><i>ii. Decontamination of the site as appropriate.</i></p> <p>Clean up will be consistent with Sewage Spills/Overflow Response Work Instruction as appropriate to the location, and to minimise risk to the Environment. Lime as placed over the area and the contaminated soil will be excavated and disposed of at one of Power and Waters sewage facilities.</p> <p>The Lakeside Drive Sewer Pump Station (SPS) is currently isolated from the system and the Lakeside catchment is diverted to Rapid Creek SPS. It is currently planned to replace this section of pipe as a matter of urgency to ensure further breaks in the pipe are prevented. Clean-up of impacted soils will be finalised once the replacement pipe has been installed. Works</p>
