Koongarra Inventory

Wednesday 15th May 2013

Kakadu National Park – Sarah Kerin, Sally-Anne Atkins and Danielle Hore

Koongarra - Site Inventory

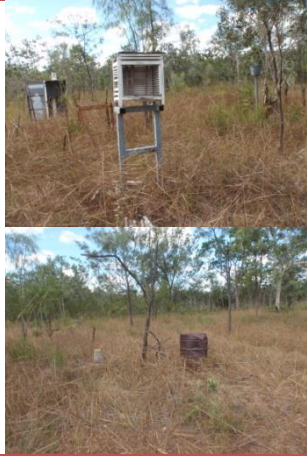
Weather station	Dysfunctional rain gauges	8576489	266802

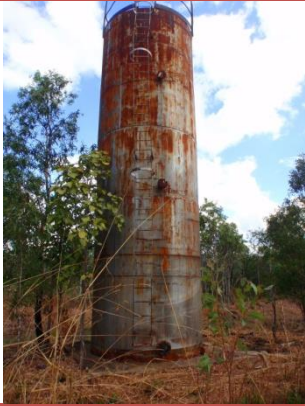
Diesel tank	10,000 gallons	Possible asbestos gasket	8576412	266673

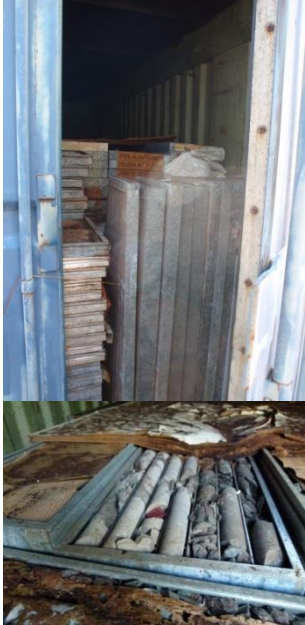
Shipping container No1	Rust along bottom of container	Core sample trays 0.5 – 0.6 μ Sv Locked with district D3 key

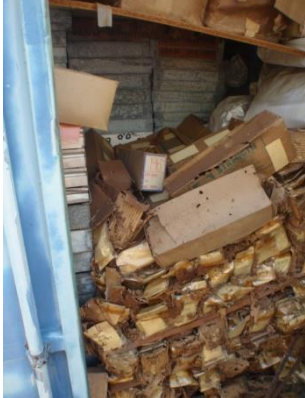
Shipping container No2	Rust along bottom of container	Core samples in trays and laboratory residue samples in boxes 1.182 – 1.356 μ Sv Locked with district D3 key

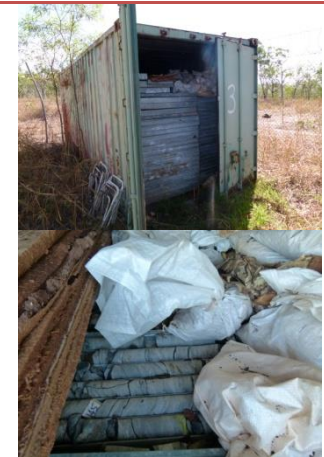
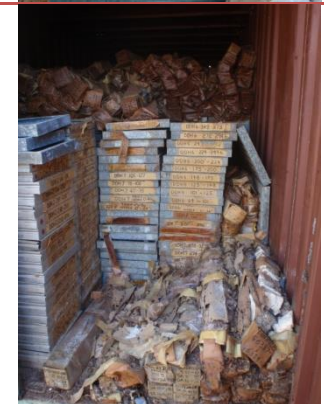
Shipping container No3	Rust along bottom of container	Core samples in trays from DDH Need to replace lock

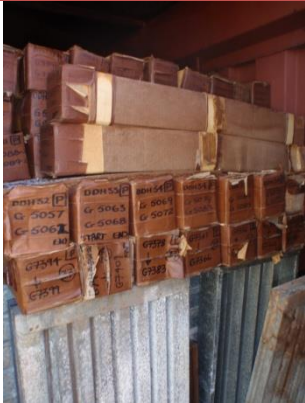
Shipping container No5	Rust along bottom of container	Core samples in trays and cardboard boxes 2 – 2.5 μ Sv Locked with district D3 key

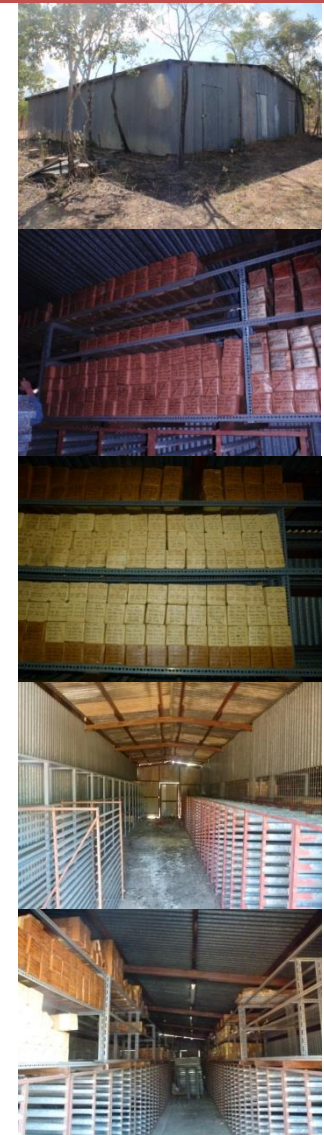
Core Shed No1

Approximately 13m x 15m
Wooden frame, tin exterior 3 doors
at both ends
New wooden roof beams and locks
fitted in approximately 2011
(access road to lease upgraded at
same time)

Core racks along the full length
of each of the 3 sections of the
shed.
761 boxed samples 1m x 20cm x
20cm

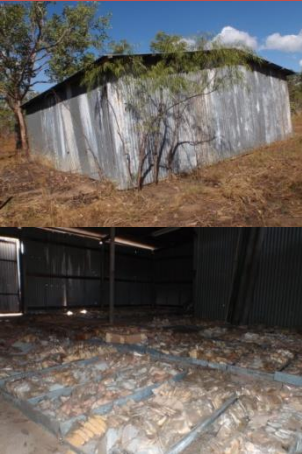
Core Shed No2	Approximately 4m x 9m Wooden frame, tin exterior	Laboratory residue samples on floor. 91 trays of samples 26 decaying boxes of samples 1.1 – 1.8 μ Sv	8576461	266619

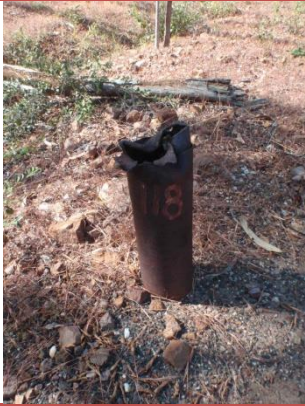
Bore 118	Non capped, damaged at top	8576781	266385

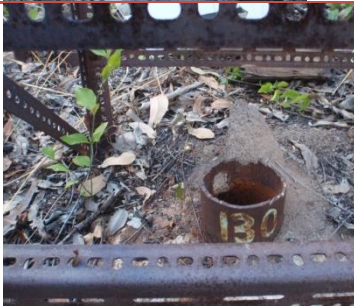
Bore 130	Non capped, approximately 20 cm above surface	8576831	266387

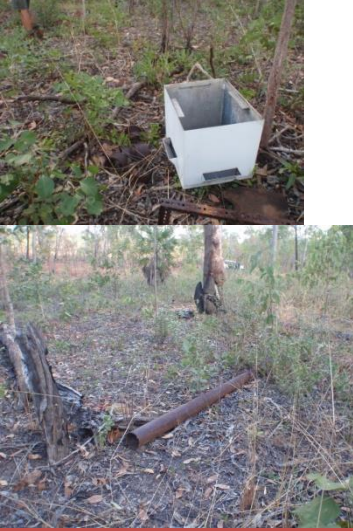
Rubbish	Bore casing remnants, galvanised tin box, steel	8576831	266387
