## **SECTION 14 INCIDENT REPORT (*Waste Management and Pollution Control Act*)**

| <b>Incident:</b> | Overflow of diluted tannin surface water to Apsley Strait from Basin 4 and Basin 1 via concrete spillways located near each basin. |

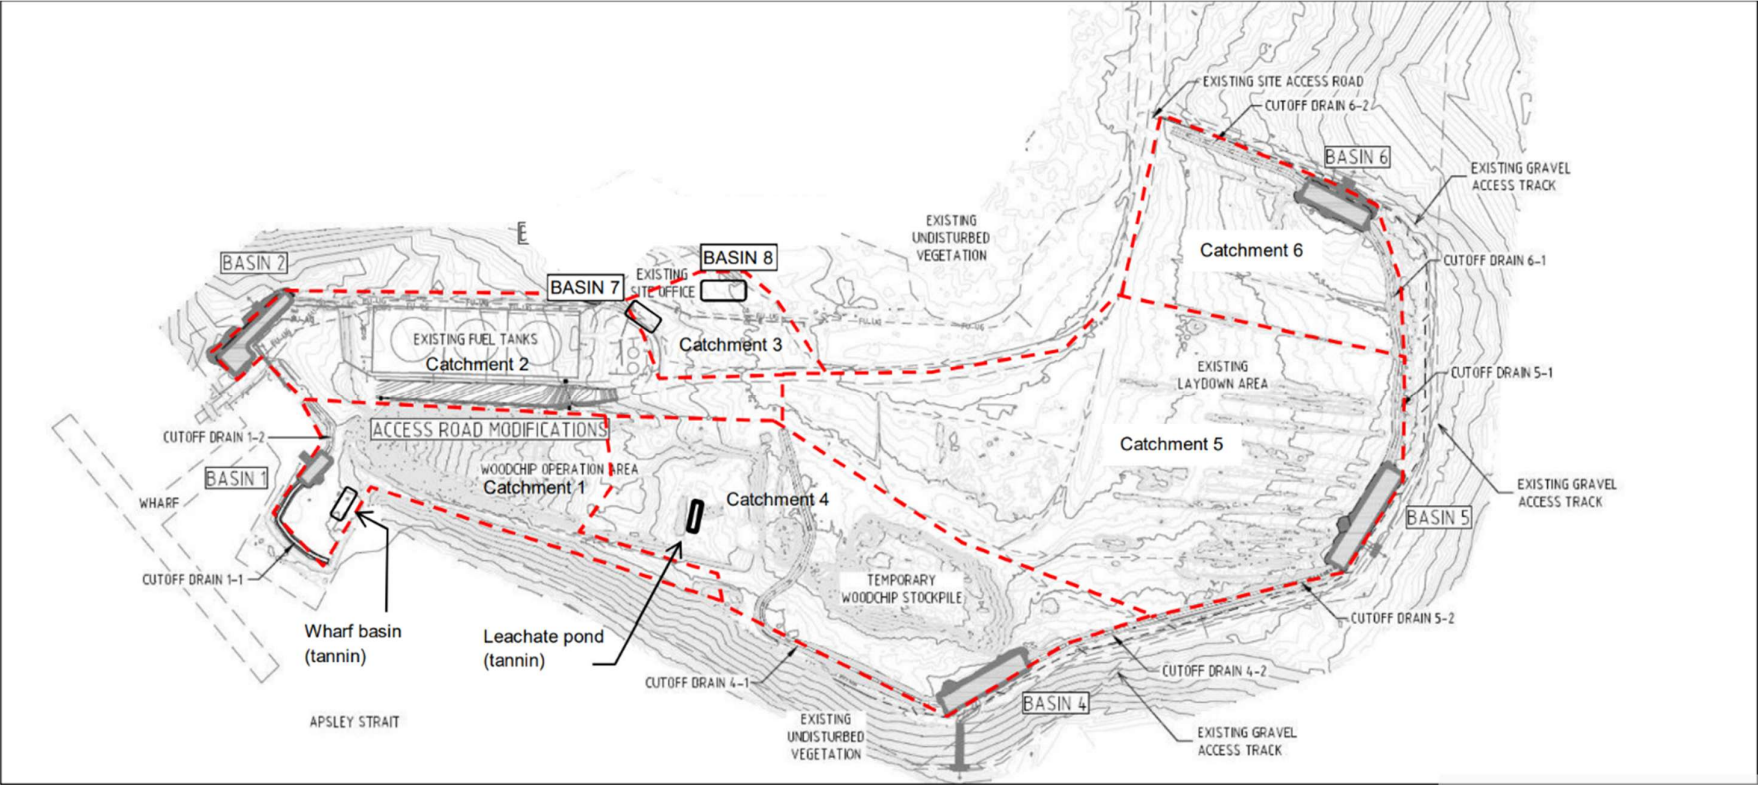
Map of Port Melville Surface Water Catchments

| <b>(b) the place where the incident occurred</b> | The Port - Port Melville, Melville Island, Tiwi Islands NT 0620<br><br>(Map attached in appendix)<br><br>GPS Coords:<br>Basin 4: 130.252889E, 11.252230S<br>Final Discharge point: 130.252826E, 11.252464S<br><br>Basin 1: 130°25'14.40"E, 11°25'19.14"S<br>Final Discharge point: 130°25'13.80"E, 11°25'17.40"S |
