# Notification of environmental incident

| Incident details | | | | |
|---|---|---|---|---|
| Name of mining site | GEMCO | | | |
| Date and time of incident<br>And / or when you first became aware of it | 17/04/2026 at 10:00am | | | |

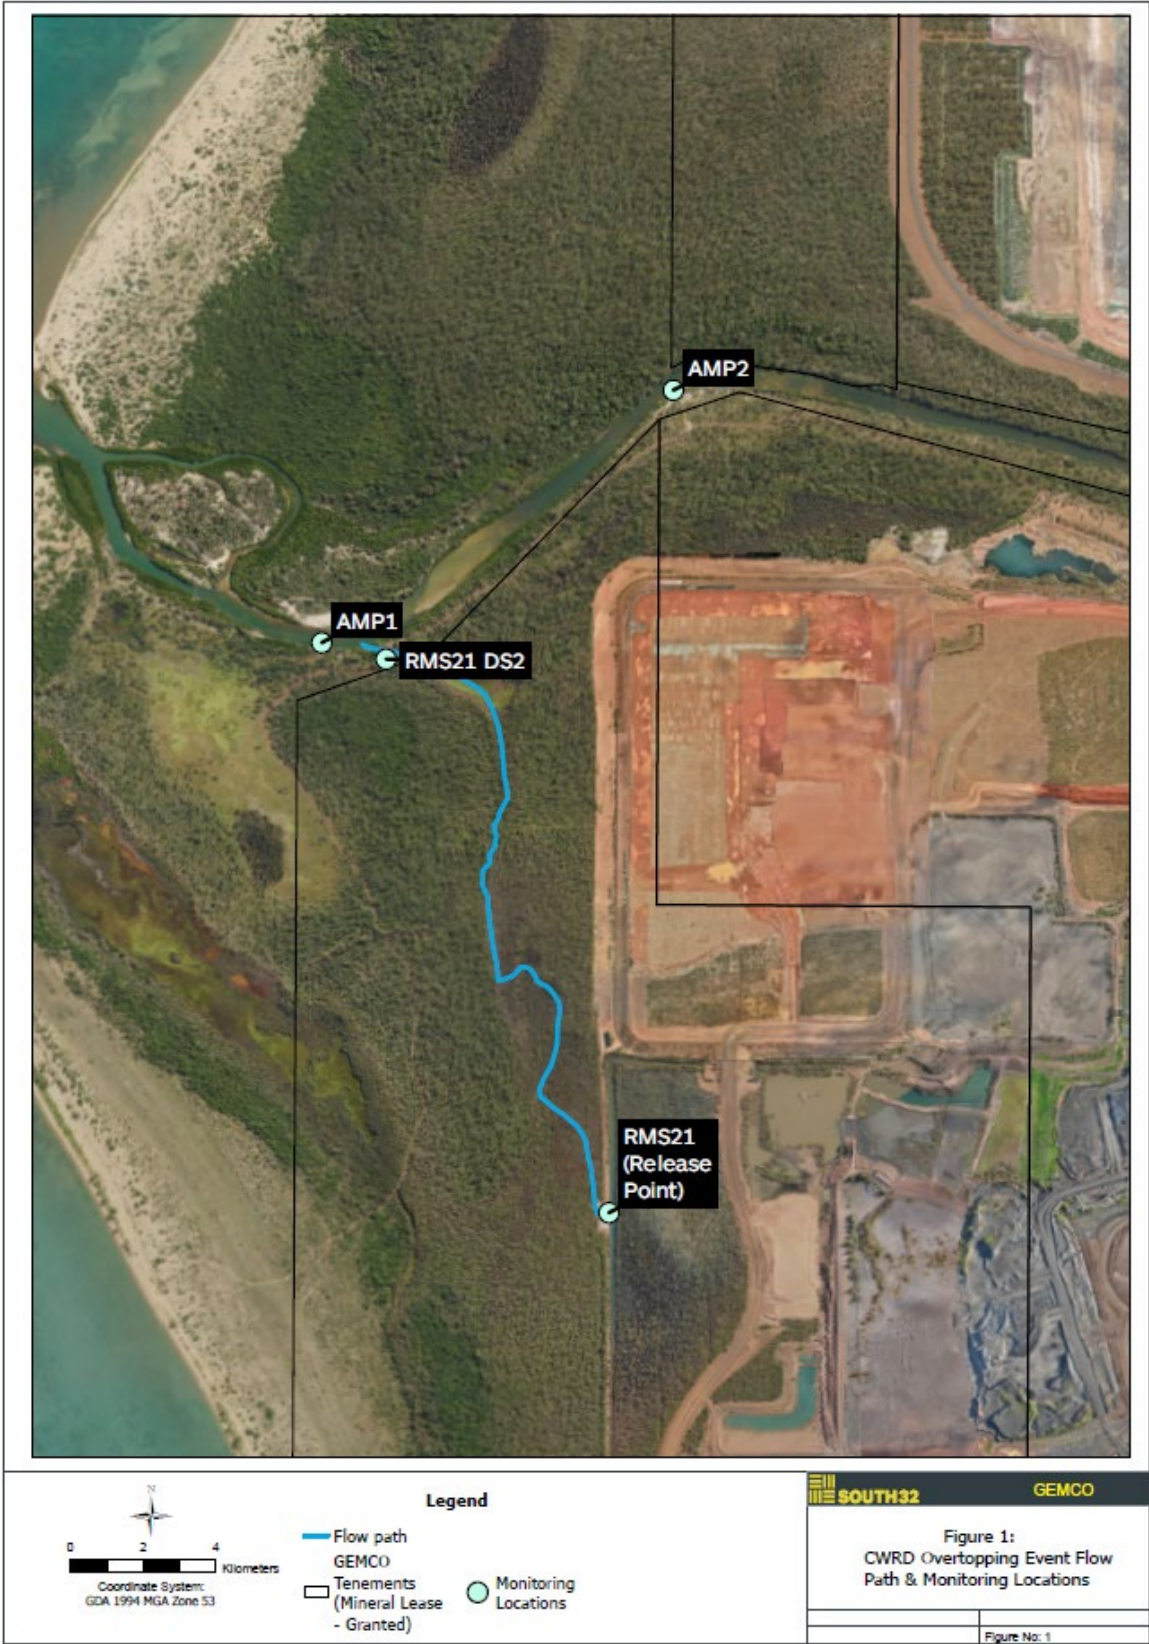
Figure 1: Map of Water Flow Path and Monitoring Locations

| Incident details | | | | |
|---|---|---|---|---|
| Incident location<br>Use GPS co-ordinates, attach map etc. as appropriate | GEMCO Mine Site. Water flow path and discharge location (53L 653275, 8454829) provided in <b>Figure 1</b> . | | | |

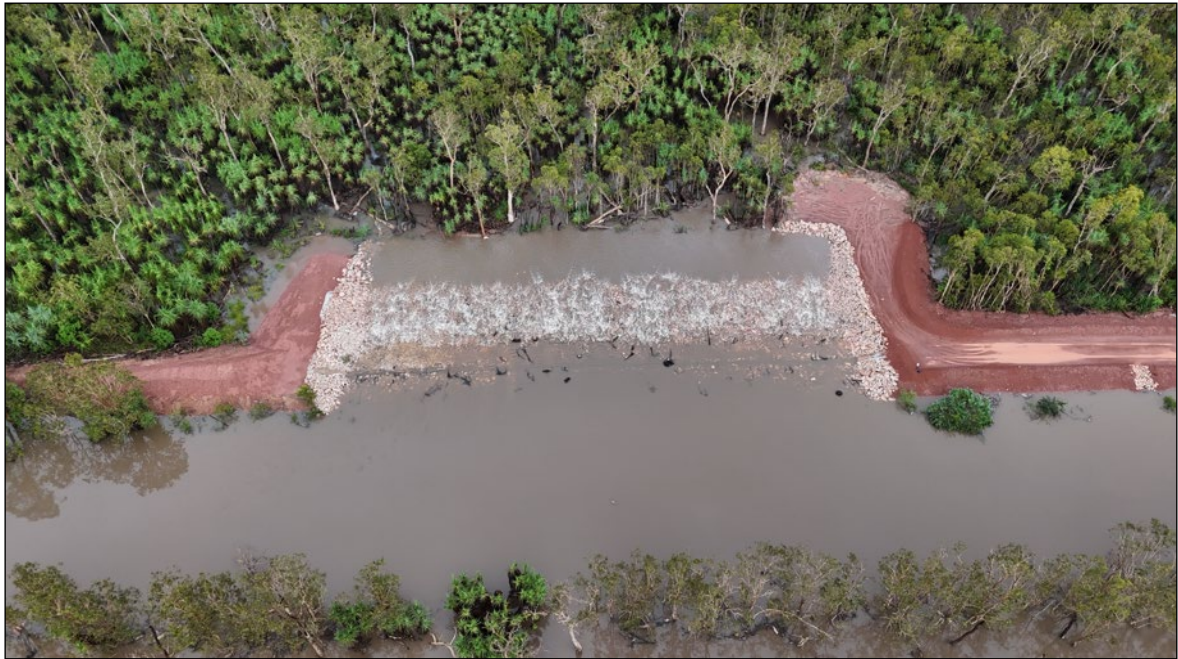
**Figure 2: CWRD Spillway (19/04/2026 7:31am)**

| Incident details | | | | |
|---|---|---|---|---|
| Description of incident<br>Attach photographs etc. | <p>Water was released from the engineered spillway of the Concentrator Western Return Drain (CWRD). Following a significant event (&gt;170 mm), water levels in the CWRD rose and flowed over the spillway. Subsequent rainfall (&gt;130 mm) has prolonged the release.</p> <p>Water from this release has the potential to travel overland and discharge off-lease to the Angurugu River approximately 1.7 km distant.</p> <p>Drone photographs are provided in <b>Figures 2 and 3</b>.</p> | | | |

| <b>Current situation</b><br>Potential / ongoing / ceased etc. Include current location of contaminated material | Ongoing release via an engineered spillway. | | | | |

| <b>Immediate action taken</b><br>ie, spill contained / stopped / location of disposal | Verified all CWRD inflows were stopped and that all discharge pumps from the CWRD were operating as per GEMCO's water management approach. | | | | |

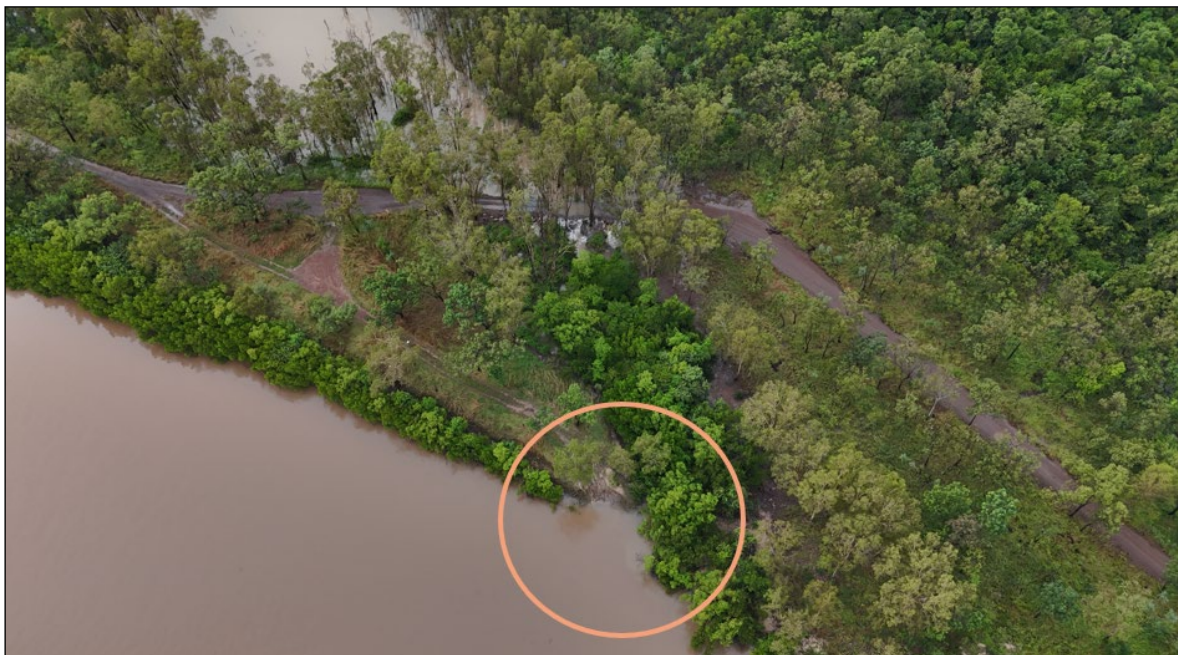
**Figure 3: Discharge Point (RMS21 DS2) at Angurugu River (19/04/2026 7:35am)**

| <b>Details of any samples taken</b><br>When / where / type / number / time for availability of results etc. Include plans of sampling locations where possible | <p>In-situ and laboratory water samples were taken from the source water (CWRD – RMS21), from a point immediately prior to entering the Angurugu River (discharge point – RMS21 DS2), and locations upstream (AMP2) and downstream (AMP1) of the discharge point on 17/04/2026. (see Figure 1). AMP1, AMP2 and RMS21 DS2 were sampled again on 19/04/2026.</p> <p>These samples have been sent to an external laboratory for analysis.</p> | | | | |
