## s14 Incident Notification

| <b>Incident</b> | Hydraulic oil spill |
| <b>(a) the incident causing or threatening to cause pollution</b> | Approximately 310 litres of hydraulic oil was spilt from an excavator during transport. |

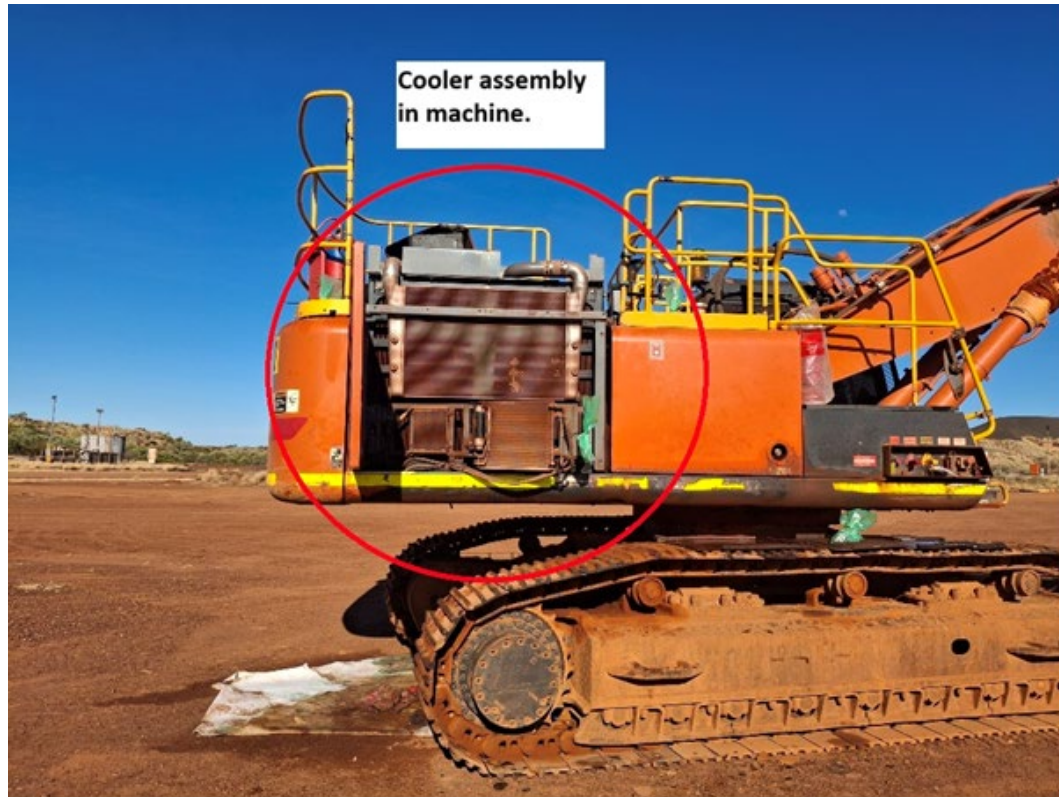
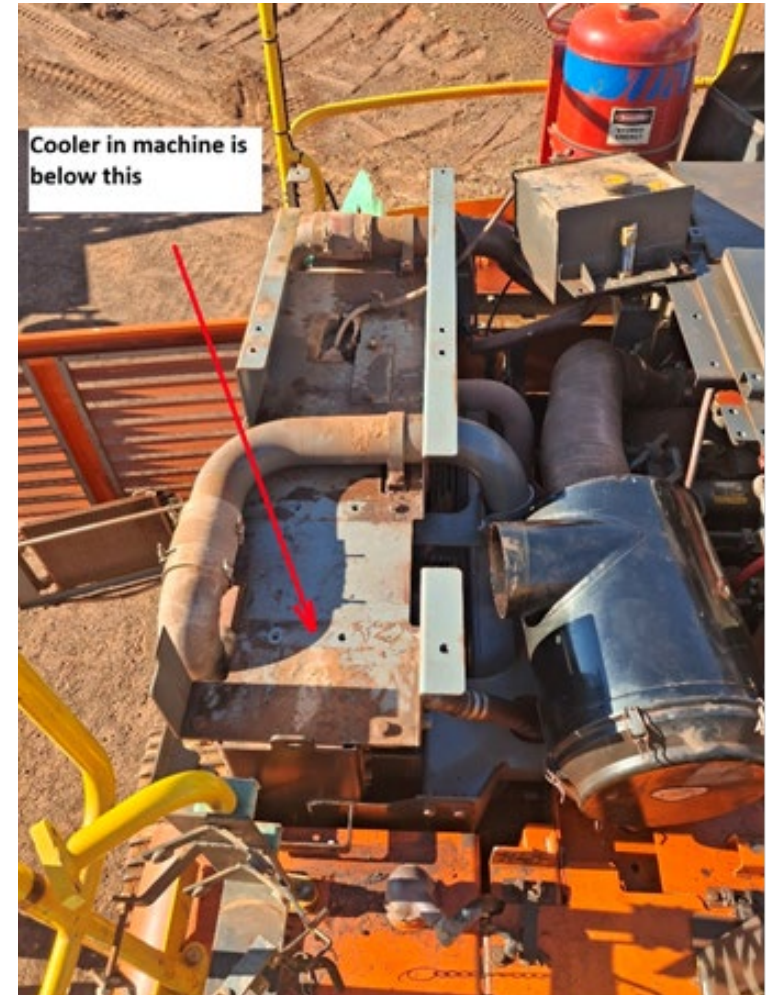
| | <p>The secondary smaller spill (estimated &lt;10 litres) occurred beneath the excavator upon start-up and operation of the hydraulic system, before it was realised that the hydraulic system had been damaged. The oil cooler is not visible from the exterior of the excavator and the leak was only detected once oil had leaked onto the ground below the excavator.</p> |

View from below the machine with three rear belly guards removed. Front guard is still in place for reference.  
Circled in red is the bottom of the cooler assembly where the oil will run down to.  
Black panel is the outside frame of the cooler assembly. Hydraulic oil cooler is inside this frame behind shrouds.

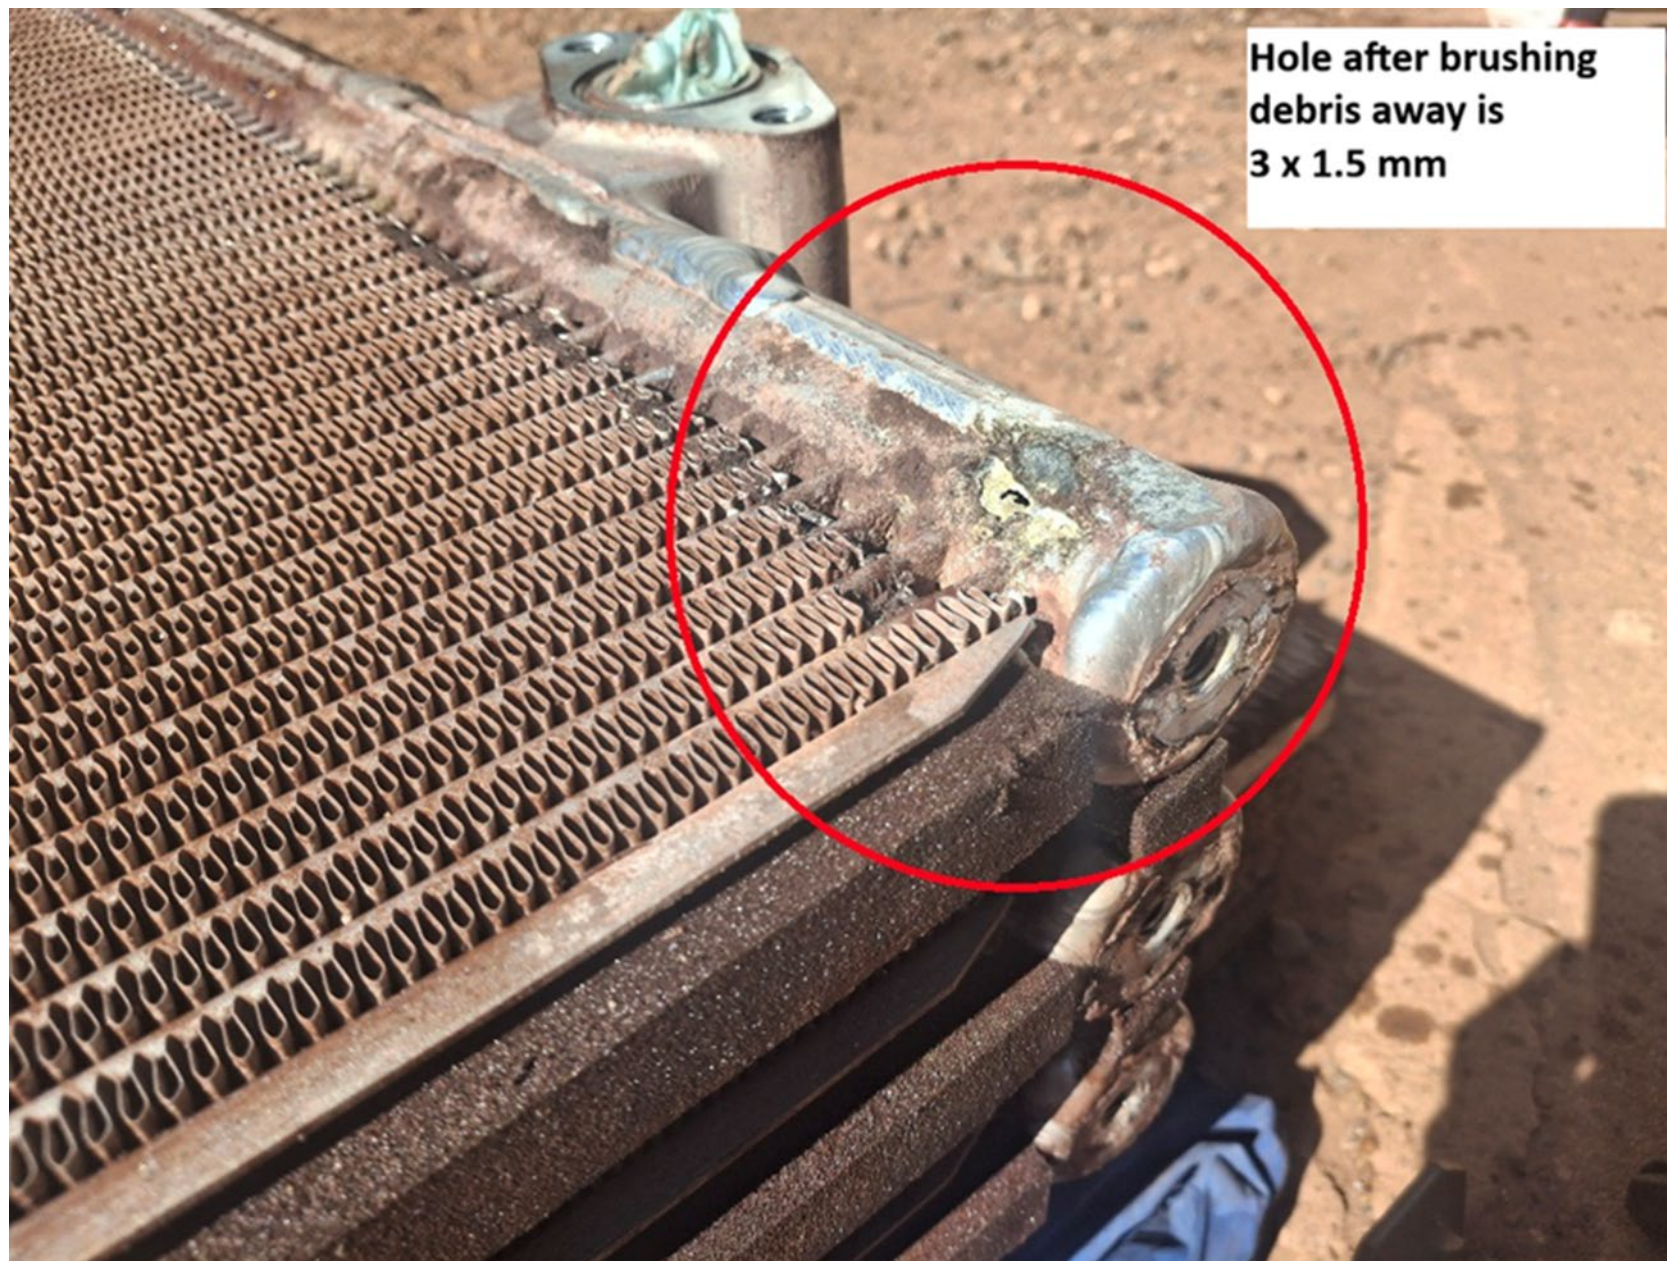
| <b>(d) how the pollution has occurred, is occurring or may occur</b> | <p>The excavator was started/run-up in the days prior to transport, with no leaks noted. The machine was trammed around and washed. On the day of loading in Derby WA, a small leak was repaired prior to loading.</p> <p>The cause of the primary spill is attributed to road transport conditions resulting in excessive vibration that damaged the excavator's hydraulic cooling system (refer Attachment 2 for photos of the damaged oil cooler). The origin point of the primary spill is unknown, although it is considered more likely to have commenced on the unsealed Tanami Road after the junction with the Great Northern Highway south of Halls Creek.</p> <p>The damage to the lowest point of the hydraulic oil cooler resulted in an oil leak at the rate of a drop every few seconds (when the machine is off the cooling system is not operating). Note that the rate of the leak is expected to have slowed over time due to the loss of head pressure as the oil level declined.</p> <p>In addition to the unknown origin point, the distance over which the spill occurred is also unknown. However, if it is assumed that the leak commenced at the beginning of the Tanami Road en route to CTP, then the flow rate is estimated at 60 l/h for a truck travelling 400km at an average speed of 80 km/h. This equates to an estimated spill rate of 0.75 l/km.</p> |

Hole after brushing  
debris away is  
3 x 1.5 mm
