SECTION 14 INCIDENT REPORT (*Waste Management and Pollution Control Act*)

Date and Time of Notification:	Tuesday 3 rd January 2023, 15:20hrs
Person / Company:	Power and Water Corporation (PWC)
Incident:	Discharge of diluted raw sewage from Tennant Creek sewage infrastructure.

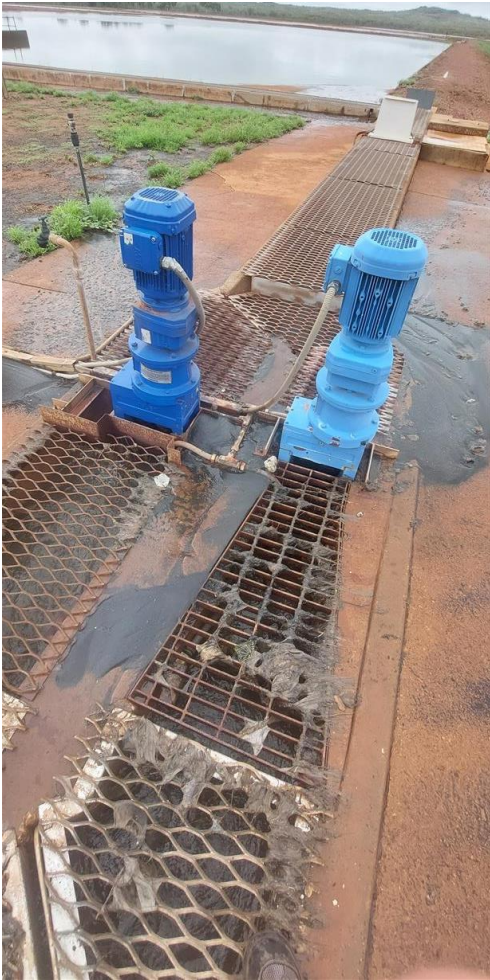
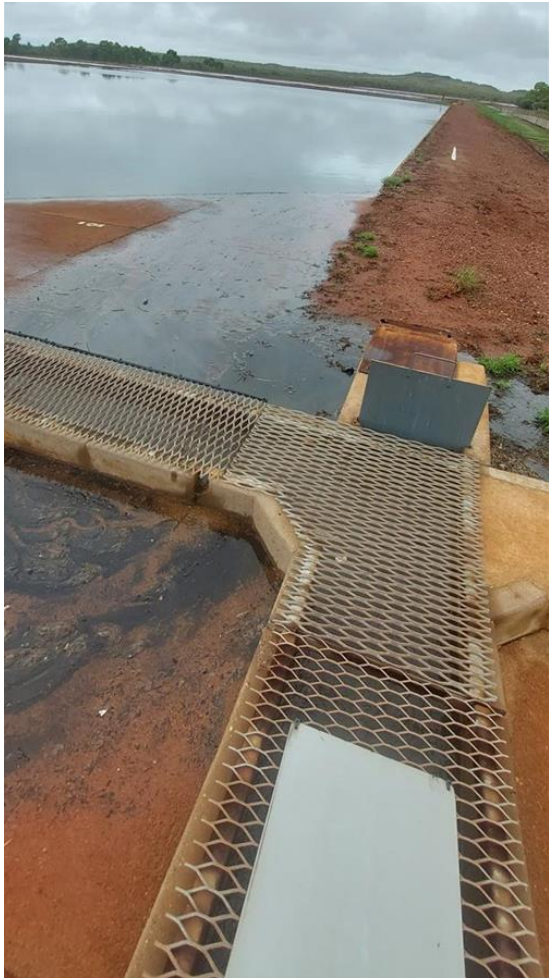
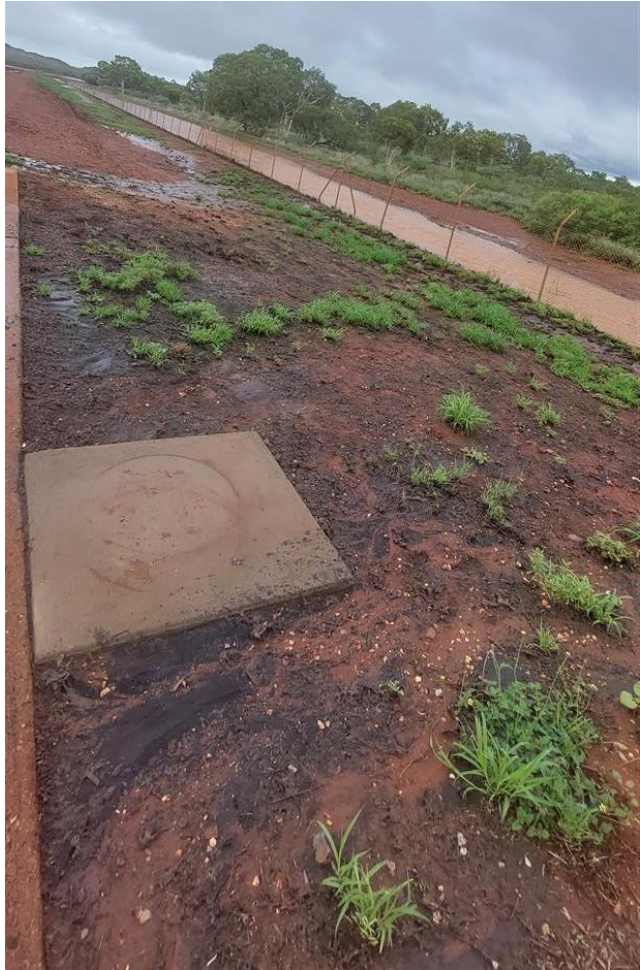
<p>Access by the public to the spill location is possible, as it ended up flowing into other pooling stormwater along the outside of the ponds perimeter fence, along a vehicle track. A visual barrier in the form of witches hats and warning signage has been erected in prominent and appropriate locations.</p>
<p>(c) the date and time of the incident</p>	<p><i>i. The time and date of commencement and cessation of the discharge.</i></p> <p>The exact timing of the overflow is unknown, but would have started in the early hours of 29/12/2022. The overflow ceased around 07:40hrs 29/12/2022, when the systems pressure was relieved by diverting some of the flow.</p> <p><i>ii. How PWC were notified, or became aware of the discharge.</i></p> <p>The Tennant Creek Systems Coordinator observed the overflow during a routine inspection of the ponds, and discovered the overflow at the incoming channel near the macerators. The Water and Sewer Technician was advised as was management. Environmental Services only became aware of the event 03/01/2023.</p> <p><i>iii. The process by which the discharge occurred.</i></p> <p>The overflow was a result of a combination of debris stuck in the inflow channel at the macerators and the large amount of inflow and infiltration into the sewerage system during a high rainfall event experienced during the morning of the 29/12/2022.</p> <p><i>iv. The reason why the discharge occurred.</i></p> <p>As per (c) iii, The capacity of the partially blocked flume was temporarily exceeded by a combination of inflows and infiltration caused by heavy rains on the morning of the 29/12/2022.</p>

Appendix B – Location Photographs – macerators at inflow channel and where overflow occurred down embankment.

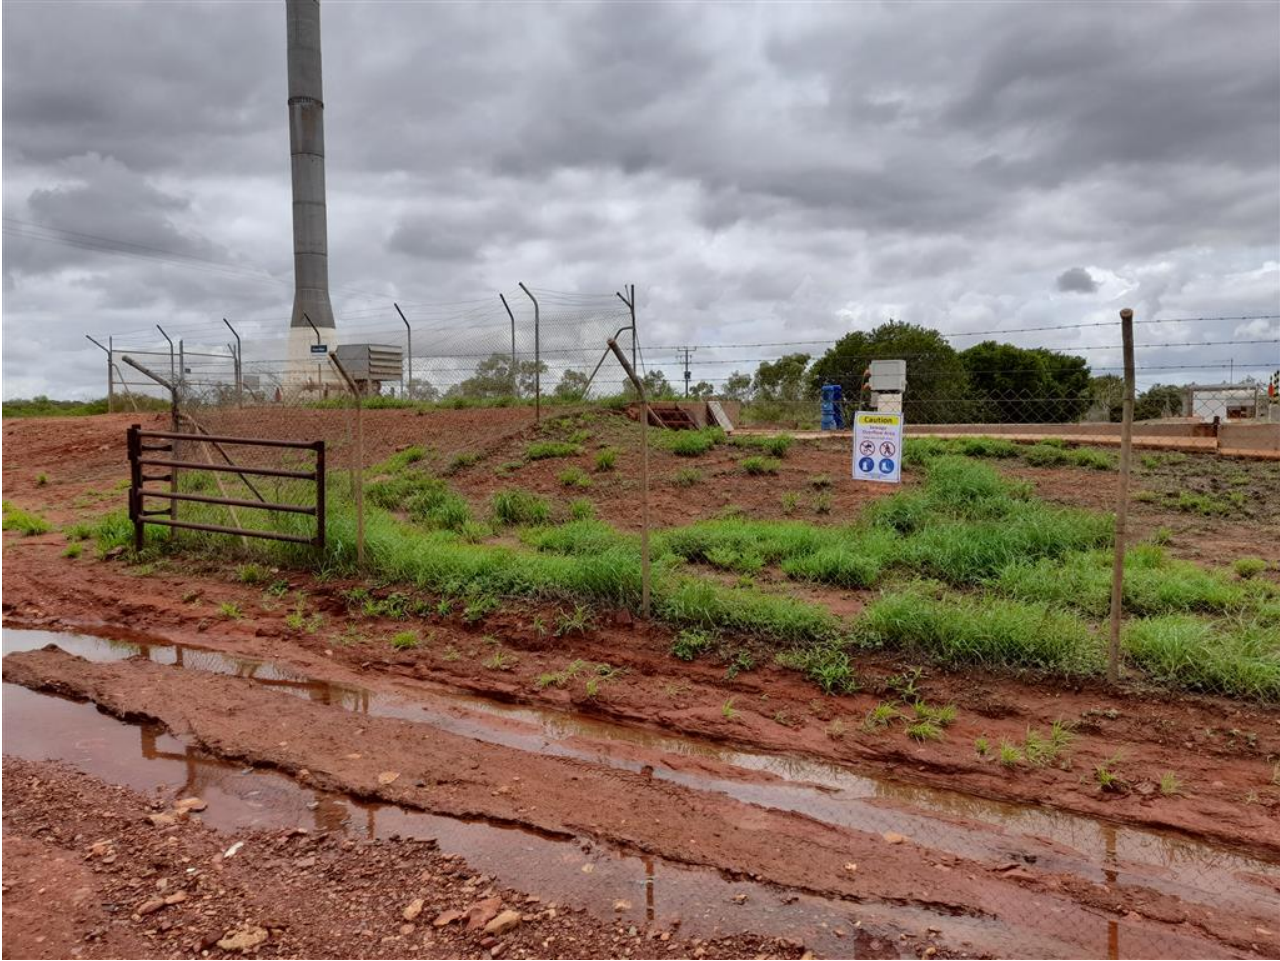
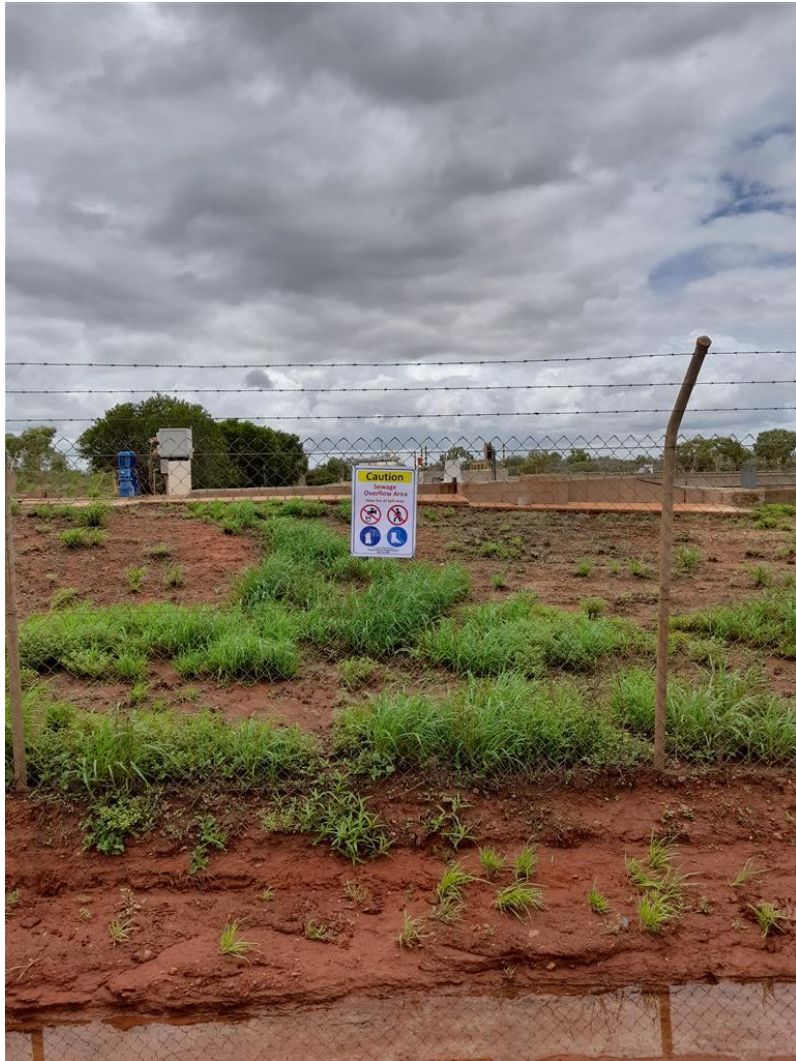
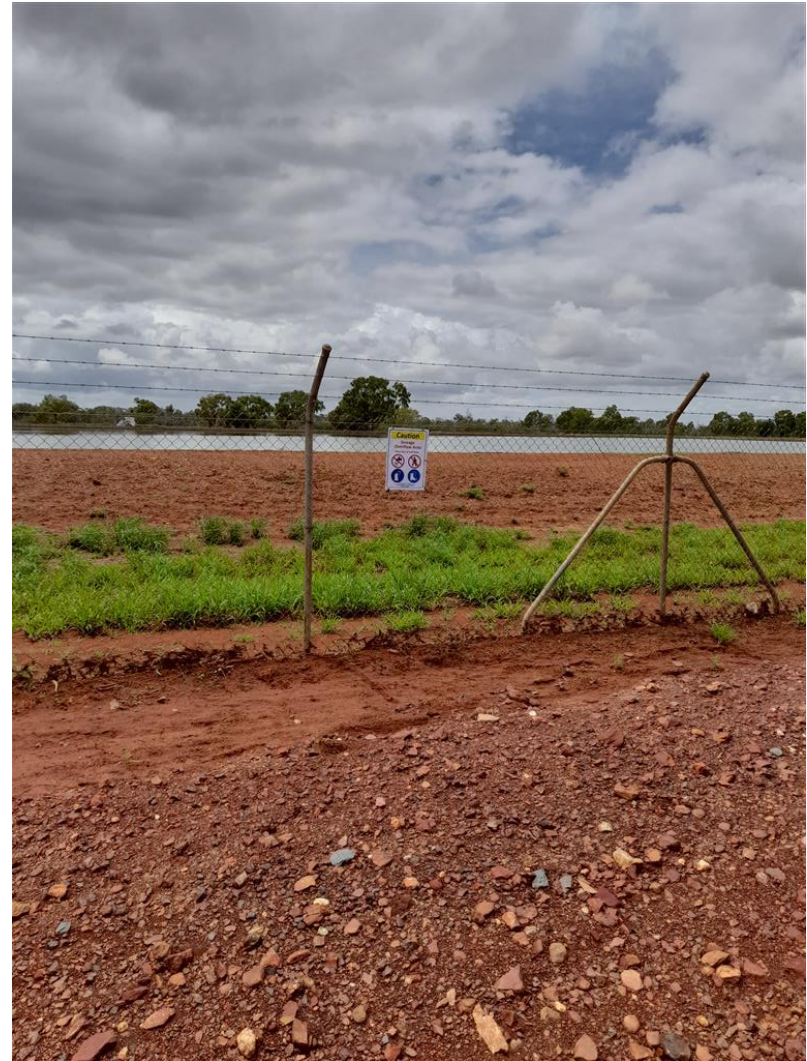
Appendix C – Location Photographs – Warning signage displayed along the perimeter fence
