SECTION 14 INCIDENT REPORT (*Waste Management and Pollution Control Act*)

| Incident: | Discharge of highly diluted sewage effluent from the Yuendumu wastewater stabilisation ponds |

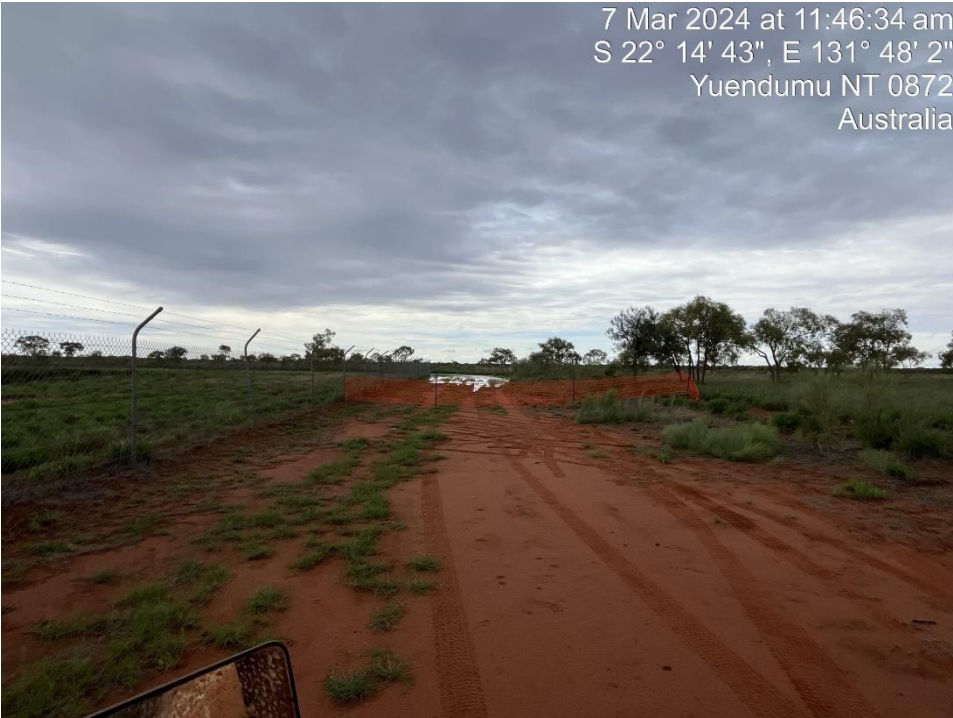
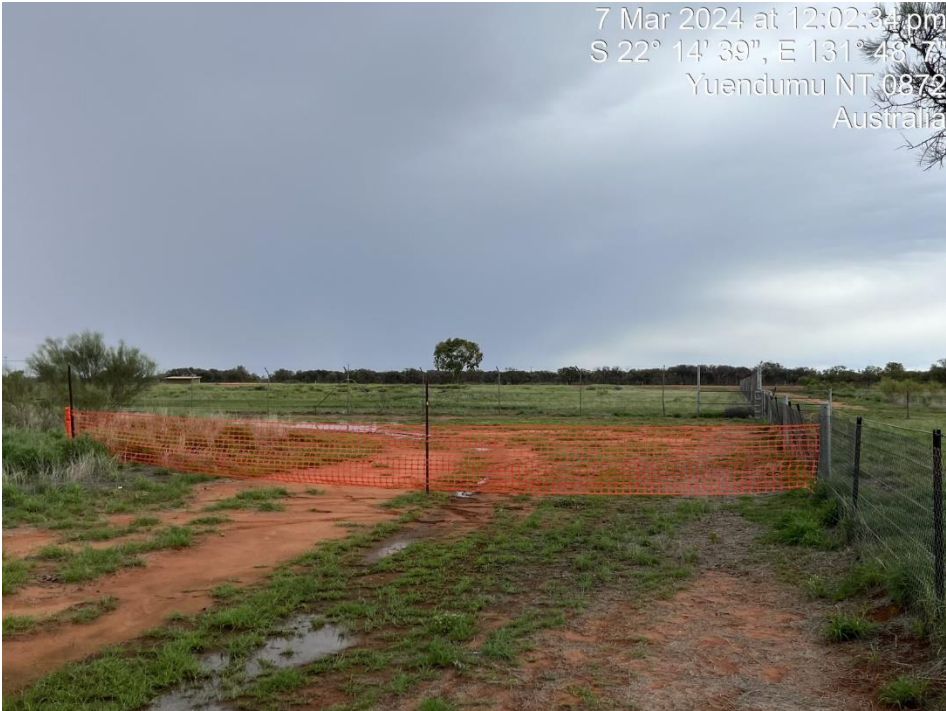
Appendix B – Location Photographs, showing the access track around the facility blocked off to prevent access to the spill site

| <p>(b) the place where the incident occurred</p> | <p><i>i. Description of the PWC asset from which the discharge occurred.</i></p> <p>Yuendumu wastewater stabilisation ponds.</p> <p><i>ii. GPS coordinates of the discharge point from the PWC asset, and the final coordinates of the final discharge point.</i></p> <p>Discharge Point 1: 131.8011133E, 22.2445769S (pond 7 wall) Final Discharge Point: 131.8014771E, 22.2442583S (approximate final discharge point)</p> <p>Discharge occurred from the lowest point of the final treatment pond, meaning it was fully treated effluent.</p> <p><i>iii. Indicate any locations nearby to the discharge point where public can gain ready-access, such as public open spaces through which the discharge moves.</i></p> <p>Access by the public to the spill is possible, however the access track around the wastewater stabilisation ponds (WWSP) facility has been blocked off at both ends of where the spill area is, with temporary fencing, see appendix B.</p> |

| <p>(e) the attempts made to prevent, reduce, control, rectify or clean up the pollution or resultant environmental harm caused or threatening to be caused by the incident</p> | <p><i>i. Confirmation signage and fencing has been erected, as appropriate.</i></p> <p>Barricading has been erected at both ends of the access track surrounding the facility where the pooling effluent is, to prevent or reduce the possibility of the public making contact with the spill.</p> <p><i>ii. Decontamination of the site as appropriate.</i></p> <p>Clean up consistent with Sewage Spills/Overflow Response Work Instruction as appropriate to the location, and to minimise risk to the Environment. Site was inspected for any wastewater gross pollutants, of which none were observed.</p> |
