## SECTION 14 INCIDENT REPORT (*Waste Management and Pollution Control Act*)

<b>Date and Time of Notification:</b>	Friday 18 <sup>th</sup> October 2019, 14:35pm
<b>Person / Company:</b>	Power and Water Corporation ( <b>PWC</b> )
<b>Incident:</b>	Discharge of raw sewage from sewerage network (suspected ruptured rising main)

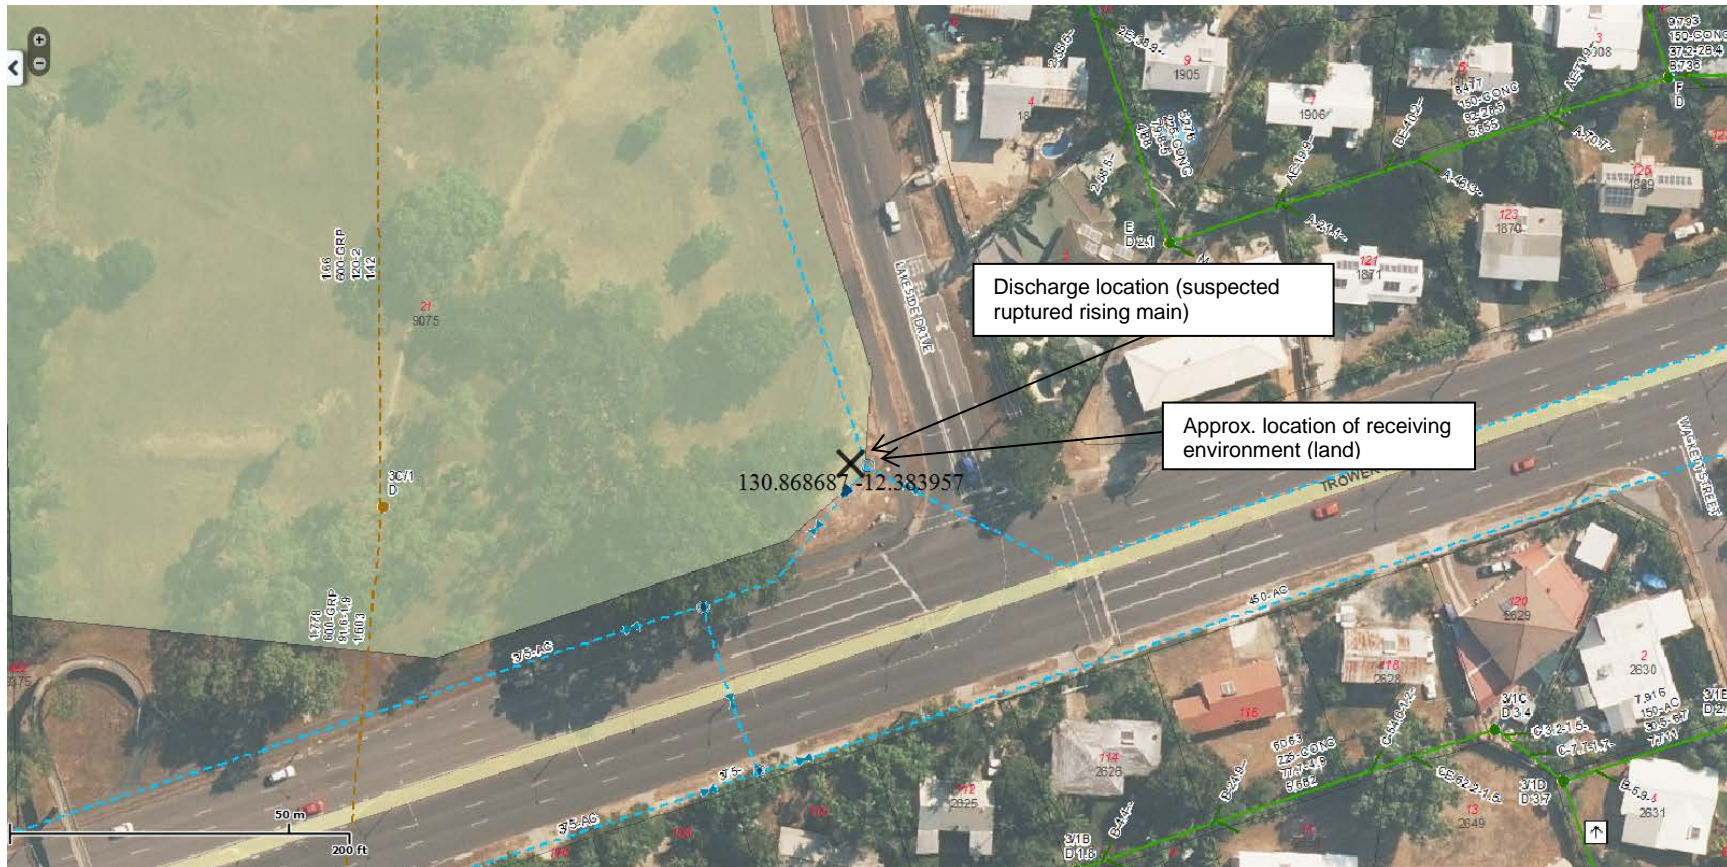
<p><b>(b) the place where the incident occurred</b></p>	<p>Corner of Lakeside Drive and Trower Road, Alawa – Suspected Ruptured Rising Main</p> <p><i>i. Description of the PWC asset from which the discharge occurred.</i></p> <p>Rising main located at Corner of Lakeside Drive and Trower Road, Alawa – as per map below.</p> <p><i>ii. GPS coordinates of the discharge point from the PWC asset, and the final coordinates of the final discharge point.</i></p> <p>Discharge Point: 130.868687, -12.383957 Final Discharge Point: 130.868687, -12.383957</p> <p><i>iii. Indicate any locations nearby to the discharge point where public can gain ready-access, such as public open spaces through which the discharge moves.</i></p> <p>Access was possible by the public, however the area impacted by the discharge on land has been fenced off, preventing access. The area was checked for gross pollutants of which none were visible, due to the overflow seeping through the ground to the surface. Clean up was undertaken as per Sewage Spills/Overflow Response Work Instruction.</p> <p>The wastewater pooled on the land beside the main alignment, and did not enter stormwater or any nearby surface water.</p>
