## SECTION 14 INCIDENT REPORT (*Waste Management and Pollution Control Act*)

<b>Date and Time of Notification:</b>	9:30 AM on 30 <sup>th</sup> January 2020
<b>Person / Company:</b>	GEMCO Mining Pty Ltd
<b>Incident:</b>	The GEMCO Port Facility received rainfall that resulted in the overtopping of stormwater infrastructure for a short duration. The water from the event entered into Milner Bay.
<b>(a) the incident causing or threatening to cause pollution</b>	Stormwater from GEMCO Port stockpiles entering Milner Bay.
<b>(b) the place where the incident occurred</b>	GEMCO's Port Facility (see Figure 1 below).
<b>(c) the date and time of the incident</b>	29 <sup>th</sup> January 2020 (approximately 9:30 PM)
<b>(d) how the pollution has occurred, is occurring or may occur</b>	Overtopping of stormwater infrastructure.
<b>(e) the attempts made to prevent, reduce, control, rectify or clean up the pollution or resultant environmental harm caused or threatening to be caused by the incident</b>	<p>An investigation has commenced into why the stormwater pumps in place to manage the water have failed. If there has been a failure, repairs will be carried out to resolve the issue.</p> <p>Water is

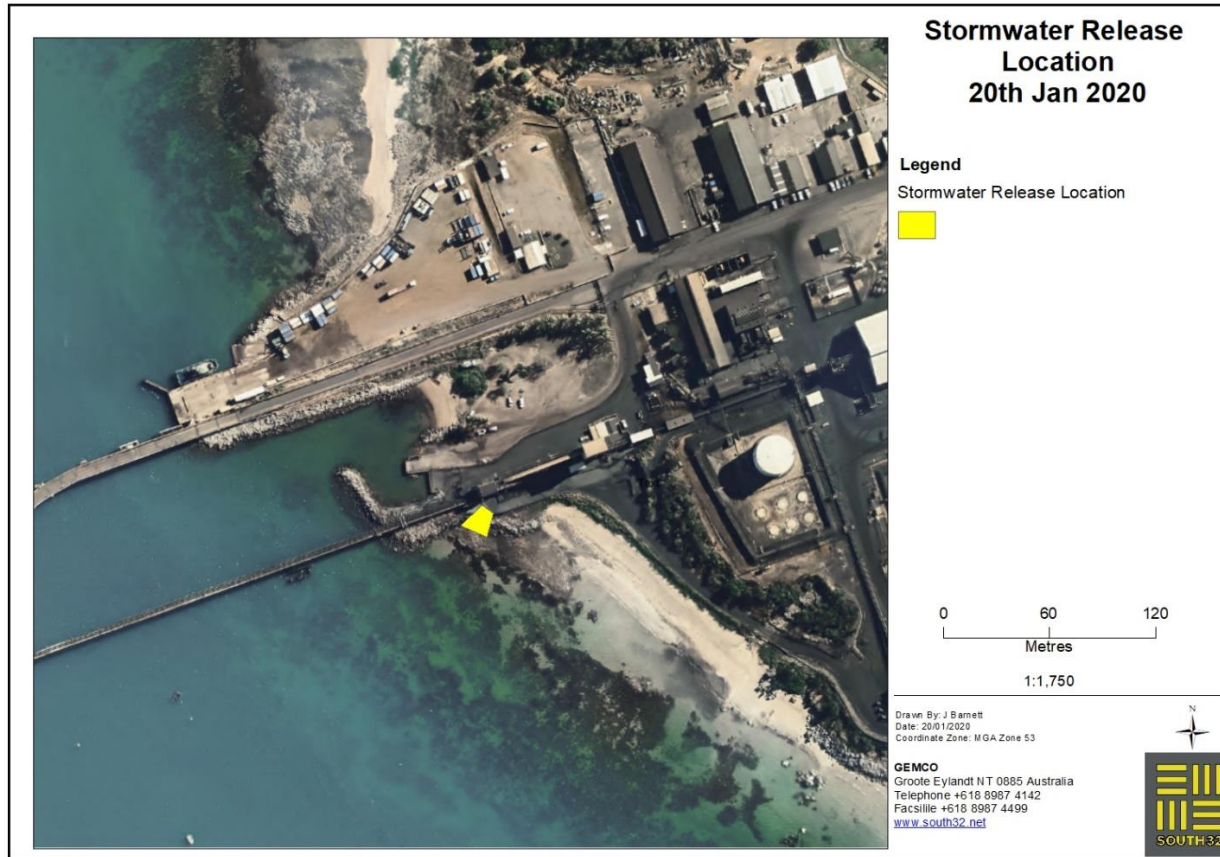
Figure 1: Stormwater release location
