## SECTION 14 INCIDENT REPORT (*Waste Management and Pollution Control Act*)

<b>Date and Time of Notification:</b>	Wednesday 2 <sup>nd</sup> November 2021, 13:00hrs
<b>Person / Company:</b>	Power and Water Corporation ( <b>PWC</b> )
<b>Incident:</b>	Discharge of raw sewage from sewerage network

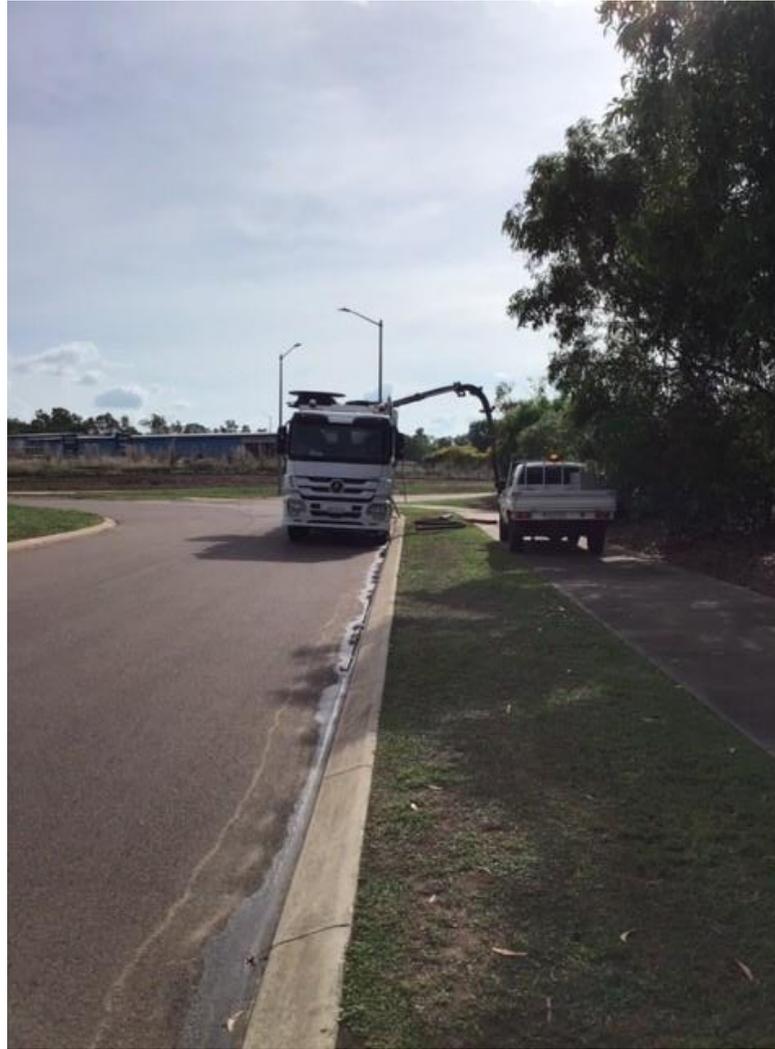
Appendix B – Photograph of one of four educator trucks relieving pressure on sewage system.
