SECTION 14 INCIDENT REPORT (*Waste Management and Pollution Control Act*)

Date and Time of Notification:	Friday 7 th January 2022, 14:00hrs
Person / Company:	Power and Water Corporation (PWC)
Incident:	Discharge of sewage from sewerage network (ORG)

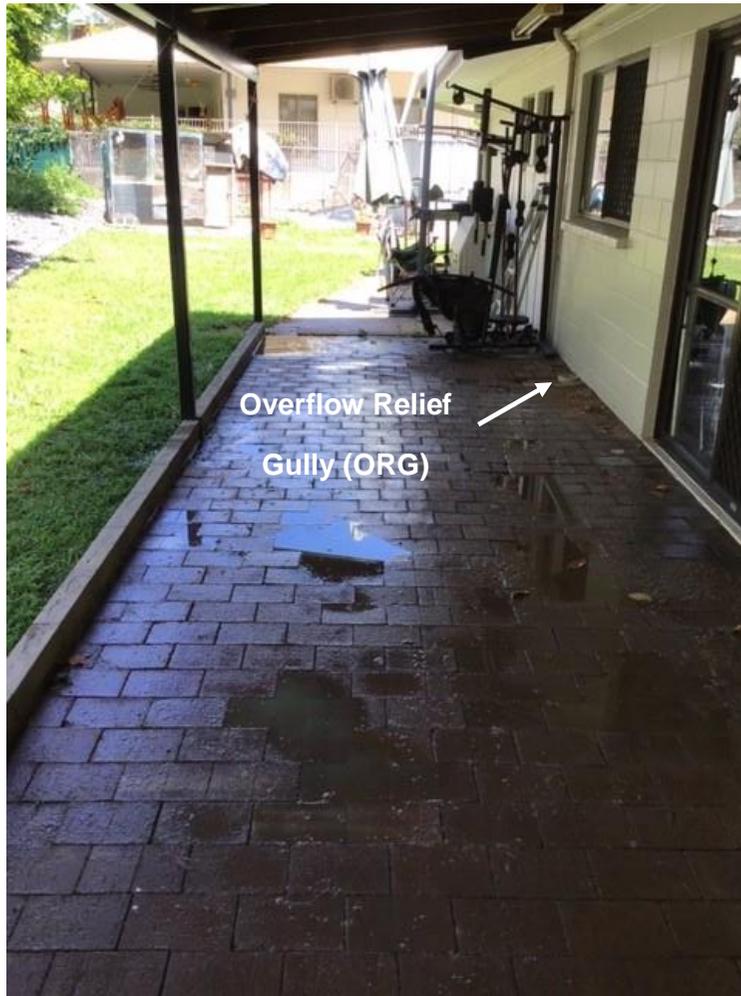
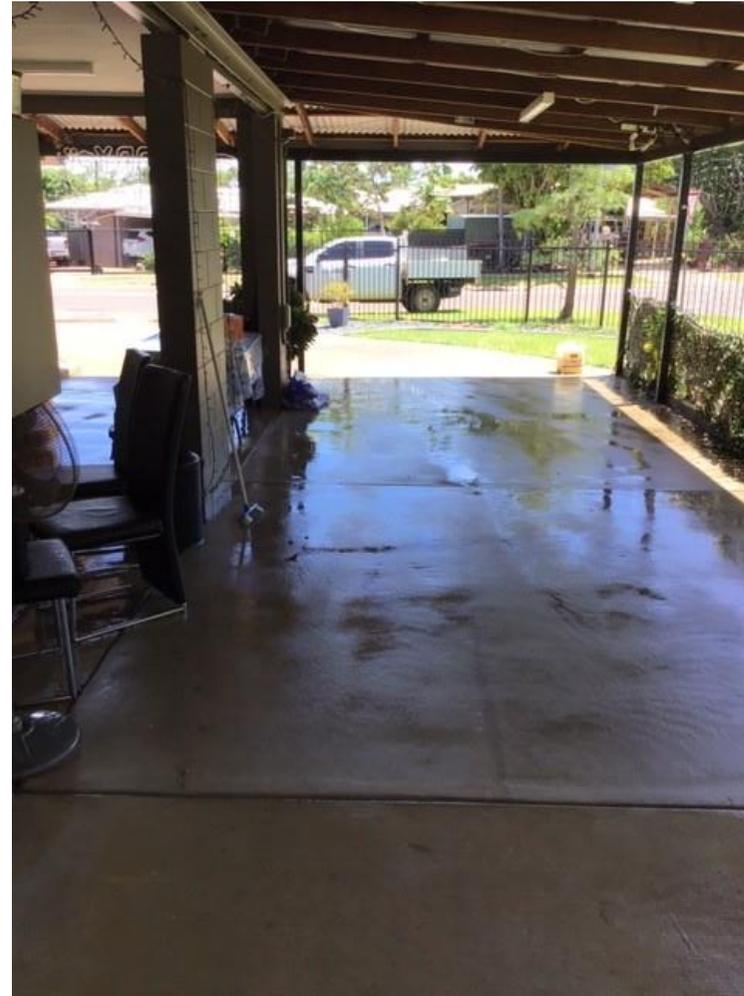
Appendix B – Photographs of the spill site, post clean up.

(c) the date and time of the incident	<p><i>i. The time and date of commencement and cessation of the discharge.</i></p> <p>The commencement time of the overflow is unknown. The overflow was observed at approximately 10:15hrs by PWC staff on 07/01/2022, and the spill was stopped by 11:00hrs 07/01/2022.</p> <p><i>ii. How PWC were notified, or became aware of the discharge.</i></p> <p>This overflow was reported by one of the residents to the PWC call centre, who then relayed the information to the PWC sewer reticulation team that attended the property at 10:15hrs (07/01/2022) and undertook action to resolve the situation and make it safe.</p> <p><i>iii. The process by which the discharge occurred.</i></p> <p>The cause of the spill was due to a partial or full blockage in the sewer line, which resulted from a build-up of what most likely was fats. Fat and other non-disintegrating items like wet wipes and kitchen paper towels have been incorrectly disposed of into the sewer network by customers, resulting in the blockage and the overflow. When fats and oils are poured down the sink it is usually as a liquid, but as it cools it can become more solid and cause build-up, resulting in bad odours and blockages in the sewerage system. This can lead to the sewage overflows into the environment, households and businesses.</p> <p>Public education about what can be disposed in sewer/is flushable: https://www.powerwater.com.au/about/what-we-do/wastewater/sewer-blockages-and-overflows/think-before-you-put-it-down-the-sink In the aim of prevention, this material is available on the PWC website and is used as an educational tool for customers.</p> <p><i>iv. The reason why the discharge occurred.</i></p> <p>As per (c) iii. Sewerage network infrastructure has been designed to overflow with the best public health and environmental outcomes possible. Design focuses on not overflowing directly inside houses; rather discharge is designed to occur in a controlled manner at locations which can be accessed for infrastructure repair and clean up and with minimal public health or environmental impacts.</p>

or threatening to be caused by the incident	<i>ii. Decontamination of the site as appropriate.</i> Clean up consistent with Sewage Spills/Overflow Response Work Instruction as appropriate to the location, and to minimise risk to the Environment. Blockage was cleared and upon resolution of the blockage, the site was left in a clean state, free from any gross pollutants and the surrounding surface was cleaned and disinfected.
(f) the identity of the person notifying the NT EPA	PWC Environmental Team on behalf of Water Services
