SECTION 14 INCIDENT REPORT (*Waste Management and Pollution Control Act*)

Date and Time of Notification:	Thursday 04 th February 2022, 14:10hrs
Person / Company:	Power and Water Corporation (PWC)
Incident:	Discharge of 464L of transformer oil from 200kva transformer.

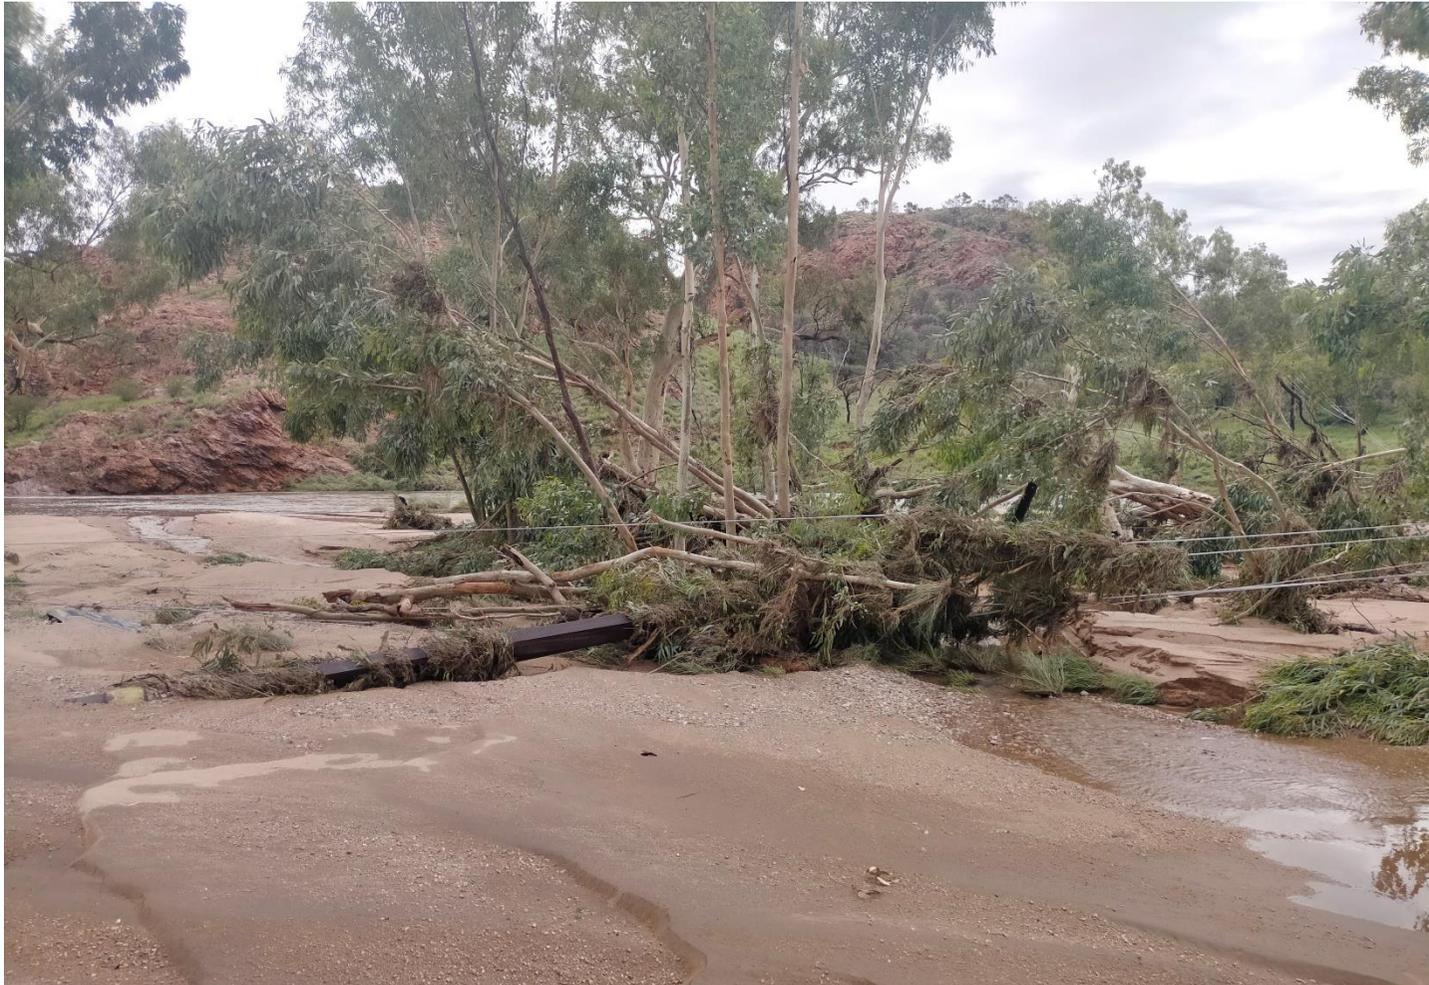
Figure 1: Jay Creek - Potential Receiving Environment (and downed pole)

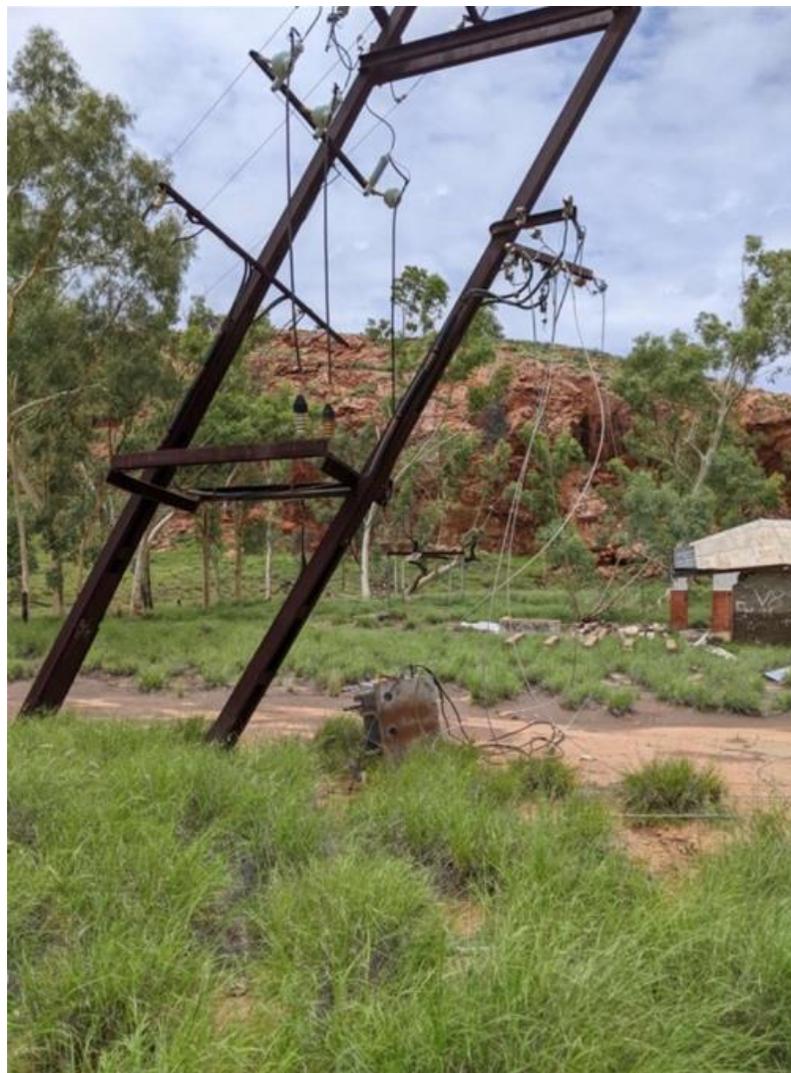
<p>During extreme weather event (86mm for 24hr to 9am 03/02/2022 station 015590) a pole mounted 200kva transformer became dislodged due to flooding pulling down adjacent pole, which intern compromised the asset holding the transformer. The ceramic bushings broke off when it impacted the ground, leaking 464L of transformer oil contained within to the surrounding floodwater.</p> <p><i>iv. The reason why the discharge occurred.</i></p> <p>As per (c) iii.</p>

Figure 2: Transformer on Ground
