## SECTION 14 INCIDENT REPORT (*Waste Management and Pollution Control Act*)

<b>Date and Time of Notification:</b>	Saturday 5 <sup>th</sup> November 2022, 19:34hrs
<b>Person / Company:</b>	Power and Water Corporation ( <b>PWC</b> )
<b>Incident:</b>	Discharge of sewage from sewage network

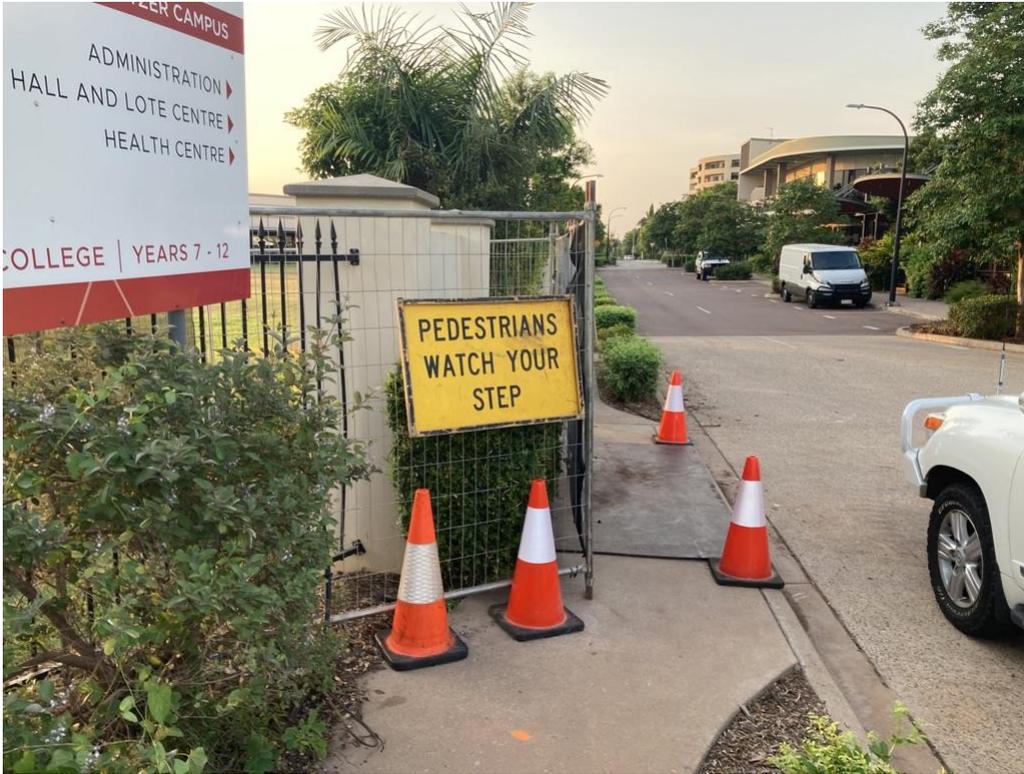
Figure 1 Looking North West along Salonika Street.

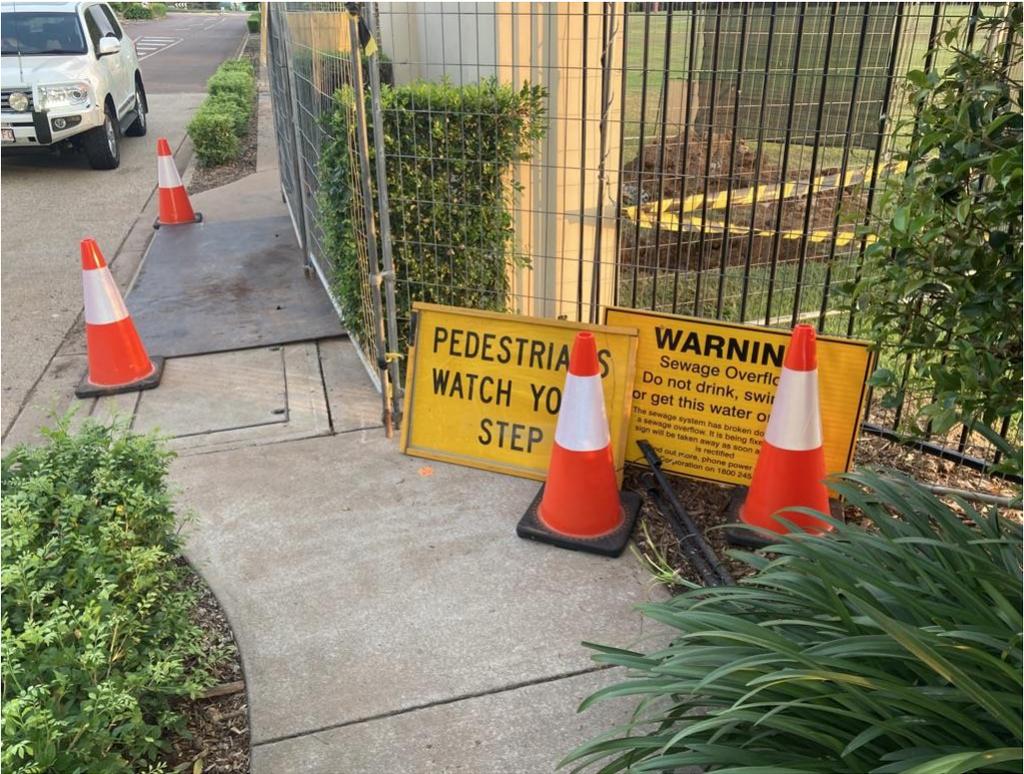
Figure 2 Looking South East down Salonika Street.

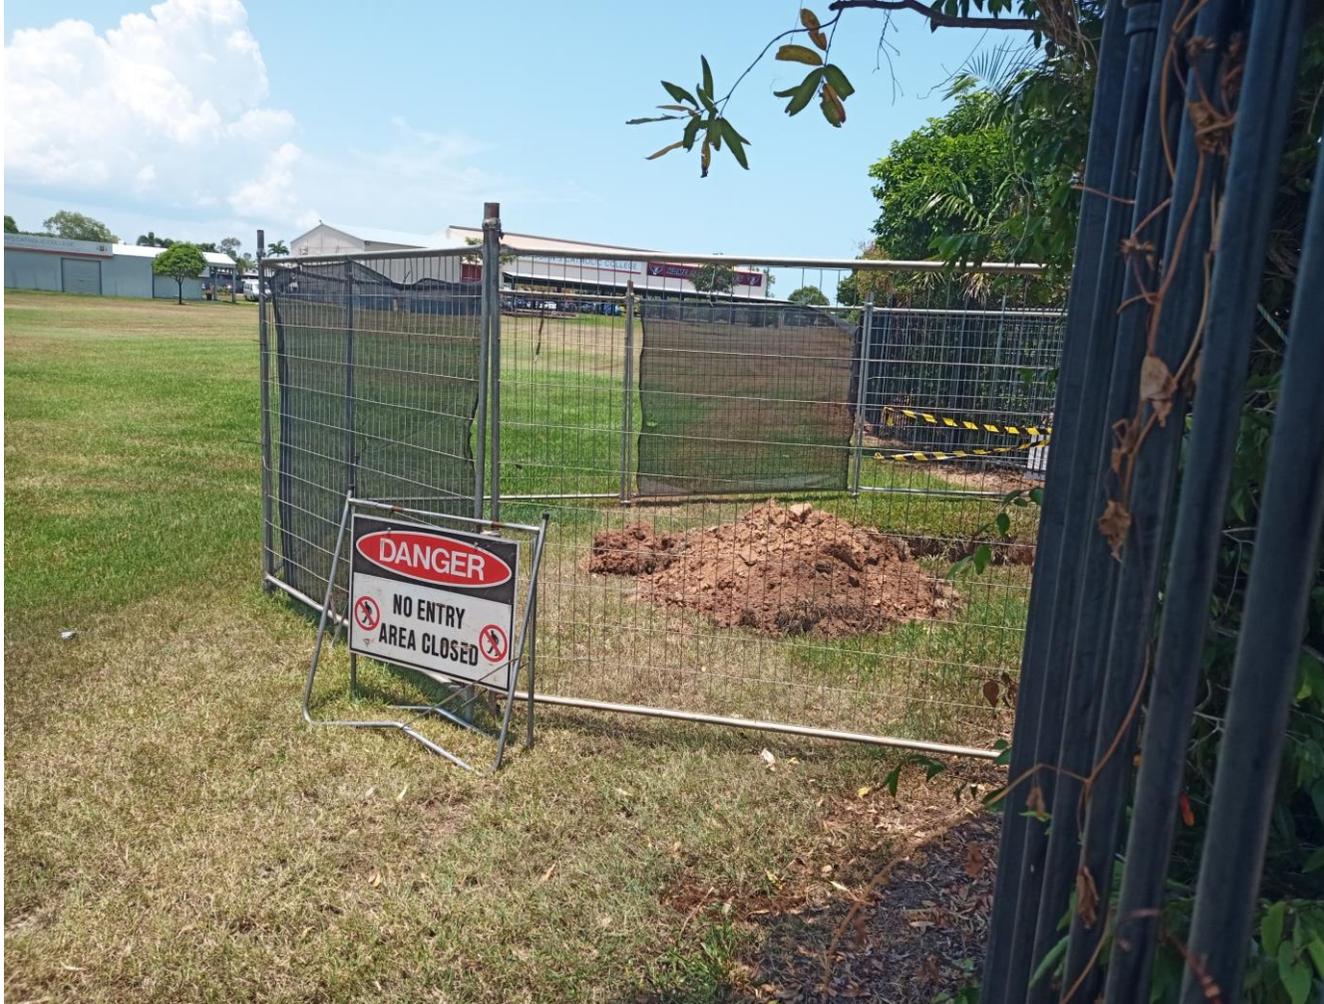
*Figure 3 Fencing and signage of excavation on St Paul's Catholic College oval, other side of permanent fencing.*
