SECTION 14 INCIDENT REPORT (*Waste Management and Pollution Control Act*)

Date and Time of Notification:	Friday 24 th February 2023, 13:48hrs
Person / Company:	Power and Water Corporation
Incident:	Milikapiti (Snake Bay) barge landing diesel fuel spill

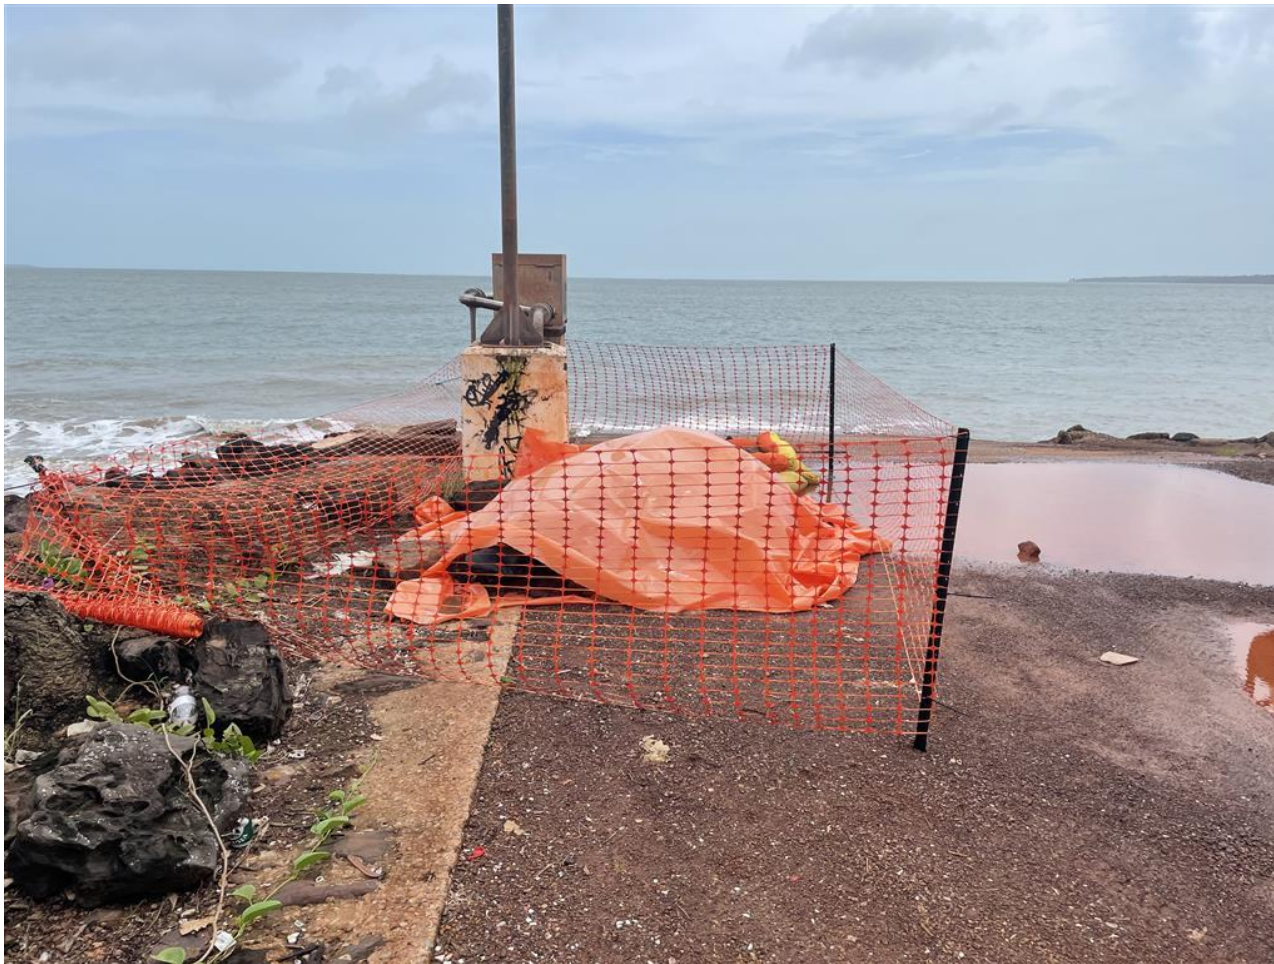
Figure 2. Initial excavation's contaminated soil covered with plastic, with spill booms just visible behind the mound.

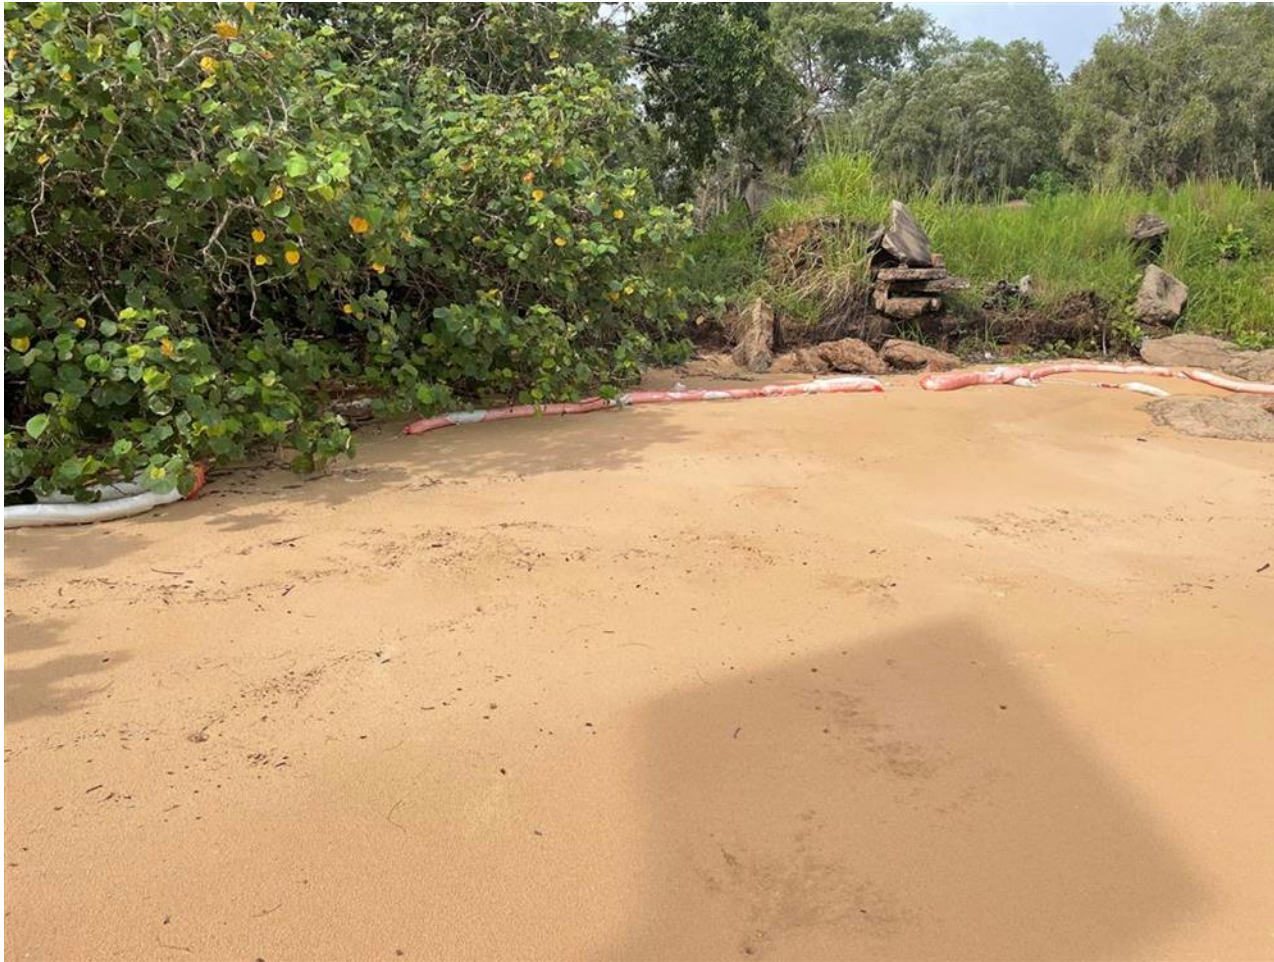
Figure 3. The fuel containment spill boom that washed up on the beach, due to the inclement weather on the day of the incident.

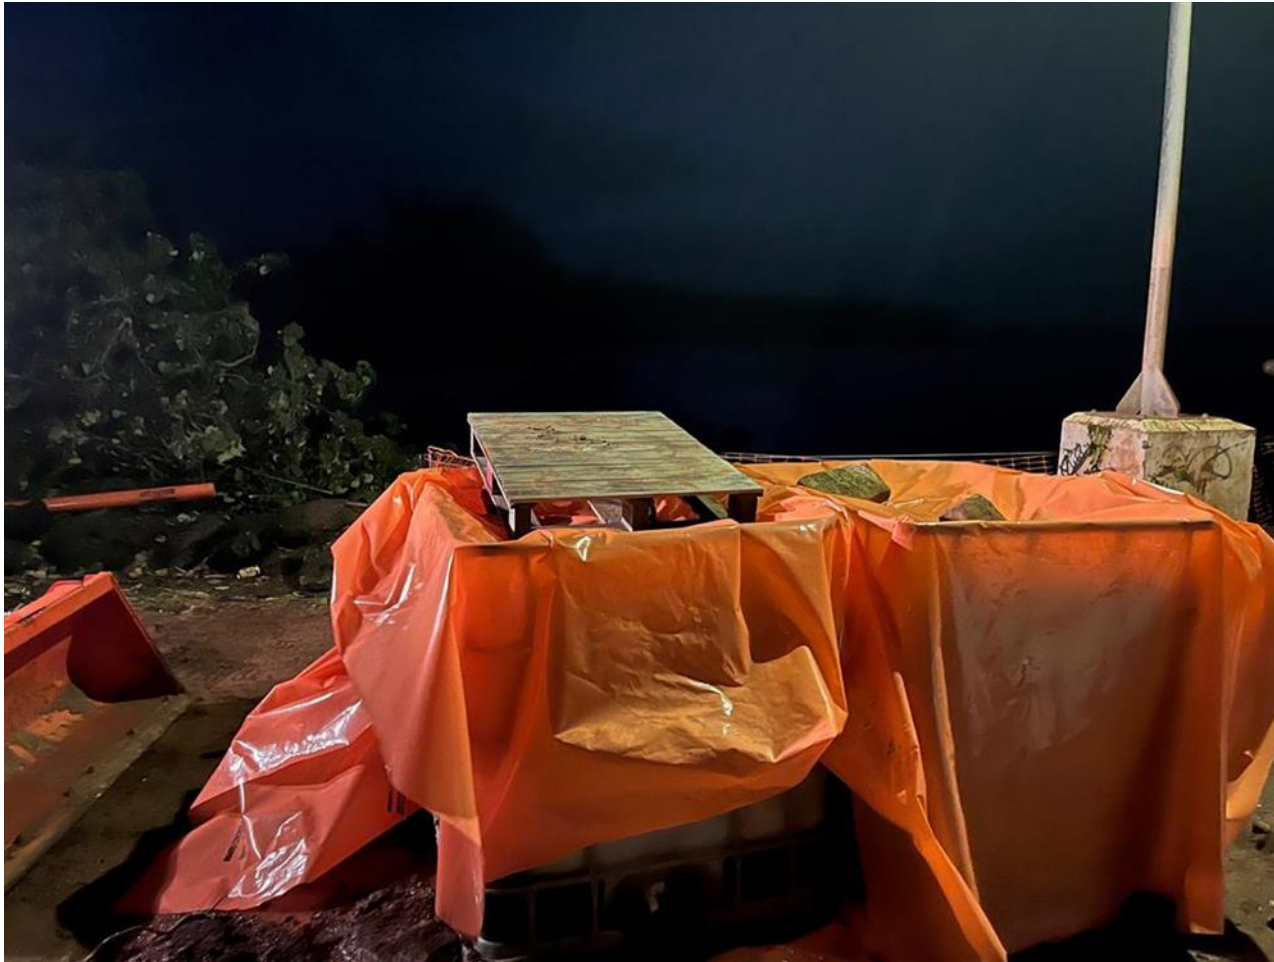
Figure 4. The contaminated soil that was transferred to IBCs and covered with plastic, in preparation for transport back to Darwin.
