SECTION 14 INCIDENT REPORT (*Waste Management and Pollution Control Act*)

Date and Time of Notification:	Friday 31 st 2023, 15:42hrs
Person / Company:	Power and Water Corporation (PWC)
Incident:	Discharge of sewage from sewerage network – Inspection opening

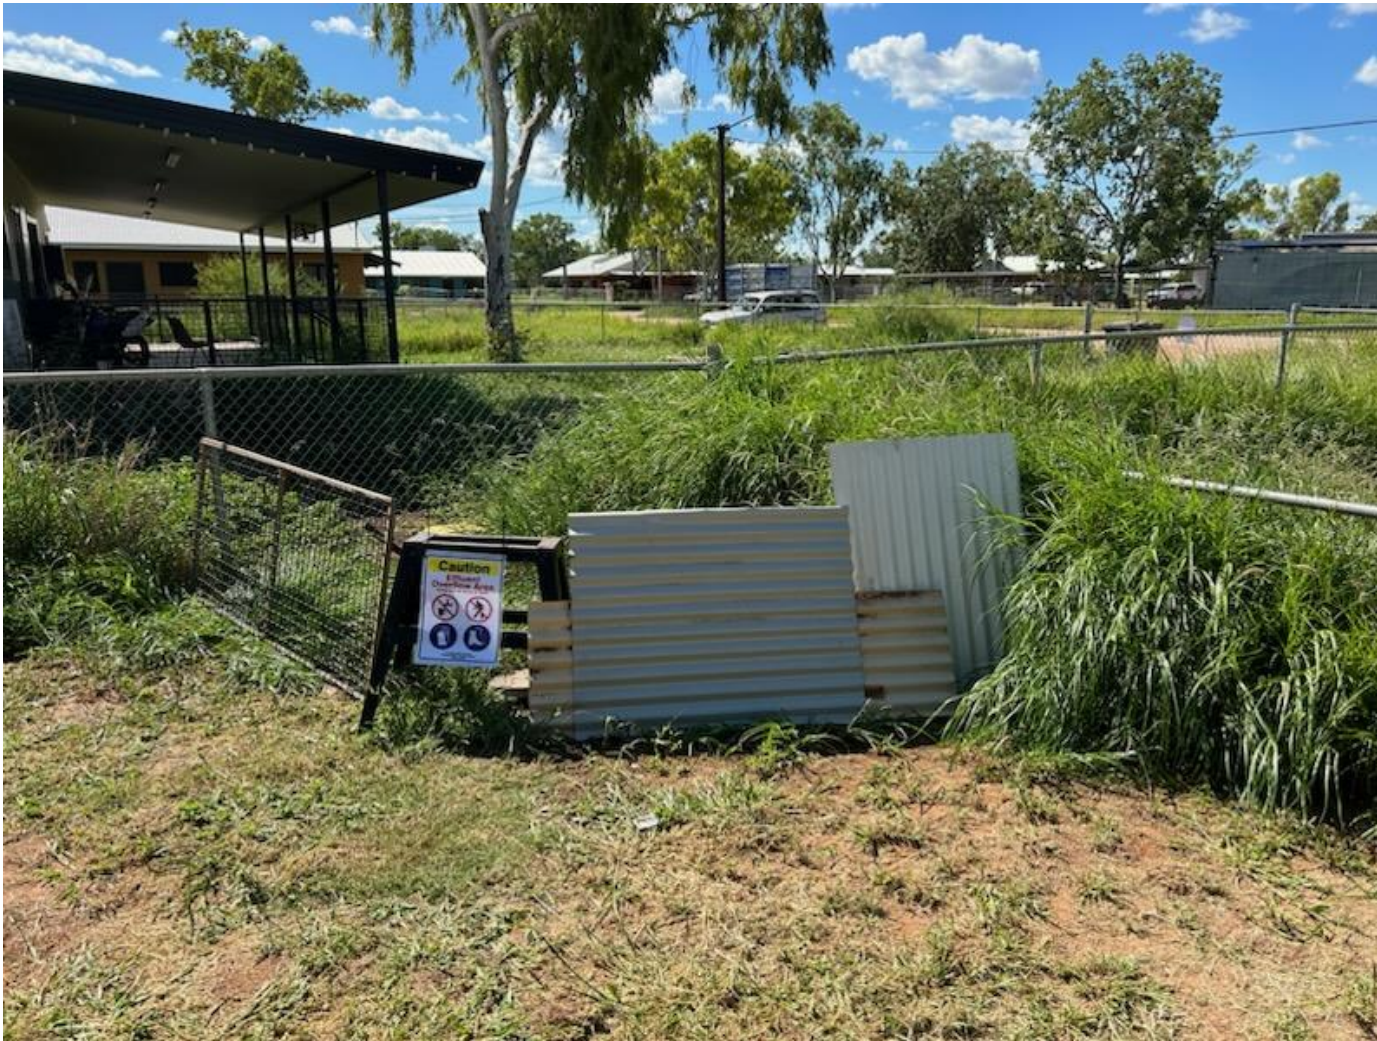
Figure 1 - Spill source, barricaded as best as possible with materials available.

(d) how the pollution has occurred, is occurring or may occur	As per (c) iii & (c) iv.
(e) the attempts made to prevent, reduce, control, rectify or clean up the pollution or resultant environmental harm caused or threatening to be caused by the incident	<p><i>i. Confirmation signage and fencing has been erected, as appropriate.</i></p> <p>The USCW has barricaded the immediate area off as best as he could with materials available to him. Warning signage, including pictograms was also put on display at key locations advising community members to keep away. Residents living close to the affected properties were also verbally advised by the USCW of the spill and to keep away from it. The two affected properties were unoccupied at the time of the incident.</p> <p><i>ii. Decontamination of the site as appropriate.</i></p> <p>Clean up consistent with Sewage Spills/Overflow Response Work Instruction as appropriate to the location, and to minimise risk to the environment. The area was inspected for any gross pollutants and it was confirmed that the inspection opening lid prevented these from being part of the spill. The affected area was treated with lime by the plumbing contractor sent to site to undertake repairs.</p>

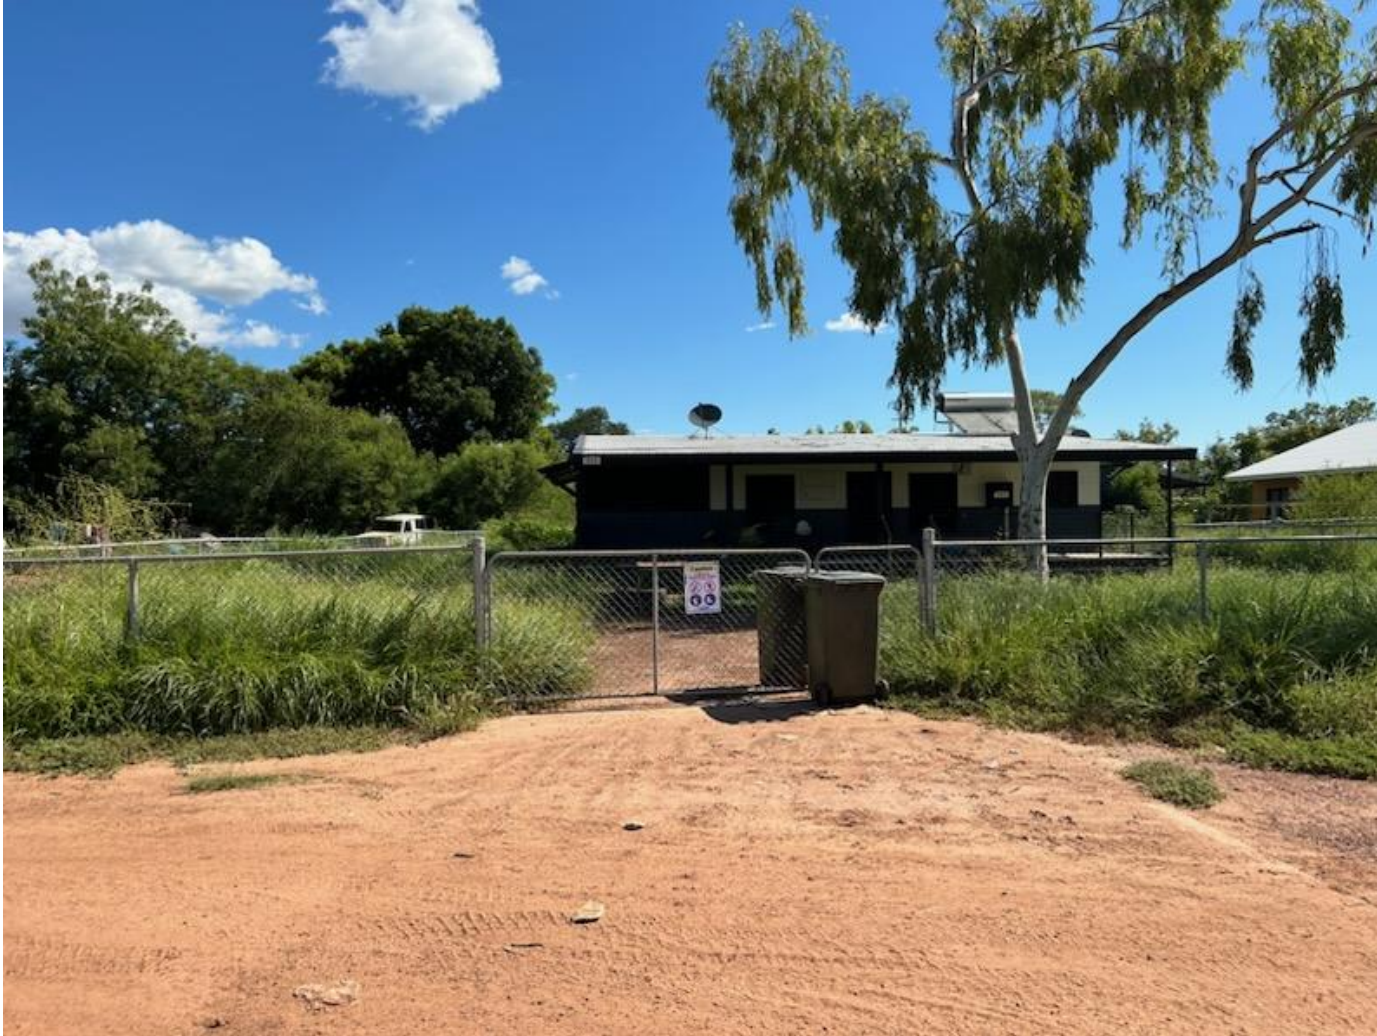
Figure 2 - Warning signage on display at affected property boundary entry point.

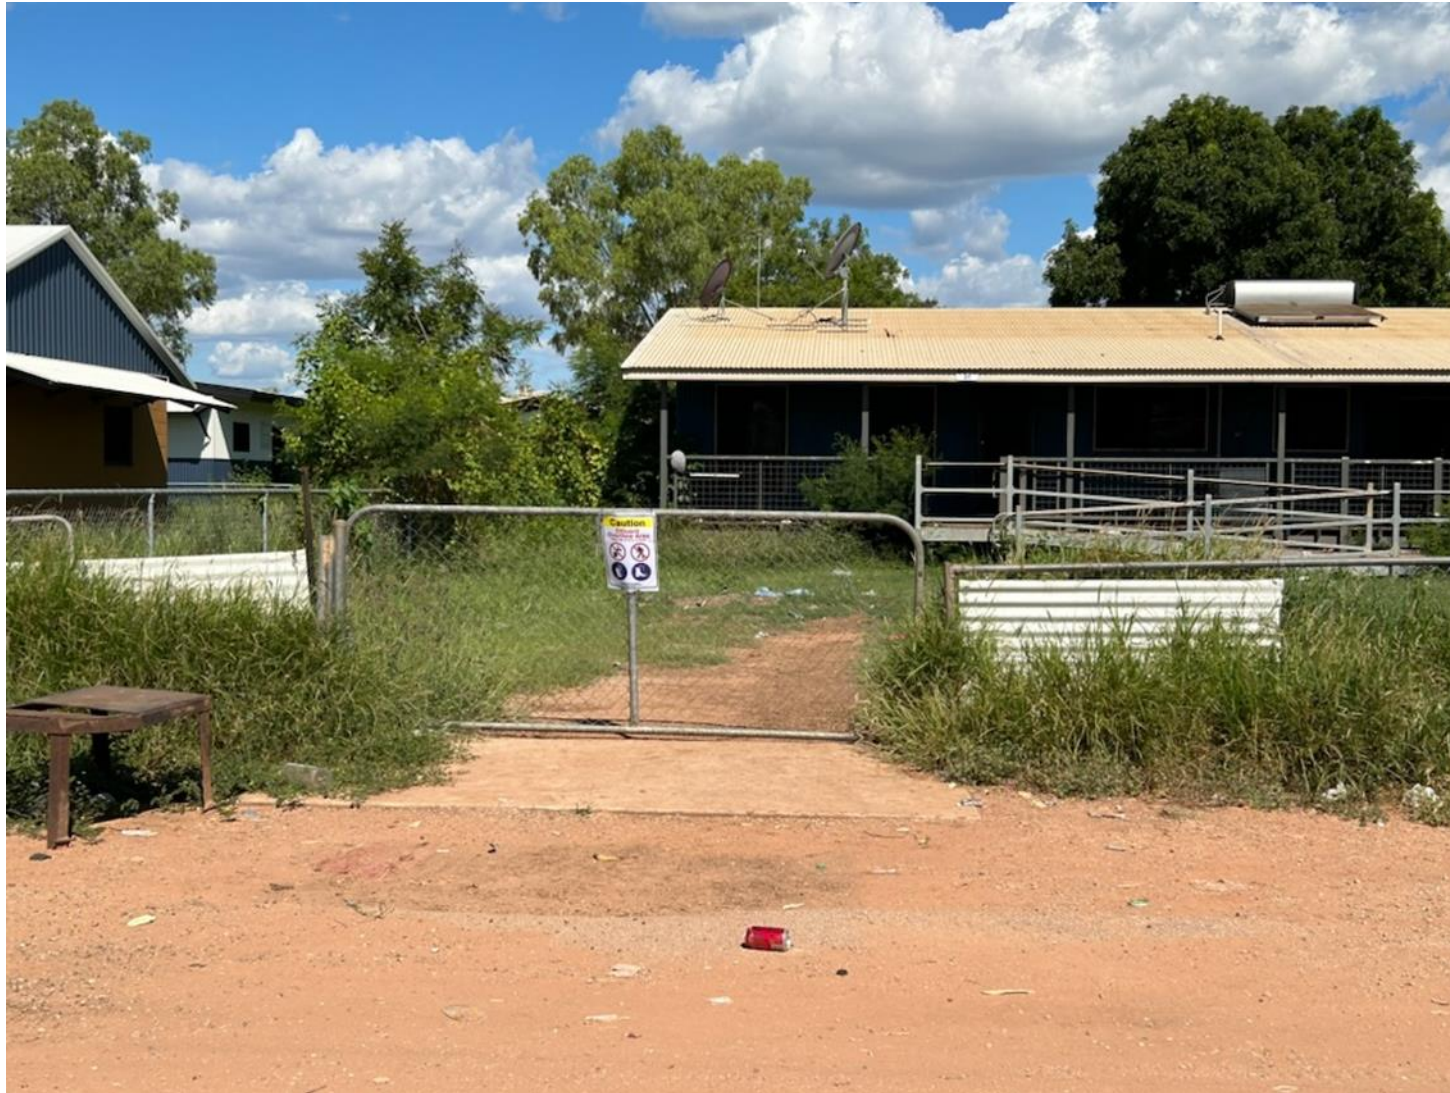
Figure 3 - Warning signage on display at affected property boundary entry point.
