SECTION 14 INCIDENT REPORT (*Waste Management and Pollution Control Act*)

Date and Time of Notification:	Friday 14 July 2023, 10:00hrs
Person / Company:	Power and Water Corporation
Incident:	Discharge of raw sewage (no gross pollutants) from sewerage network – manhole (lot 460 Ngukurr community)

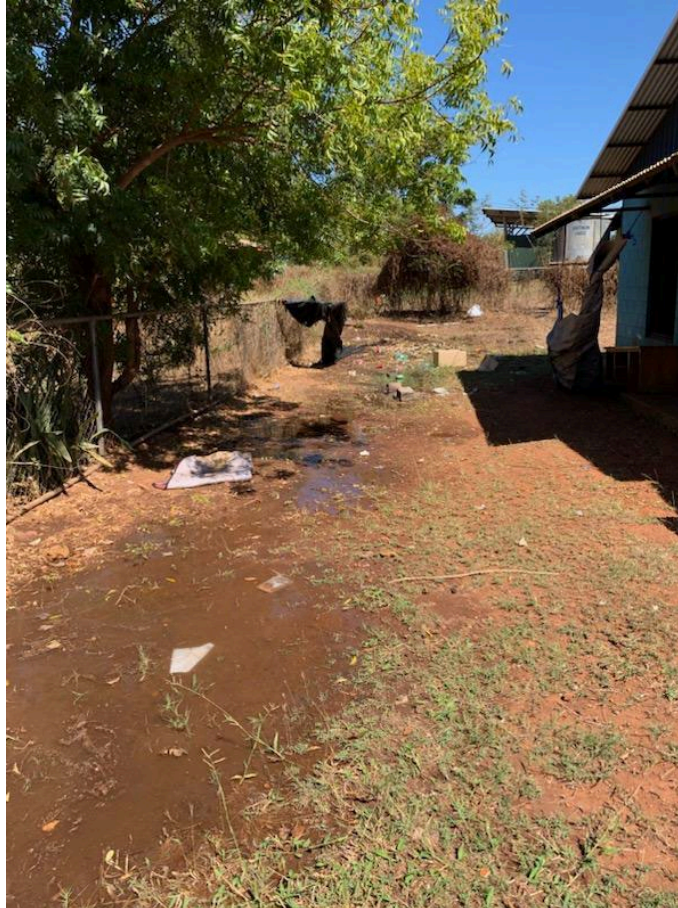
Appendix B – Photo of discharge in Lot 460 (pre-clean up), Ngukurr community and contained within fenced property (provided by USC)

<p>(d) how the pollution has occurred, is occurring or may occur</p>	<p>As per (c) iii & (c) iv.</p>
<p>(e) the attempts made to prevent, reduce, control, rectify or clean up the pollution or resultant environmental harm caused or threatening to be caused by the incident</p>	<p>Contained spill was cleaned as per Power and Water procedure.</p> <p><i>i. Confirmation signage and fencing has been erected, as appropriate.</i></p> <p>No signage or fencing was erected as spill was contained in a fenced yard (lot 460 Ngukurr community). Contaminated area was not accessible to the public.</p> <p><i>ii. Decontamination of the site as appropriate.</i></p> <p>Clean up consistent with Power and Water's Sewage Spills/Overflow Response Work Instruction as appropriate to the location. Site was inspected for any gross pollutants, of which none were observed, and the area was cleaned and disinfected with biodegradable detergent.</p>
