SECTION 14 INCIDENT REPORT (*Waste Management and Pollution Control Act*)

Date and Time of Notification:	Monday 11 March 2024 13:00
Person / Company:	Power and Water Corporation
Incident:	Discharge of very diluted effluent from Ludmilla Sewage Pump Station (SPS), due to wet weather events.

Ludmilla SPS

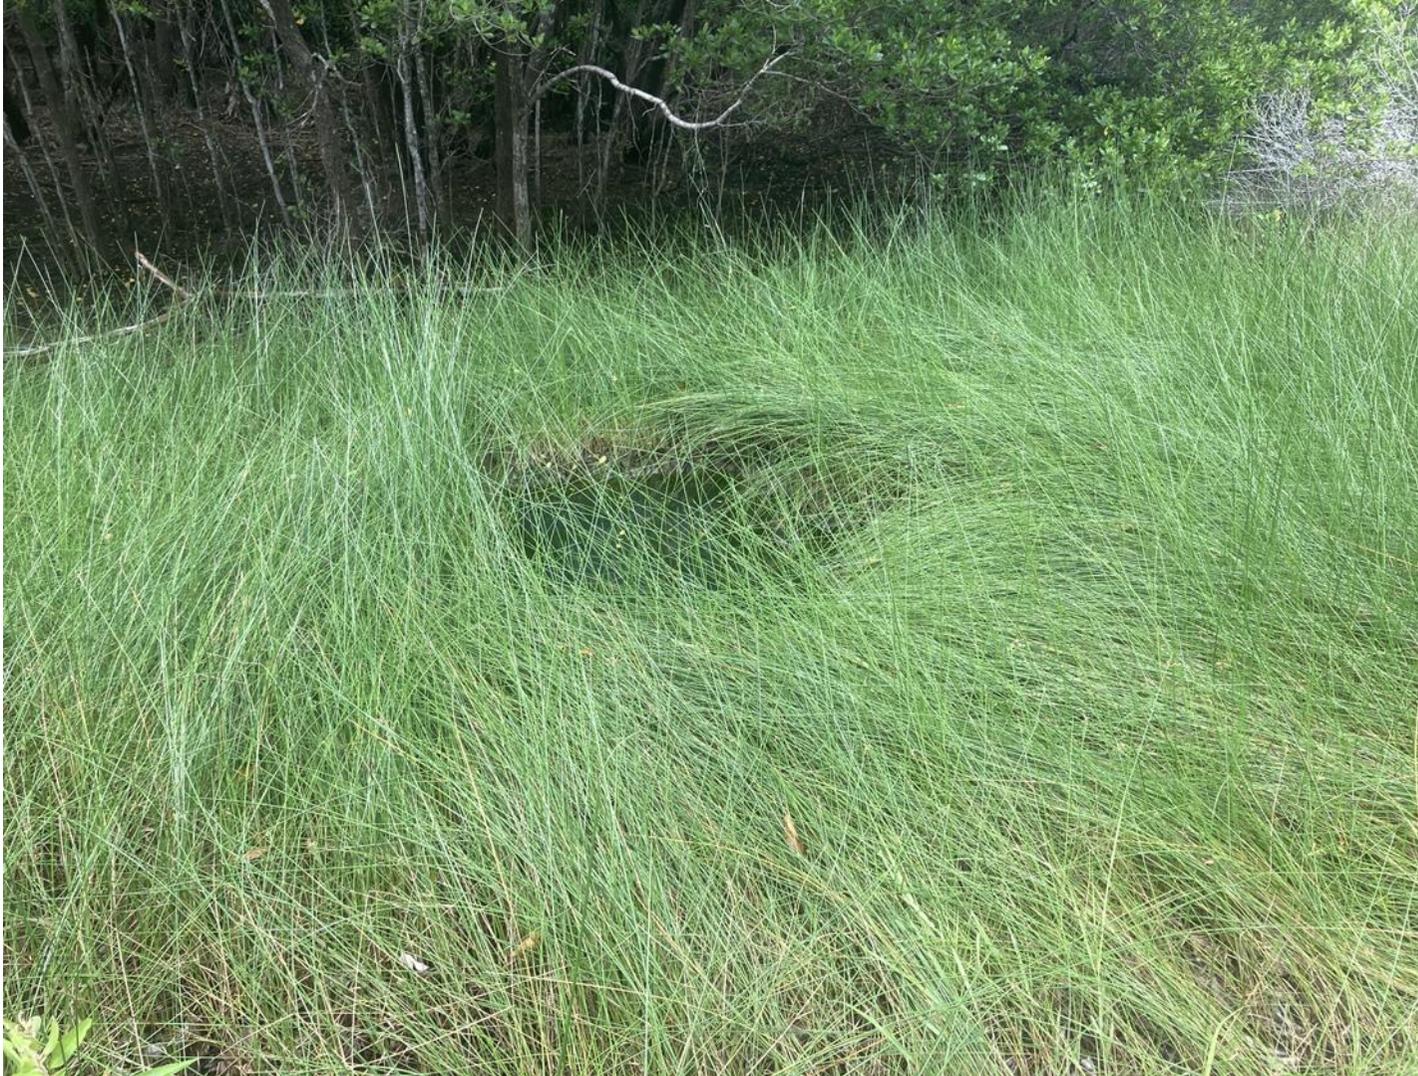
Ludmilla SPS Emergency Discharge Point, Historical Photo dated 21 January 2021
