SECTION 14 INCIDENT REPORT (*Waste Management and Pollution Control Act*)

Date and Time of Notification:	Tuesday 12 th March 2024, 16:12hrs
Person / Company:	Power and Water Corporation
Incident:	Overflow of diluted sewage effluent at Belyuen School

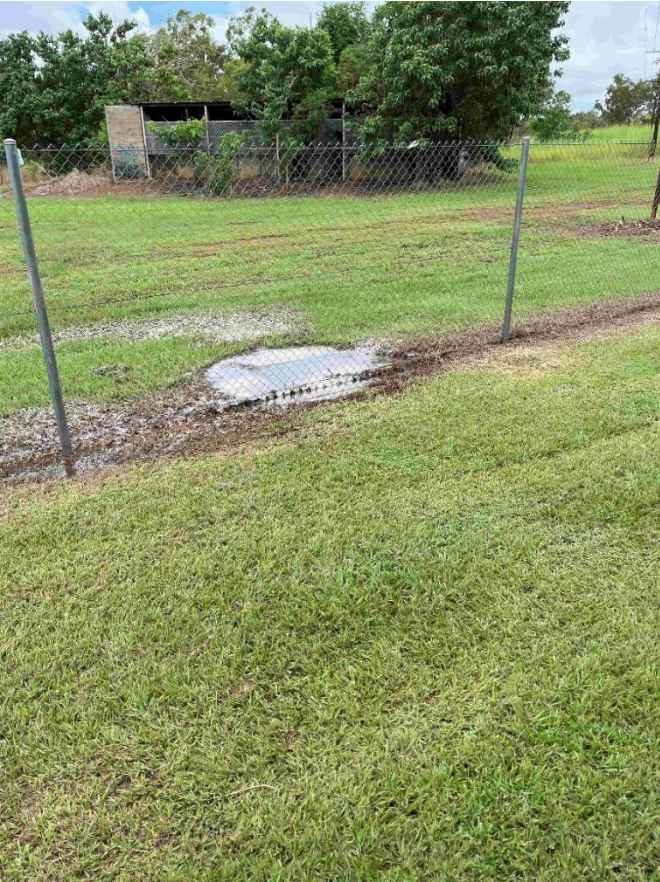
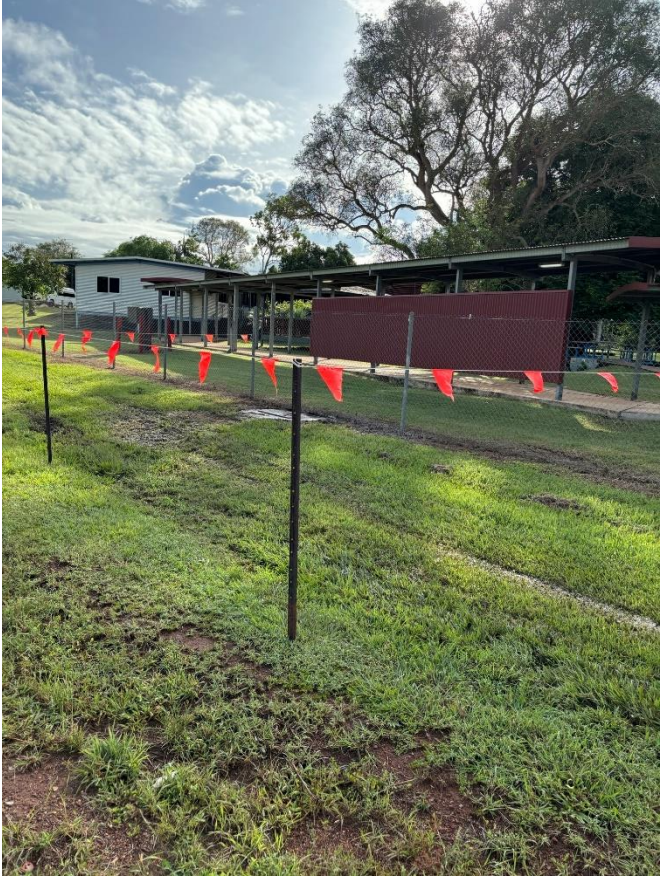
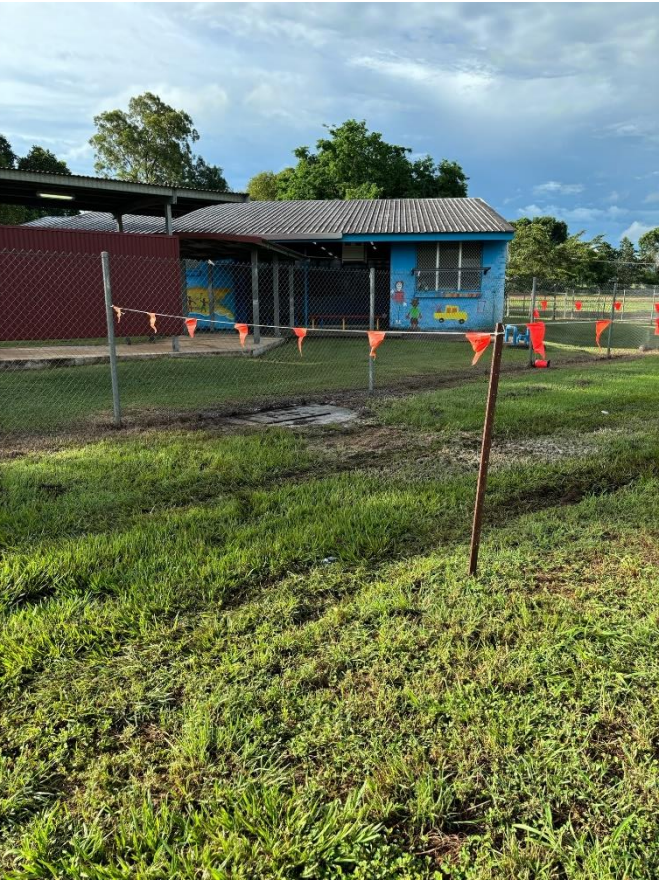
Source: Power & Water contractor – Belyuen & Acacia Utility Services Contract worker. Taken Monday 10/03/2024
