## SECTION 14 INCIDENT REPORT (*Waste Management and Pollution Control Act*)

Date and Time of Notification:	Tuesday 24 <sup>th</sup> August 2021, 16:40hrs
Person / Company:	Power and Water Corporation ( <b>PWC</b> )
Incident:	Discharge of treated sewage from sewerage network (Hermannsburg wastewater stabilisation ponds)

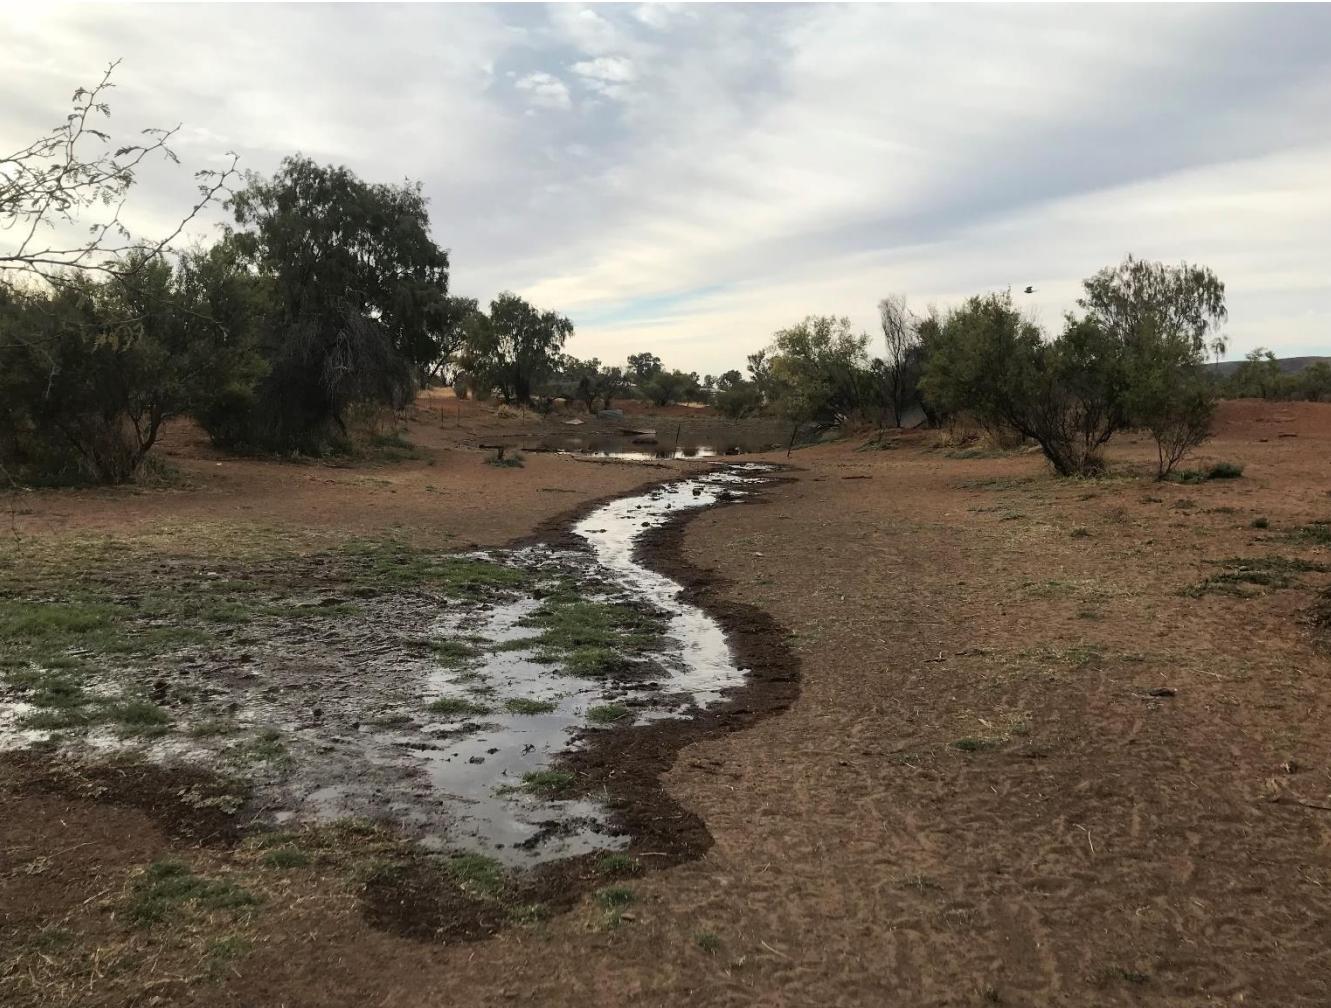
Appendix B – Location Photograph – Final discharge point

<p>Discharge Point: 132.7709006E, 23.9387002S (pond 3 overflow point)  Final Discharge Point: 132.7709723E, 23.9393036S (small dam)</p> <p>Discharge occurred from the emergency overflow point on pond number three, to a nearby makeshift dam within which the overflow has been captured within. This area will be fenced off to prevent access by the public or livestock until the site has been cleaned up.</p> <p><i>iii. Indicate any locations nearby to the discharge point where public can gain ready-access, such as public open spaces through which the discharge moves.</i></p> <p>Access by the public is possible to the spill location however is not believed to be frequently accessed. The affected area is in the process of being fenced off and signage will also be erected. The dam water has been disinfected with sodium hypochlorite and lime has been applied to the spill site between the discharge point and the dam.</p>

Photograph taken 24<sup>th</sup> August 2021

(d) how the pollution has occurred, is occurring or may occur	As per (c) iii & (c) iv.
(e) the attempts made to prevent, reduce, control, rectify or clean up the pollution or resultant	<p><i>i. Confirmation signage and fencing has been erected, as appropriate.</i></p> <p>The fencing of the small dam structure is now complete. Fencing and signage is currently being installed around the now limed spill site to</p>
