**SECTION 14 INCIDENT REPORT (*Waste Management and Pollution Control Act*)**

<b>Date and Time of Notification:</b>	Initial notification (email) – 9 October 2021 11:34									
<b>Person / Company:</b>	McArthur River Mining Pty Ltd (MRM)									
<b>Incident:</b>	Spillage of bulk concentrate on the Carpentaria Highway. The source of the spill originated from a road train travelling from McArthur River Mine (the Mine) to the Bing Bong Loading Facility (BBLF).									
<b>(a) the incident causing or threatening to cause pollution</b>	A total of approximately 100 kilograms (kg) of bulk concentrate was released at one location on the Carpentaria Highway, between the Mine and the BBLF. All concentrate was confined to the road and roadside.									
<b>(b) the place where the incident occurred</b>	<p>The Global Positioning System (GPS) points for the spill start and end is provided in Table 1 below and shown in Figure 1.</p> <p style="text-align: center;"><i>Table 1 – GPS Coordinates of spill end and start.</i></p>

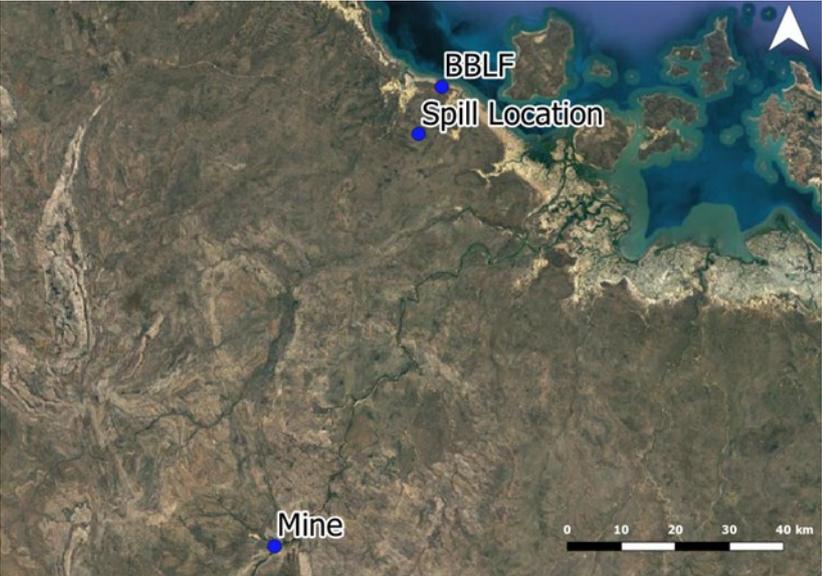
<p style="text-align: center;"><i>Figure 1: Approximate spill location in relation to the Mine and BBLF.</i></p>	Spill	Easting*	Northing*	End	644604	8262521	Start	644628	8262577
Spill	Easting*	Northing*								
End	644604	8262521								
Start	644628	8262577

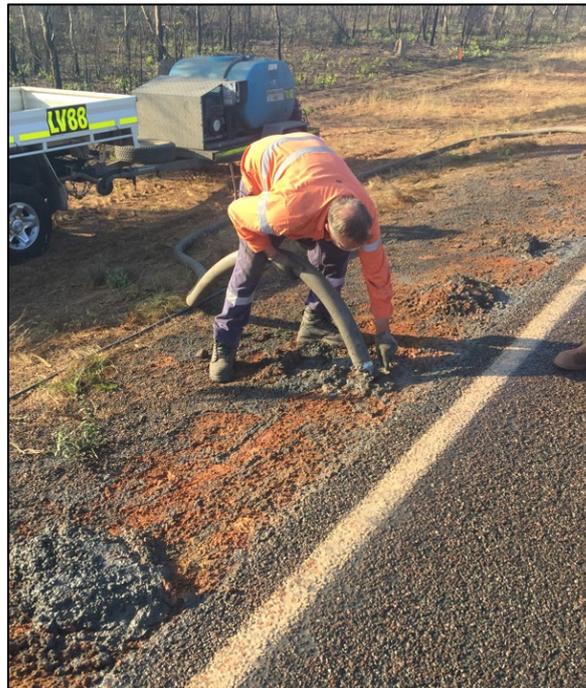
Figure 3: Spill clean-up efforts via pressure cleaner and vacuum truck.

At approximately 5:30 on 8 October 2021, a vacuum truck was deployed to clean-up all of the material on the sealed bitumen (Figure 3). This involved pressure washing the concentrate and simultaneously using a vacuum truck to collect the residue, which was transported back to the BBLF containment ponds for disposal.

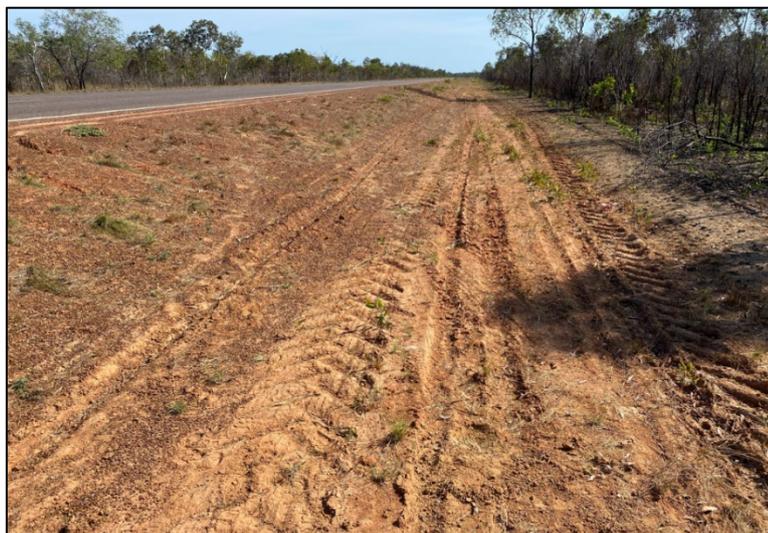
Figure 4: Spill location after the completion of clean-up works.

At approximately 8:00 on 9 October 2021, following the completion of the works, MRM personnel inspected the road and did not identify any visible signs of bulk concentrate at the spill location (Figure 4).

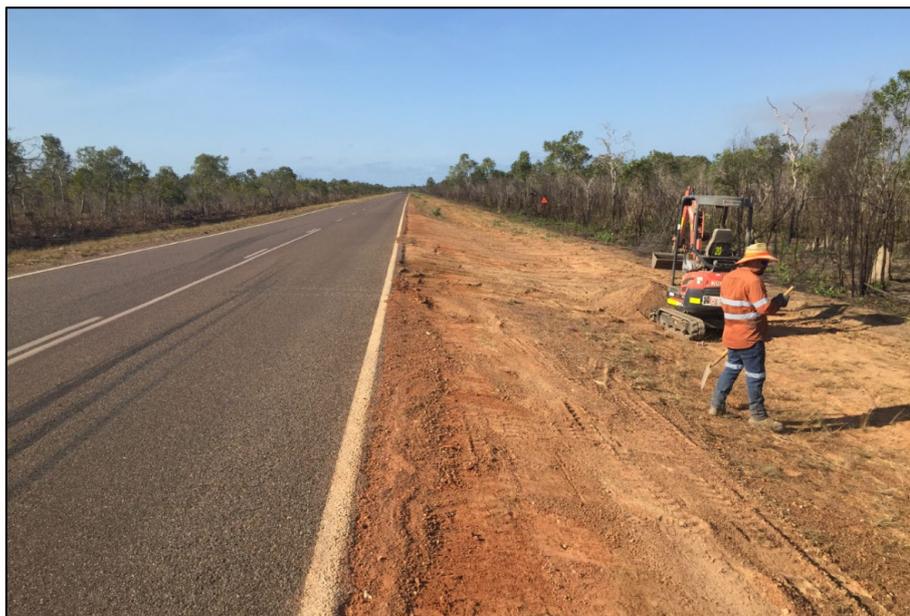
The potential for material environmental harm is considered to be low due to the majority of the spill being confined to one location, and the timely remedial response (Figure 5). Soil samples were collected at the spill location to determine whether the soil is suitable for the current land use. MRM is awaiting the soil sample results.

*Figure 5: Incident location during clean-up.*

MRM used a vacuum truck and pressure cleaner to remove the concentrate present on the sealed bitumen and an excavator to remove potentially impacted soil from the roadside that resulted from the spill and any residue resulting from the pressure cleaning works. The soil was disposed of in Cell 1 of the TSF and the vacuumed material was disposed of in the BBLF containment ponds. Further details of clean-up works are provided further below.

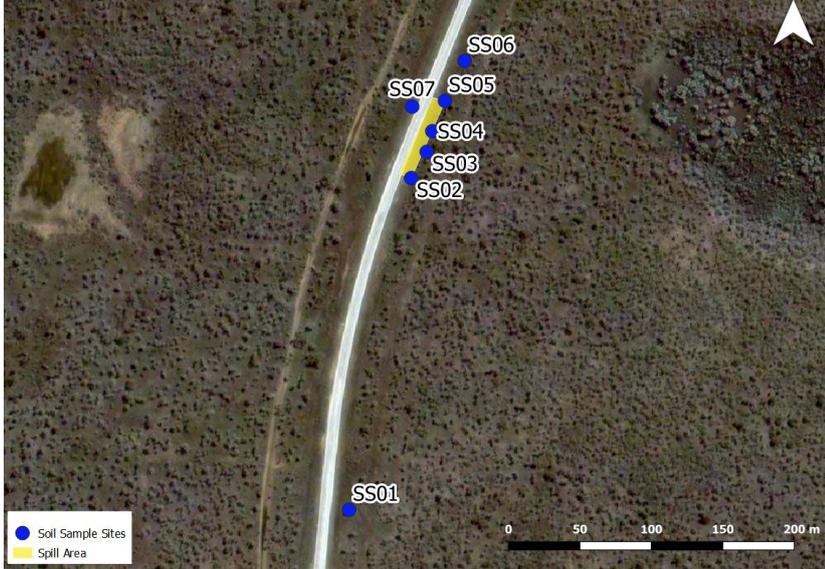
<p>Figure 6: Sampling locations at the spill locations.</p>
	<p><b>Prevention</b></p> <p>The incident investigation concluded that the contributing factors included the cattle on the road and failure to follow the transport of concentrate procedure.</p> <p>The work crew undertook training via a toolbox talk, reiterating the requirements of the <i>MRM Concentrate Transport Procedure</i>. As per the procedure, the operators must avoid swerving due to the potential risk that it poses to workers, community members and the environment (e.g. trailer roll-overs and/or concentrate spills).</p> <p>MRM is awaiting validation sampling results to determine whether the remediation was successful.</p>

<p><b>Validation of Clean-up</b></p> <p>On 9 October 2021, soil samples were collected at 7 locations at the spill location (Figure 6) in accordance with <i>Australian Standard 4482.1-2005: Guide to the investigation and sampling of sites with potentially contaminated soil</i>.</p> <p>All soil samples are being analysed for contaminants of concern (i.e. zinc and lead) and results will be compared against the relevant <i>National Environment Protection (Assessment of Site Contamination) Measure 1999</i> (NEPM, 1999) Guidelines to determine whether the soil is suitable for the current land-use.</p>
