SECTION 14 INCIDENT REPORT (*Waste Management and Pollution Control Act*)

Date and Time of Notification:	Time :3 pm Date 24/3/2023
Person / Company:	West Arnhem Regional Council
Incident:	Sewage overflow due Sewerage lift station Pump failure

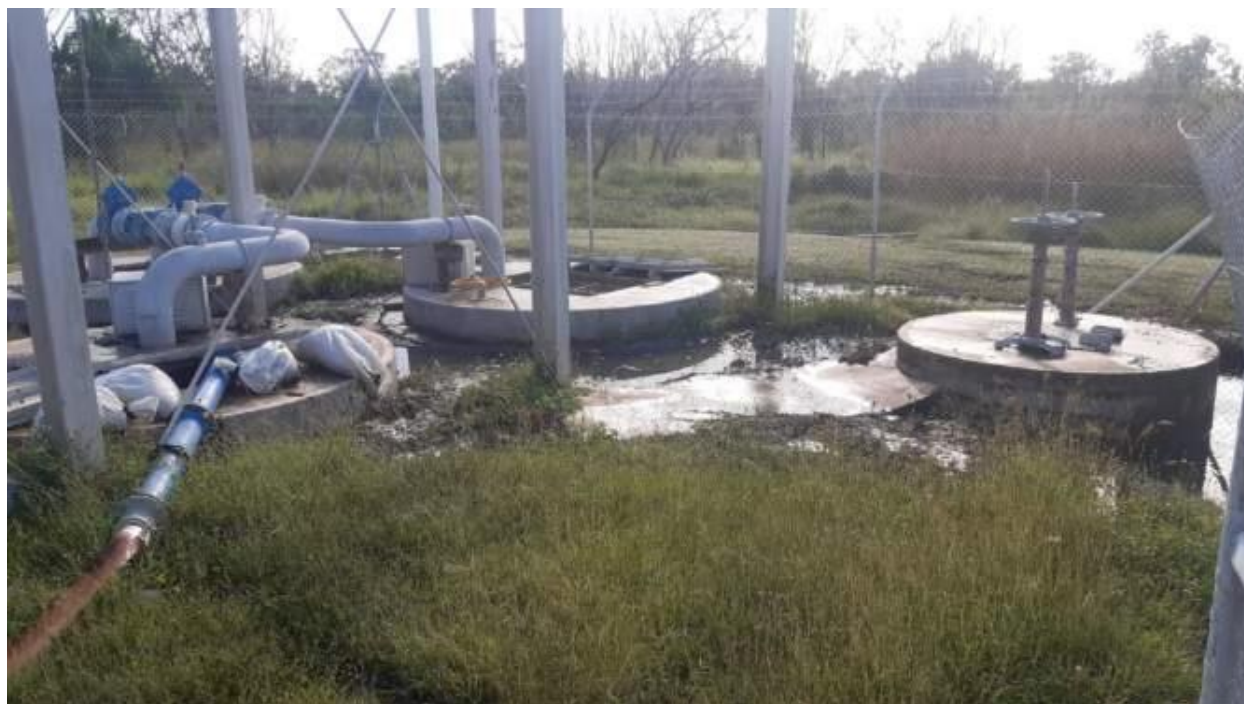
<p>(d) How the pollution has occurred, is occurring or may occur</p>	<p>Due to the pump failure at the sewerage lift station overflow occurred and spilled into the surroundings and since the pollution has been contained and a new pump has been installed</p>
<p>(e) The attempts made to prevent, reduce, control, rectify or clean up the pollution or resultant environmental harm caused or threatening to be caused by the incident</p>	<p>i. Confirmation signage and fencing has been erected, as appropriate. Fencing and signage was erected in this instance around the area surrounding the spill.</p> <p>ii. Decontamination of the site as appropriate WARC has engaged a contractor to clean up the site consistent with sewage spills/Overflow response work Instruction as appropriate to the location and to minimise risk to the environment.</p> <p>The full area of impact has been identified by the contractor and is treated accordingly.</p>

Figure 3: Overflowing Due to Pump failure

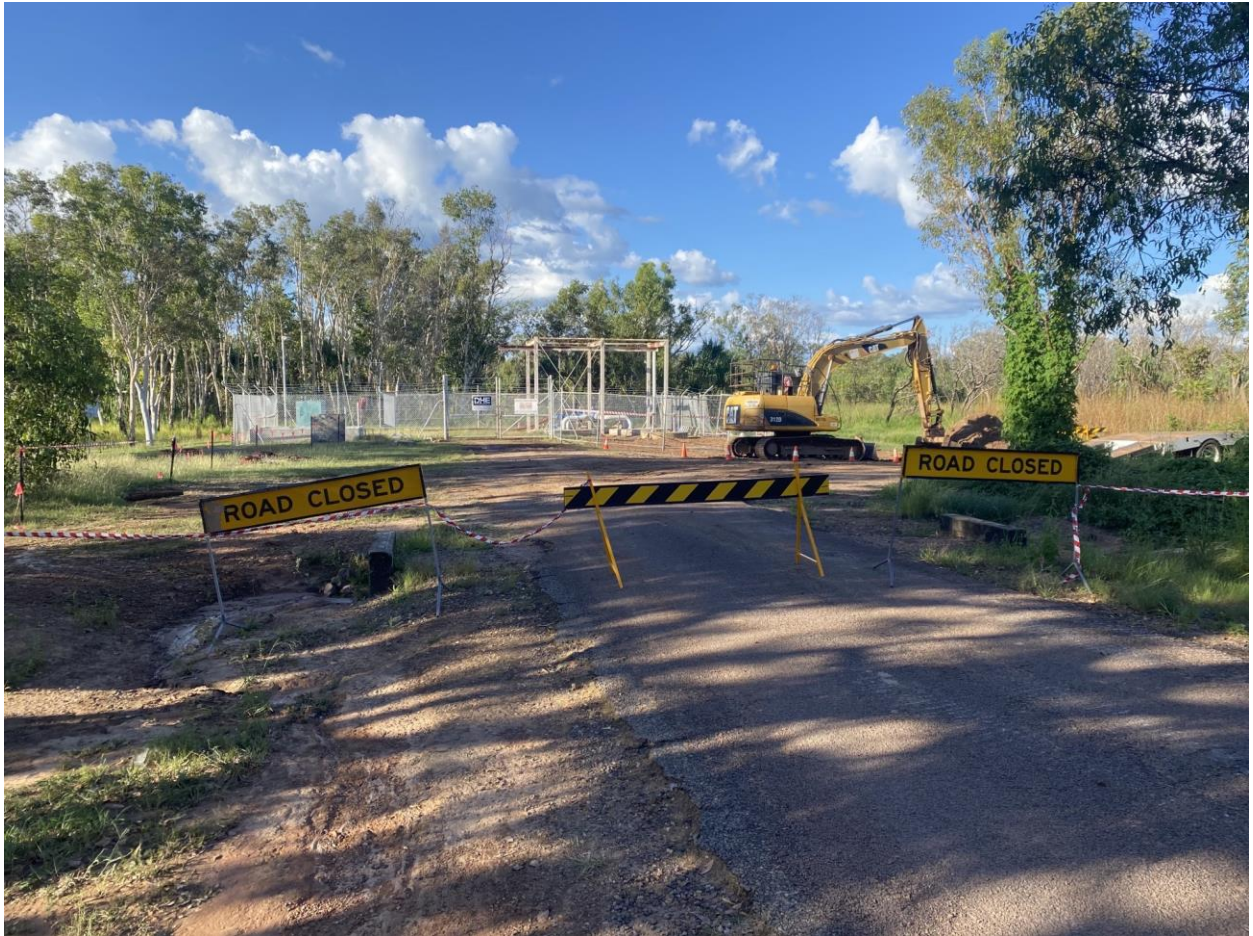
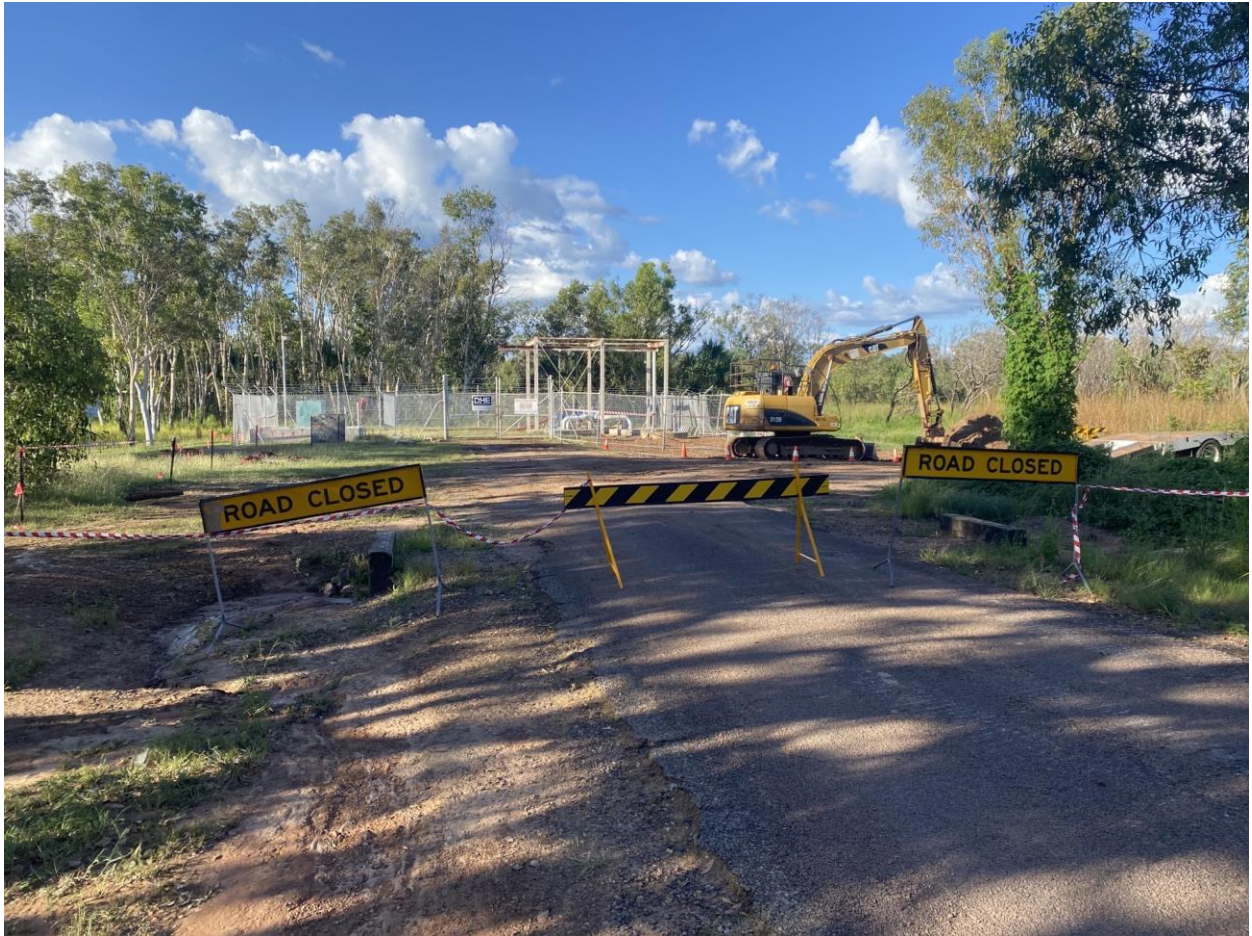
Figure 4: Site Secured with temporary Fencing
