SECTION 14 INCIDENT REPORT (*Waste Management and Pollution Control Act*)

Date and Time of Notification:	Tuesday 26 th September 2023, 09:45hrs
Person / Company:	Power and Water Corporation
Incident:	Discharge of sewage from sewerage network

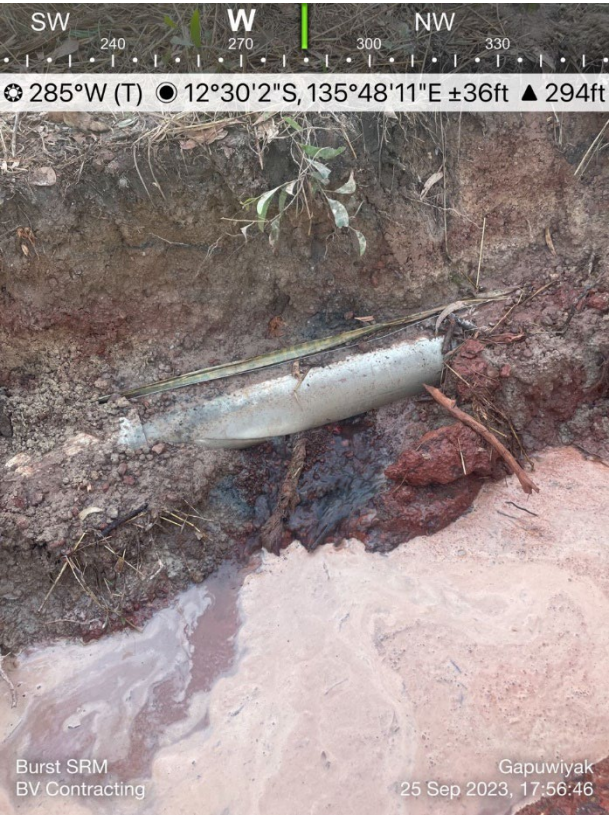
Photo 1. Leak in 150mm sewer rising main

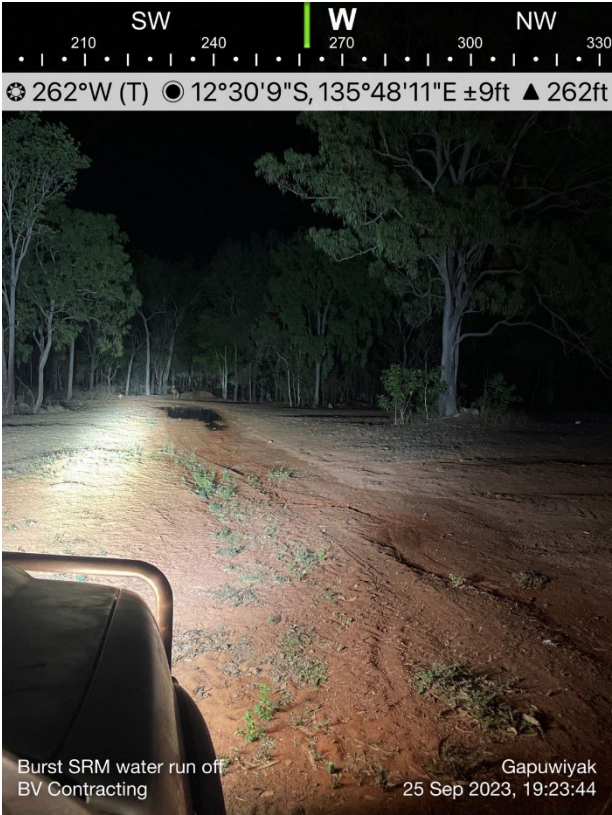
<p>inspected did not reach any residential areas. Note, the nearest building (non-residential) is approximately 60m south of the discharge point.</p>
<p>(c) the date and time of the incident</p>	<p><i>i. The time and date of commencement and cessation of the discharge.</i></p> <p>The commencement time of the overflow is unknown as the site is not telemetered. The overflow was first reported to Environmental Services by a Power and Water Technical Coordinator on Monday 25 September 2023 at around 9:30am. The Technical Coordinator was following-up an odour complaint that was received by telephone just prior.</p> <p>After the discharge was located the Technical Coordinator immediately arranged for BV Contracting (located in Ramingining) to fix the leak. The Technical Coordinator also stopped the sewerage flowing into that pipe to limit further discharge. The Technical Coordinator is monitoring the overflow relief access chamber to ensure sewerage doesn't discharge at a second location.</p> <p><i>ii. How PWC were notified, or became aware of the discharge.</i></p> <p>The Technical Coordinator received an odour complaint by telephone from a Gapuwiyak resident. They explained they noticed a strong odour when standing at the airport. When the matter was investigated a leak in the 150mm sewer rising main was discovered approximately 340m away from the airport. On discovery the discharge was reported to Environmental Services.</p> <p><i>iii. The process by which the discharge occurred.</i></p> <p>Inspection was undertaken by BV Contracting. The contractor believes aging infrastructure bedded in rock is the cause for a leak on the 150mm sewer rising main (see Appendix B, photo 1).</p> <p><i>iv. The reason why the discharge occurred.</i></p> <p>As per (c) iii sewerage has leaked from the 150mm sewer rising main, before reaching the ponds, and pooled in bushland (see Appendix B, photo 2).</p>

Photo 2. Discharge pooling in bushland
