SECTION 14 INCIDENT REPORT (*Waste Management and Pollution Control Act*)

Date and Time of Notification:	Friday 18 th October 2019, 10:15am
Person / Company:	Power and Water Corporation (PWC)
Incident:	Discharge of raw sewage from sewerage network (ruptured rising main)

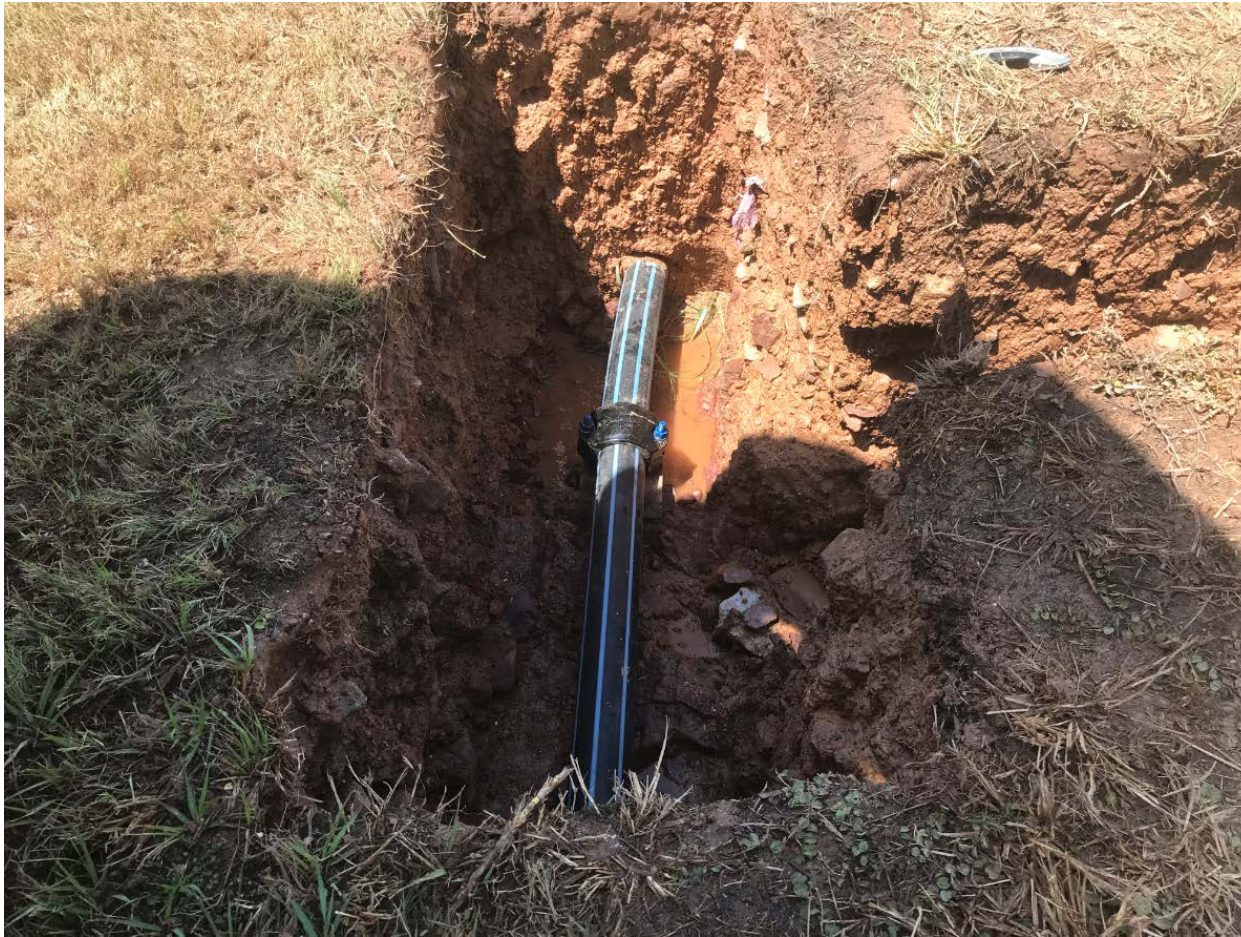
<p>(c) the date and time of the incident</p>	<p><i>i. The time and date of commencement and cessation of the discharge.</i></p> <p>The commencement time of the overflow is unknown. The overflow was observed at approximately 17:00pm on 17/10/19 and was stopped at approximately 10.30am (18/10/19).</p> <p><i>ii. How PWC were notified, or became aware of the discharge.</i></p> <p>PWC call centre was notified of the overflow, this was then reported to the on call PWC staff who attended the site at approx. 17:00pm (17/10/19), and the overflow was resolved and area cleaned by 10.30am (18/10/19).</p> <p><i>iii. The process by which the discharge occurred.</i></p> <p>Discharge of raw sewage to the land beside the manhole was associated with a ruptured rising main, resulting in the overflow. The exact cause of the ruptured rising main is unknown, although it appears during the installation of the main it may have been kinked and has recently given way and ruptured.</p> <p><i>iv. The reason why the discharge occurred.</i></p> <p>As per (c) iii.</p>

Photo 1 – Repaired sewer rising main

<p>(d) how the pollution has occurred, is occurring or may occur</p>	<p>As per (c) iii</p>
<p>(e) the attempts made to prevent, reduce, control,</p>	<p>The rupture was fixed by replacing a section of main and the overflow has now stopped. Clean up undertaken as per Sewage Spills/Overflow</p>

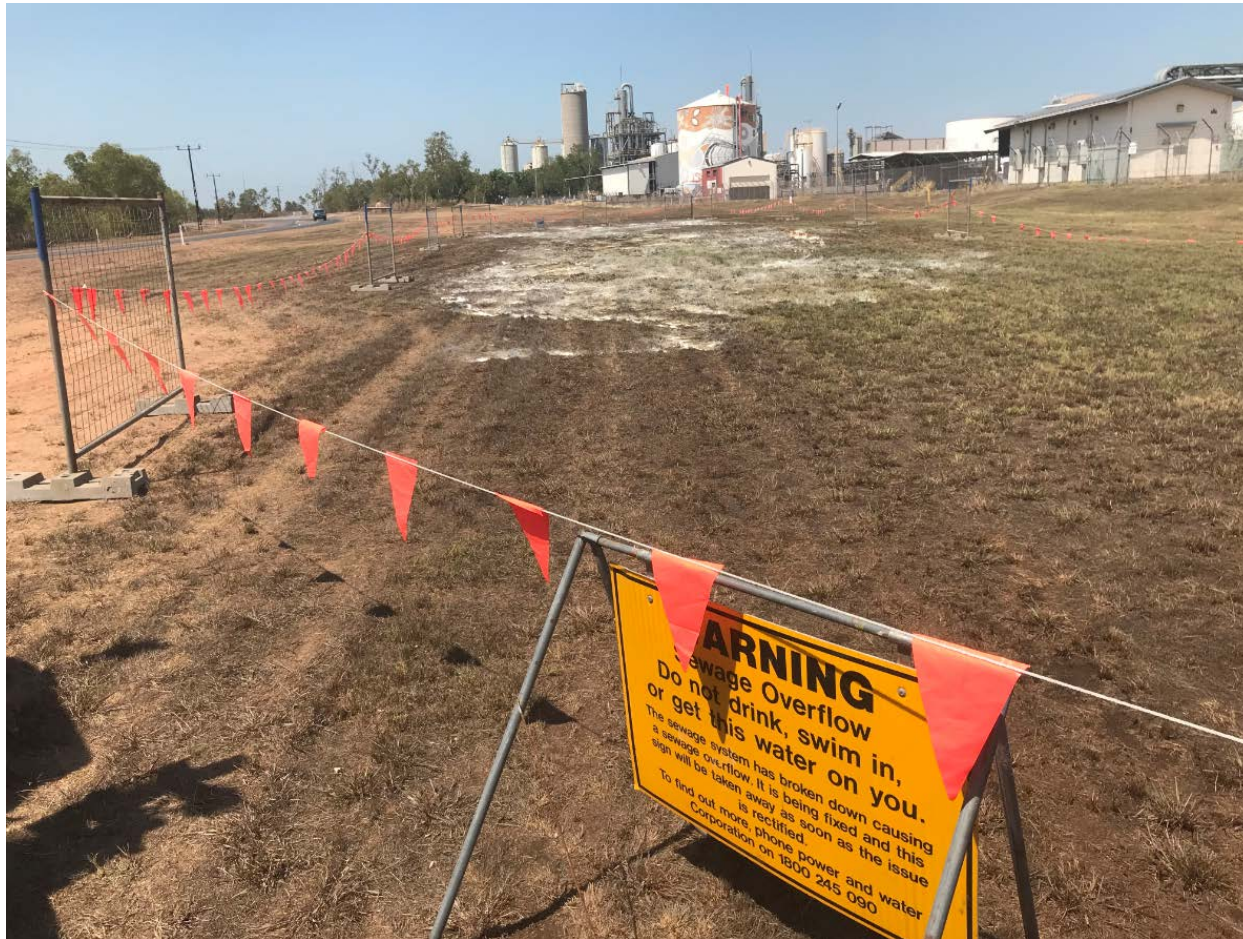
Photo 2 – Fenced and signed area

<p>rectify or clean up the pollution or resultant environmental harm caused or threatening to be caused by the incident</p>	<p>Response Work Instruction.</p> <p><i>i. Confirmation signage and fencing has been erected, as appropriate.</i></p> <p>The site has been fenced off and warning signage installed to alert the public as per Sewage Spills/Overflow Response Work Instruction (attached).</p> <p><i>ii. Decontamination of the site as appropriate.</i></p> <p>Clean up consistent with Sewage Spills/Overflow Response Work Instruction as appropriate to the location, and to minimise risk to the environment.</p> <p>Site has been limed and will be followed up by removing approx. 100mm of top contaminated soil and replaced with topsoil.</p>
<p>(f) the identity of the person notifying the NT EPA</p>	<p>PWC Environmental Team on behalf of Water Services</p>
