SECTION 14 INCIDENT REPORT (*Waste Management and Pollution Control Act*)

Date and Time of Notification:	Tuesday 17/11/2020 13:18hrs
Person / Company:	Power and Water Corporation (PWC)
Incident:	Discharge of raw sewage from sewerage network

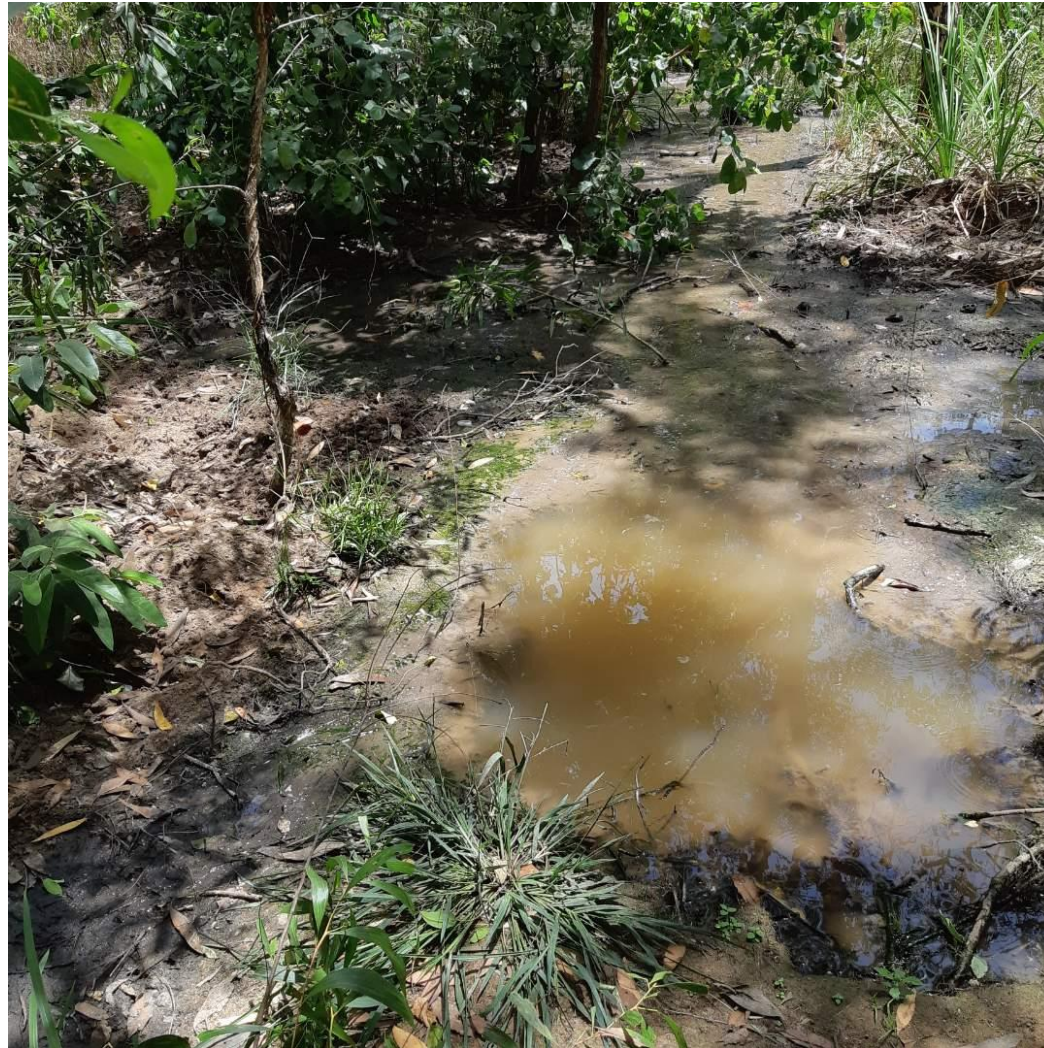
<p>Final Discharge Point: Immediately surrounding the discharge point, the wastewater soaked into the surrounding sandy soils within a few meters of where the pipe had split.</p> <p><i>iii. Indicate any locations nearby to the discharge point where public can gain ready-access, such as public open spaces through which the discharge moves.</i></p> <p>Access to the public is possible, but is believed to be infrequent given the nature of the location, as the spill occurred within very thick bushland, with no evidence that access to this location is undertaken.</p>
<p>(c) the date and time of the incident</p>	<p><i>i. The time and date of commencement and cessation of the discharge.</i></p> <p>The commencement time of the overflow is unknown. The overflow, or lack of flow into the waste ponds was first observed by the ESO on Friday 13/11/2020, with the spill from the sewer main having been stopped at approximately 12:00hrs 18/11/2020.</p> <p><i>ii. How PWC were notified, or became aware of the discharge.</i></p> <p>The ESO noticed that there was no flow into the wastewater stabilisation ponds on Friday 13/11/2020, who then advised the PWC Co-ordinator. Both the Co-ordinator and the ESO traversed the length of the pipeline to try to locate the issue.</p> <p><i>iii. The process by which the discharge occurred.</i></p> <p>The cause of the spill was due to the PVC sewer pipeline being damaged by tree roots, as the pipeline is an underground pipeline, which runs through what is now thick scrub typical of tropical environments.</p> <p><i>iv. The reason why the discharge occurred.</i></p> <p>As per (c) iii.</p>

Appendix B – Photograph of Spill Location, prior to pipework being exposed.

<p>(d) how the pollution has occurred, is occurring or may occur</p>	<p>As per (c) iii.</p>
<p>(e) the attempts made to prevent, reduce, control, rectify or clean up the pollution or resultant environmental harm caused or threatening to be caused by the incident</p>	<p><i>i. Confirmation signage and fencing has been erected, as appropriate.</i></p> <p>Warning tape has been erected around the excavation site, however no public access is anticipated as the site is approximately 256 meters into very thick scrubland.</p> <p><i>ii. Decontamination of the site as appropriate.</i></p> <p>The pipeline has been repaired, gross pollutants have been cleaned up and lime will be applied to the areas once backfill has been completed. Residents have also been advised of the spill and not to go to the area.</p> <p>In response to this event, the path of the sewer rising main will be cleared to provide vehicle access and have service markers installed, allowing the ESO to carry out routine checks of the line, helping to identify any</p>

issues earlier. The clearing will also assist with prevention of damage to the sewer main by tree roots.
(f) the identity of the person notifying the NT EPA	PWC Environmental Team on behalf of Water Services
