SECTION 14 INCIDENT REPORT (*Waste Management and Pollution Control Act*)

Date and Time of Notification:	Thursday 4 th February 2021, 16:00 hrs
Person / Company:	Power and Water Corporation (PWC)
Incident:	Infrastructure failure - Coconut Grove rising main vortex chamber at Ludmilla WWTP and localised highly diluted sewage spill around inlet chamber/manhole.

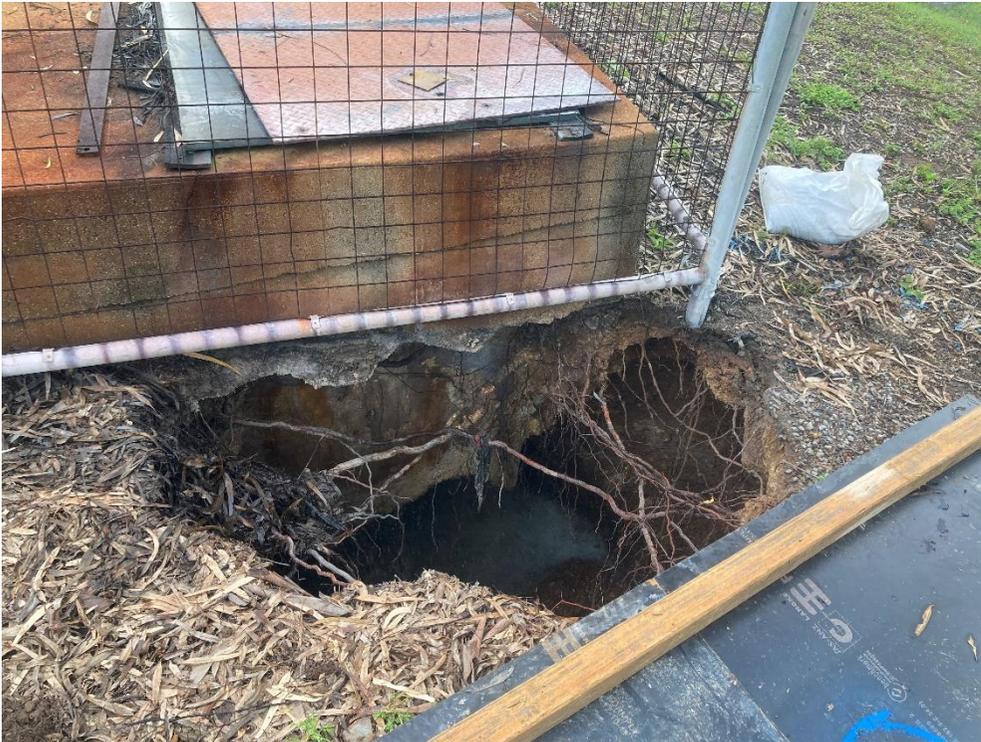
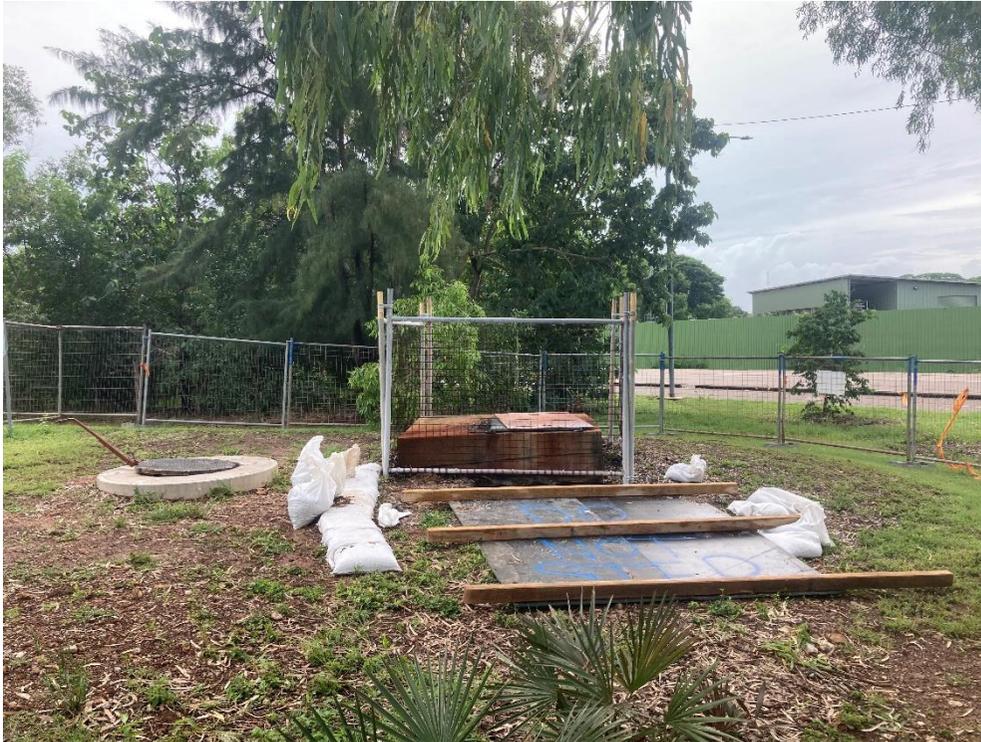
Appendix B – Photographs of the inlet chamber and surrounding fencing.

(c) the date and time of the incident	<p><i>i. The time and date of commencement and cessation of the discharge.</i></p> <p>The exact timing that the inlet chamber failed is unknown. PWC operators first noticed that the ground around the inlet chamber had collapsed around 16:00hrs 03/02/2021.</p> <p><i>ii. How PWC were notified, or became aware of the discharge.</i></p> <p>The PWC Senior Headworks Coordinator first noticed that the ground around the inlet chamber collapsed yesterday afternoon, as part of his routine site inspection.</p> <p><i>iii. The process by which the discharge occurred.</i></p> <p>Infrastructure failure of the inlet chamber, due to age and deterioration of infrastructure. As detailed above, there is currently no evidence that the sewage is discharging anywhere else other than to the wastewater treatment plant, through existing pipework. It is only the surrounding soils of the inlet chamber that are contaminated with highly diluted sewage.</p> <p><i>iv. The reason why the discharge occurred.</i></p> <p>As per (c) iii.</p>

Environment. Clean up will commence upon completion of repair works. Either contaminated soil will be replaced with clean fill or sufficient lime will be applied to the area.
(f) the identity of the person notifying the NT EPA	PWC Environmental Team on behalf of Water Services
