SECTION 14 INCIDENT REPORT (*Waste Management and Pollution Control Act*)

Date and Time of Notification:	Friday 30 th December 2022, 13:45hrs
Person / Company:	Power and Water Corporation
Incident:	Discharge of sewage from sewerage network, Galiwinku (Elcho Island) Sewage Pumping Stations No. 1 and No.2

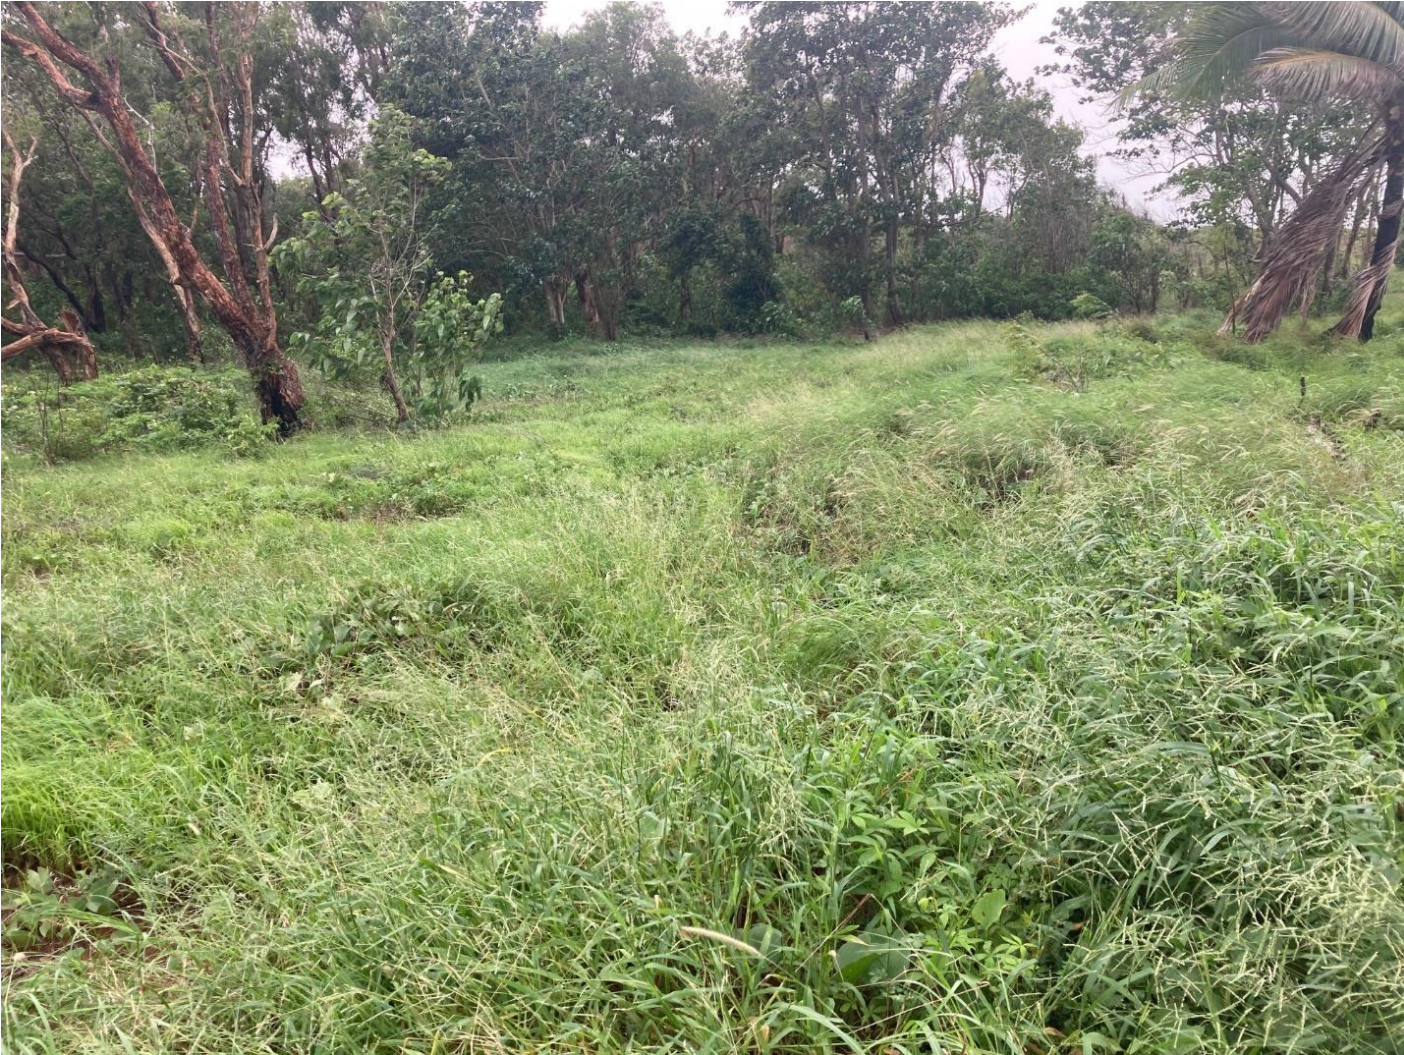
Appendix B – Location photo of SPS#2 discharge receiving environment.
