SECTION 14 INCIDENT REPORT (*Waste Management and Pollution Control Act*)

Date and Time of Notification:	28/02/2023 at 4.45 PM
Person / Company:	City of Darwin (EPL188-03)
Incident:	Leachate spill from Dewatering Well 2 (DW2)
(a) the incident causing or threatening to cause pollution	The pump that transfers leachate from DW2 (located on north-western corner of Stage 4) was not able to keep up with the leachate generation. The increased rainfall in the last 7 days (21-27 Feb 2023) of about 380 mm might have contributed to the leachate generation.

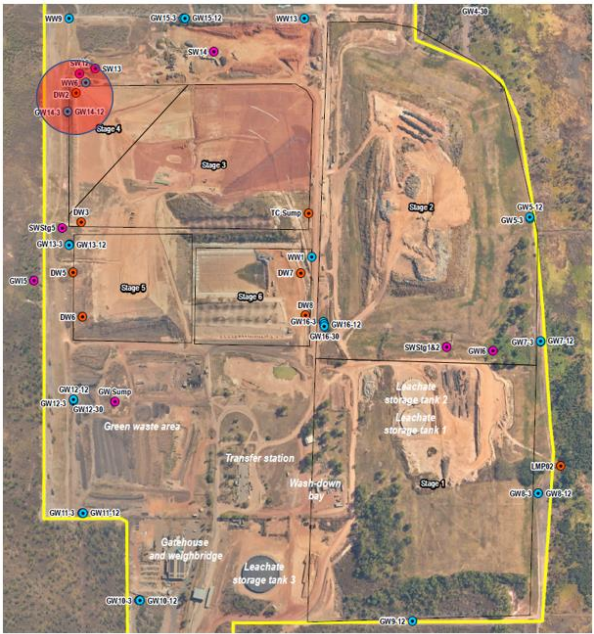
(b) the place where the incident occurred	<p>DW2 location on Stage 4 shown below in red</p>

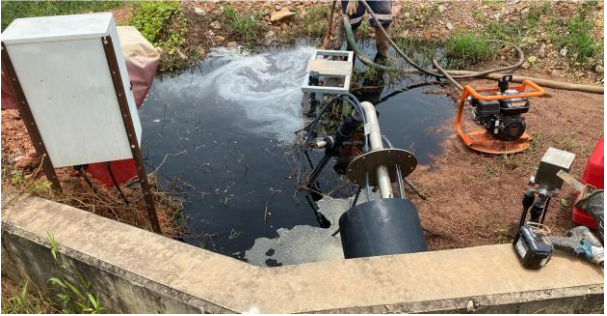
(d) how the pollution has occurred, is occurring or may occur	The spill occurred when the leachate pump that was installed in DW2 was not able to keep up with the leachate generation, mainly due to significant amount of rainfall onsite. About 300 litres of leachate was released but all contained within the bund onsite, and then pumped back into the leachate lines to the leachate pond. The situation will be constantly monitored.

<p>(e) the attempts made to prevent, reduce, control, rectify or clean up the pollution or resultant environmental harm caused or threatening to be caused by the incident</p>	<p>The spill was contained within the bund (below) and was pumped into the leachate lines diverting the leachate into the leachate storage pond.</p>
