SECTION 14 INCIDENT REPORT (*Waste Management and Pollution Control Act*)

Date and Time of Notification:	Tuesday 4 th April 2023, 09:30 hrs
Person / Company:	Power and Water Corporation
Incident:	Discharge of raw sewage from sewerage network, (sewer manhole cover to roadside stormwater drain)

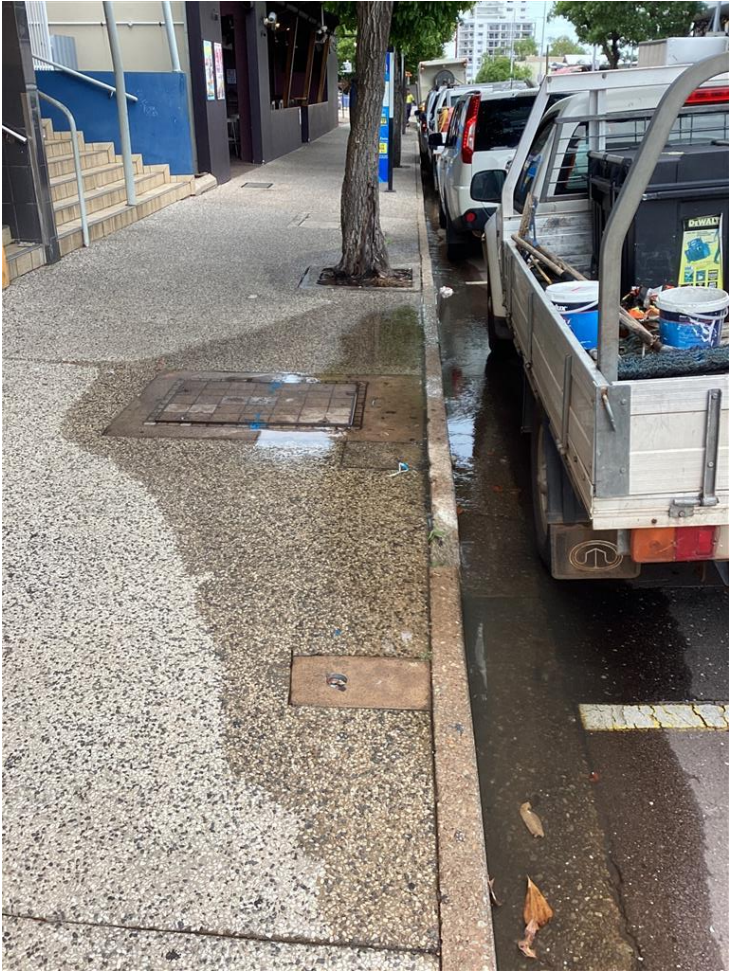
Figure 1 – Discharge point – Pre-clean up

(e) the attempts made to prevent, reduce, control, rectify or clean up the pollution or resultant environmental harm caused or threatening to be caused by the incident	<p>The blockage was cleared, and the overflow was stopped. Clean up undertaken as per Power and Water's Sewage Spills/Overflow Response Work Instruction. All visible sewage was vacuumed up and the area was immediately disinfected and thoroughly cleaned before the scene was opened up to the public again.</p> <p><i>i. Confirmation signage and fencing has been erected, as appropriate.</i></p> <p>No signage or fencing was erected in this instance; as the spill cause was rectified and the spill scene was cleaned comprehensively and disinfected straight away allowing public access immediately following clean up. Upon Power and Water crew attending the overflow site, the site was continually supervised by Power and Water staff who directed members of the public away from the spill to prevent contact.</p> <p><i>ii. Decontamination of the site as appropriate.</i></p> <p>Clean up consistent with Power and Water's Sewage Spills/Overflow Response Work Instruction as appropriate to the location. Site was inspected for any gross pollutants, of which none were observed, and the area was cleaned and disinfected with biodegradable detergent.</p>

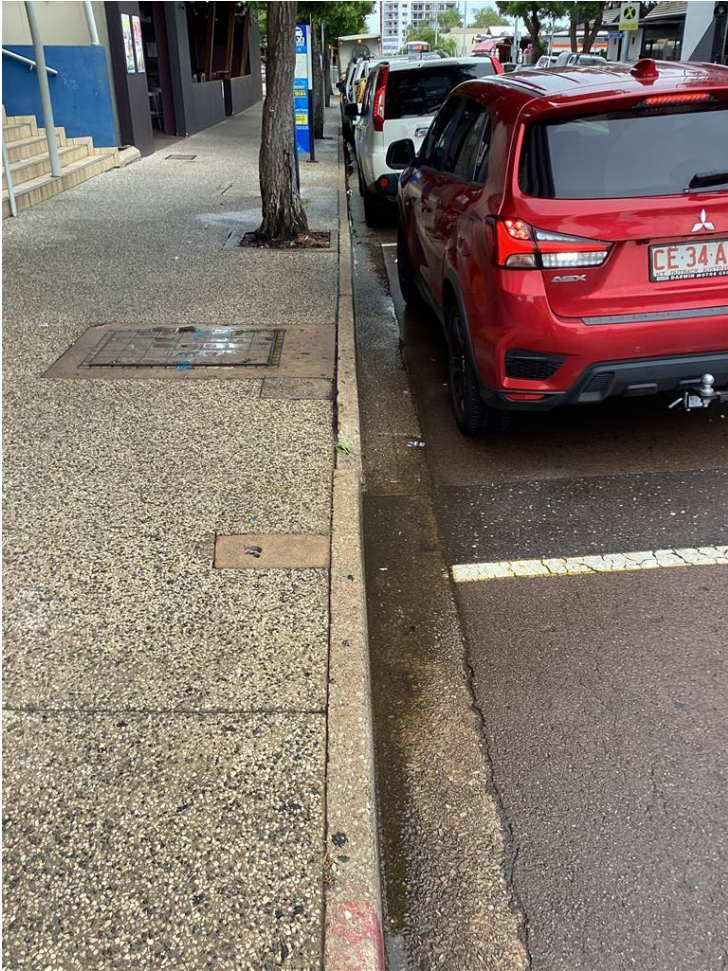
Figure 2 – Post clean up
