SECTION 14 INCIDENT REPORT (*Waste Management and Pollution Control Act*)

Date and Time of Notification:	Thursday 03 August 2023, 9:30 am
Person / Company:	Power and Water Corporation (PWC)
Incident:	Oil spill from Areyonga Power-station.

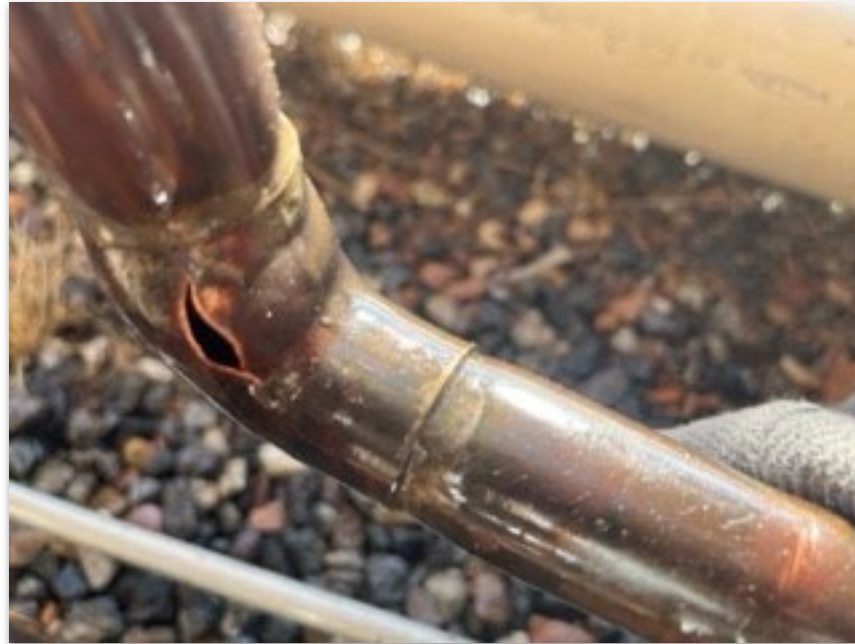
<p>under investigation.</p> <p><i>ii. How PWC were notified, or became aware of the discharge.</i></p> <p>As above, and furthermore, at approximately 11:30am the Technical Mechanical Coordinator informed the Power and Water Environmental Services Team of the engine oil incident.</p> <p><i>iii. The process by which the discharge occurred.</i></p> <p>The engine oil copper supply pipe from the oil store container has split near the entry of this pipe into the power-station (see photo 1). The engine oil discharged onto the soil within the power-station compound, exited the nearby fence and entered the adjoining roadside. (see photo 2 & 3).</p> <p><i>iv. The reason why the discharge occurred.</i></p> <p>Infrastructure failure – ruptured copper pipe.</p>

Photo 1. Split in 25mm copper pipe

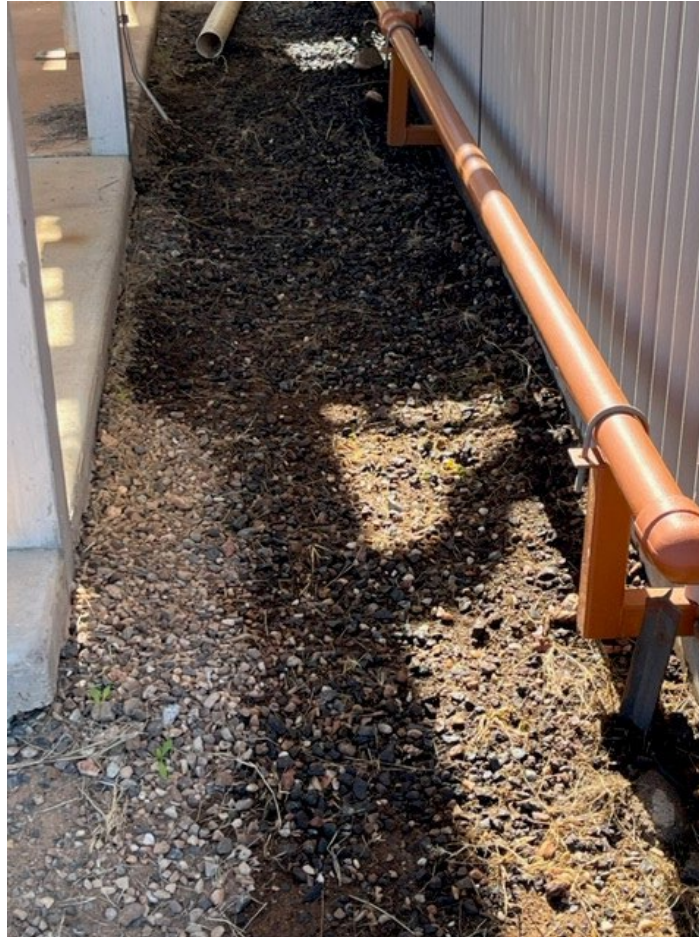
(a) the incident causing or threatening to cause pollution	<p><i>i. Description of the waste that was discharged.</i></p> <p>New engine oil.</p> <p><i>ii. Volume of the waste that was discharged.</i></p> <p>The volume of oil spilt is estimated to be a maximum of 150 litres. The spill originated from a 205 litre oil drum, of which 52 L was used within the engines, meaning the remainder is expected to have spilt to the surrounding soils.</p>

Photo 2. Engine oil spill onto Power-station ground

(d) how the pollution has occurred, is occurring or may occur	As per (c) iii & (c) iv.
(e) the attempts made to prevent, reduce, control, rectify or clean up the pollution or resultant environmental harm caused or threatening to be caused by the incident	<p><i>i. Attempts made to prevent, reduce or control the discharge</i></p> <p>Upon arrival of the USC Worker the copper supply pipe was immediately isolated to prevent any further spill. The copper pipe is being upgraded with a stronger stainless steel version to prevent any further incidents.</p> <p>Contractors have been engaged to undertake excavation of contaminated materials. Before commencement of works the Power and Water Property Team are confirming any land tenure requirements and sacred site details before commencing excavations on ground.</p> <p>Once approvals are received the material will be excavated until no visible contamination or odour is present. Site will be backfilled with locally sourced clean fill.</p> <p>Contaminated material will be stored within sealed bulka bags, and transported for disposal via licenced contractors.</p>

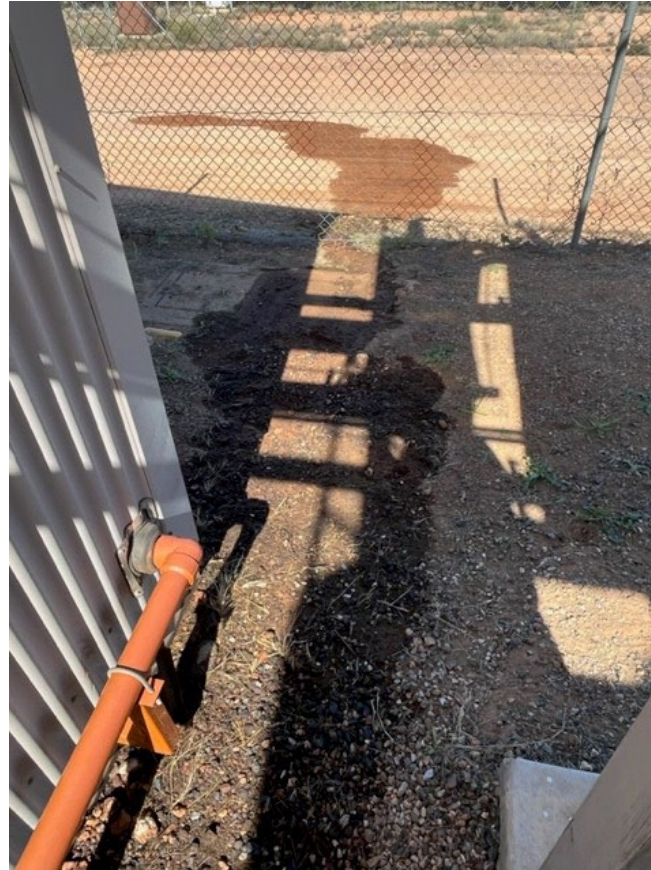
Photo 3. Engine oil spill exiting to nearby roadside
