SECTION 14 INCIDENT REPORT (*Waste Management and Pollution Control Act*)

Date and Time of Notification:	Email notification – 25 March 2024 at 20:15																		
Person / Company:	McArthur River Mining Pty Ltd (MRM)																		
Incident:	<p>Releases of water to Barney Creek (BC) during significant flooding, this included the following:</p> <ul style="list-style-type: none"> • a minor leak from a pipeline at the BC Haul Bridge; • inundation of the BC South-East Sump (BC SES), BC South-West Sump (BC SWS) and BC North-West Sump (BC NWS) causing some release of this water to BC; and • inundation of a pond at the Mill causing some release of this water to BC. 																		
(a) the incident causing or threatening to cause pollution	Water was released at five locations along BC, within the operational area of McArthur River Mine (the Mine). The released water is determined to have been significantly diluted by extreme floodwaters, therefore the environmental risk downstream of the Mine is considered to be extremely low.																		
(b) the place where the incident occurred	<p>The incident occurred at various locations along BC, within the operational area of the Min

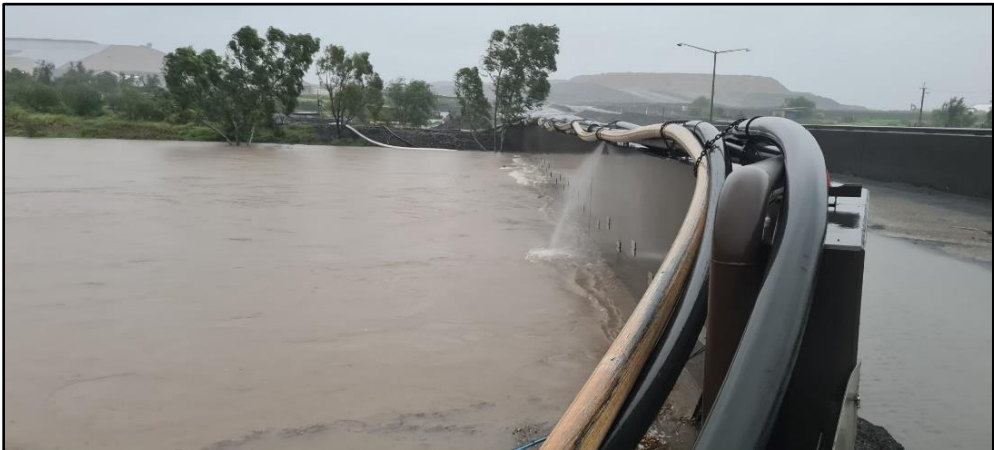
</div> <p><i>Figure 2. LA pipe burst at BC Haul Bridge.</i></p>

<p>(e) the attempts made to prevent, reduce, control, rectify or clean up the pollution or resultant environmental harm caused or threatening to be caused by the incident</p>	<p>When floodwaters receded, and after it was deemed safe, the pipe on BC Haul Bridge, identified as the Lake Archer water transfer pipe, was isolated and the transfer ceased. Additionally, the three sumps adjacent to the BC Haul Bridge and Mill Pond were no longer inundated when floodwaters receded (Figure 5).</p> <p>Any water released at this time is considered to have been significantly diluted and represents a very low risk to the environment downstream of the Mine. This is discussed further in the below section.</p> <p>Potential for Environmental Harm</p> <p><u>Barney Creek Haul Bridge Pipeline</u></p> <p>The water released from the pipeline at the BC Haul Bridge is estimated to be <0.1 megalitres (ML), which in comparison to the estimated total stream discharge volume of 69,120 ML in Barney Creek over the same time period, is considered to be minor.</p> <p><u>Barney Creek Haul Bridge Sumps (SES, SWS & NWS)</u></p> <p>The containment sumps on either side of Barney Creek capture surface runoff from the road and approach to the Haul Road Bridges. The most recent samples prior to inundation were taken from these sumps on 27 February 2024. At that time, the water quality was classified as Class 4 – managed release water.</p> <p>In addition, these sumps were dewatered prior to the event as part of preparatory works associated with ex-TC Megan, and the water quality was likely being in the managed release class (or better). The flow in the McArthur River at that time was also high, providing significant dilution of any waters released from the sump.</p> <p><u>Mill Pond</u></p> <p>The Mill Pond is a pond that collects runoff from areas of the Mill catchment. It also receives pumped inflows from distribution points such as Pete’s Pond and Van Duncan’s Dam.</p> <p>The most recent sample prior to inundation was taken on 27 February 2024. At that time, the water quality in the Mill Pond was classified as Class 6 (process water equivalent). However, the flow in the McArthur River at the time of inundation was high, providing significant dilution of any Mill Pond waters released. This magnitude of dilution presents negligible risk to the receiving waters.</p> <p><u>Water Quality Results</u></p> <p>On 19 March 2024, samples were collected at three locations along Barney Creek (SW03, SW19 and SW20) and on 25 March 2024 a water sample was taken from SW11, located downstream of the Mine. Results from SW11 shows that all analytes were well below the Waste Discharge Licence (WDL) 174-14 Site Specific Trigger Values (SSTVs) (see Table 3 below).</p>

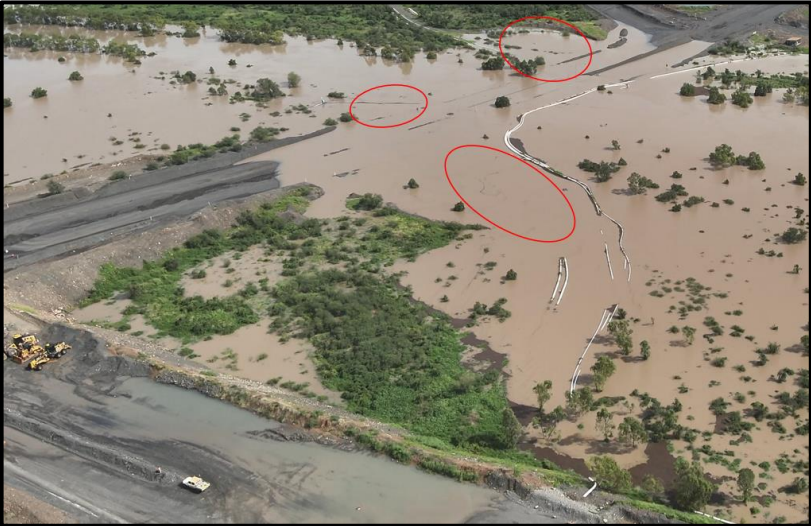
Figure 3. Inundation of the BC SES, BC SWS and BC NWS at BC.

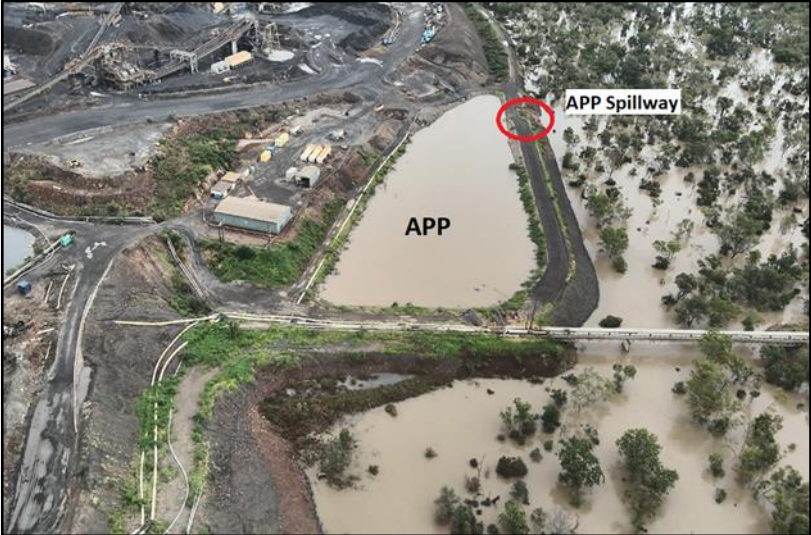
Figure 4. Location where BC floodwaters inundated the Mill Pond.

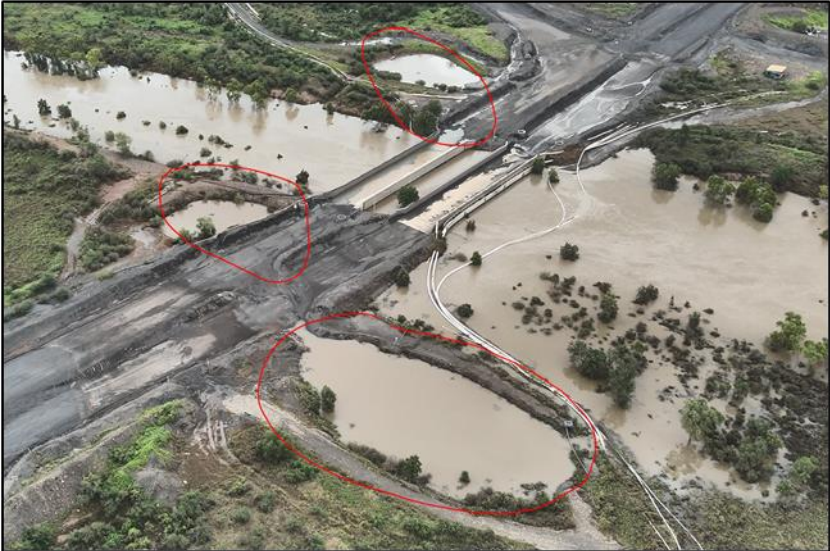
Figure 5. BC SES, BC SWS and BC NWS no longer inundated by BC.
