SECTION 14 INCIDENT REPORT (*Waste Management and Pollution Control Act*)

Date and Time of Notification:	Thursday 28 th November 2019, 15:59pm
Person / Company:	Power and Water Corporation (PWC)
Incident:	Discharge of raw sewage from sewerage network (sewer manhole cover to roadside stormwater drain)

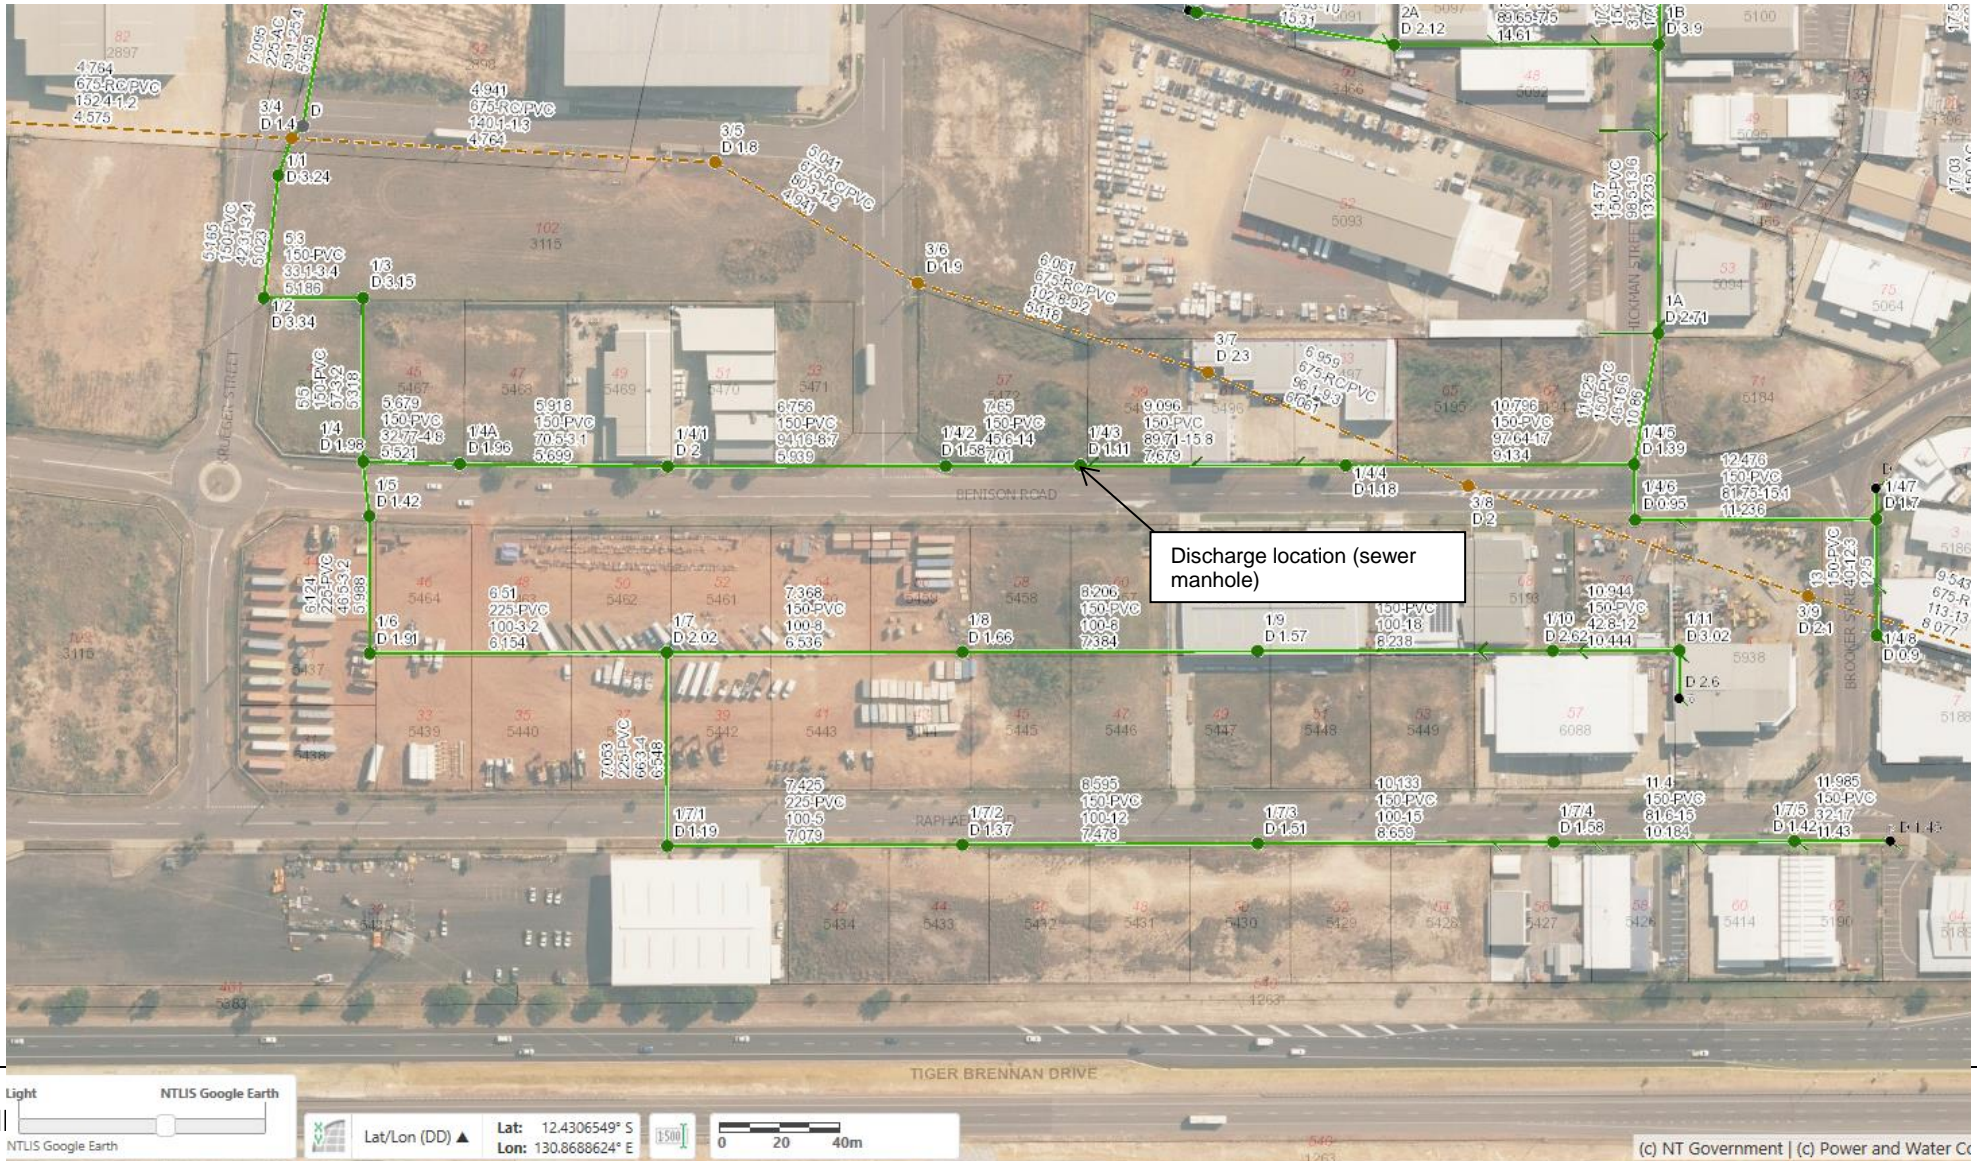
<p><i>i. Description of the PWC asset from which the discharge occurred.</i> Sewer manhole cover (1/4/3) located at 57 Benison Road, Winnellie, – as per map below.</p> <p><i>ii. GPS coordinates of the discharge point from the PWC asset, and the final coordinates of the final discharge point.</i></p> <p>Discharge Point: 130.8688624, -12.4306549</p> <p><i>iii. Indicate any locations nearby to the discharge point where public can gain ready-access, such as public open spaces through which the discharge moves.</i></p> <p>Access to the public is possible in the small section of grassed road verge between the manhole cover and the road. Spill has been fenced and signage erected. Clean up was undertaken as per Sewage Spills/Overflow Response Work Instruction.</p>
