SECTION 14 INCIDENT REPORT (*Waste Management and Pollution Control Act*)

Date and Time of Notification:	Initial notification (email) – 24 March 17:49									
Person / Company:	McArthur River Mining Pty Ltd (MRM)									
Incident:	Spillage of zinc concentrate on the Carpentaria Highway. The source of the spill originated from a road train travelling from McArthur River Mine (the Mine) to the Bing Bong Loading Facility (BBLF).									
(a) the incident causing or threatening to cause pollution	A total of approximately 200 kilograms (kg) of bulk concentrate was released at one location on the Carpentaria Highway, between the Mine and the BBLF. All concentrate was confined to the road and roadside.									
(b) the place where the incident occurred	<p>The Global Positioning System (GPS) points for the length of the spill is provided in Table 1 below and shown in Figure 1.</p> <p style="text-align: center;"><i>Table 1 – GPS Coordinates of spill end and start.</i></p>

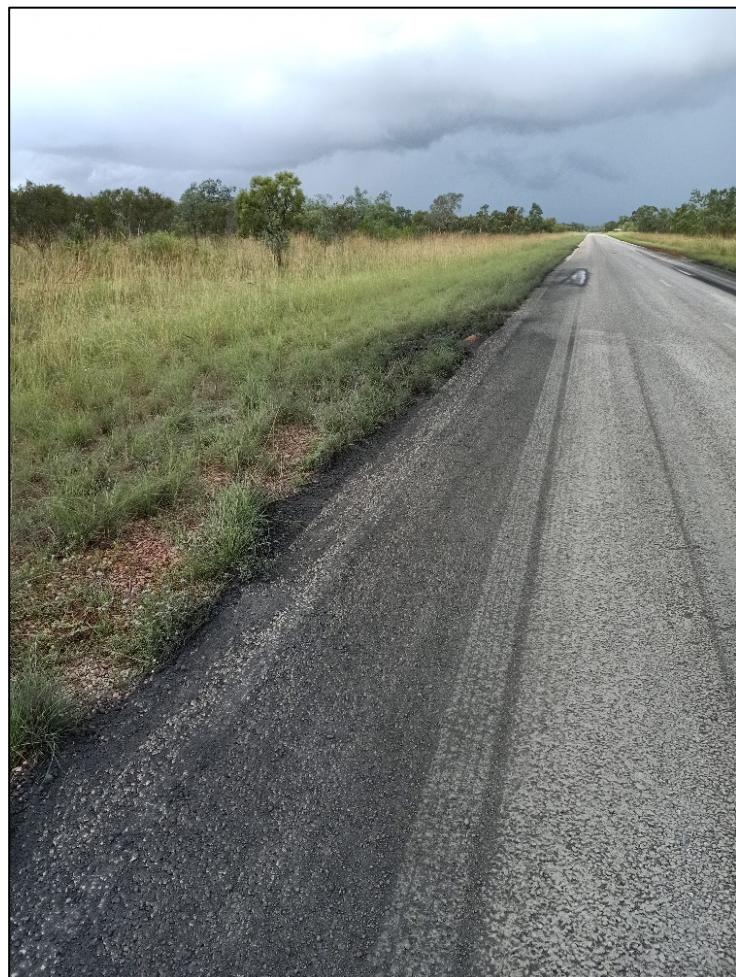
On 23 March 2021 at approximately 19:00, a road train operator carrying bulk concentrate was travelling from the Mine to the BBLF, when the road train deviated slightly into the roadside. As the operator corrected the steering, the rear trailers swung causing the lids to open and concentrate to escape the trailers (Figure 2 and 3). The operator immediately notified the Transport Contractor Supervisor of the incident.

During the inspection, grey material, indicative of concentrate, was observed at the spill location on the Carpentaria Highway. It was estimated that a total of 200 kg of bulk concentrate had been spilled from the road train across one location, on the road and roadside, over an area of approximately 0.2 hectares (ha).

The incident investigation concluded that the contributing factors included the uneven road surface and human error.

Figure 2: Concentrate observed on road prior to clean-up efforts.

<p>Prevention</p> <p>The incident investigation concluded that the contributing factors included the uneven road surface and human error. It is a critical requirement for road train operators to follow the loading procedure to prevent similar spills from occurring. The work crew undertook training via a toolbox talk, reiterating the requirement to check load levels prior to departing the Mine.</p> <p>In addition, MRM have recently implemented set trailer load fill limits to the top ridge of the trailers, approximately 200 mm below the lid of the trailers.</p> <p>Further, MRM will now conduct visual trailer inspections at the Mine Security Gatehouse prior to exiting the Mine. The inspections are conducted to confirm the trailer lids are in working order, and there is no concentrate sitting on the external body of the trailers. If the truck fails the inspection, arrangements are to be made to ensure the trailer is rectified to a suitable condition before approval to leave site is given.</p> <p>MRM is awaiting validation sampling results to determine whether the remediation was successful. The findings of the soil results will be provided to the Department in due course.</p>

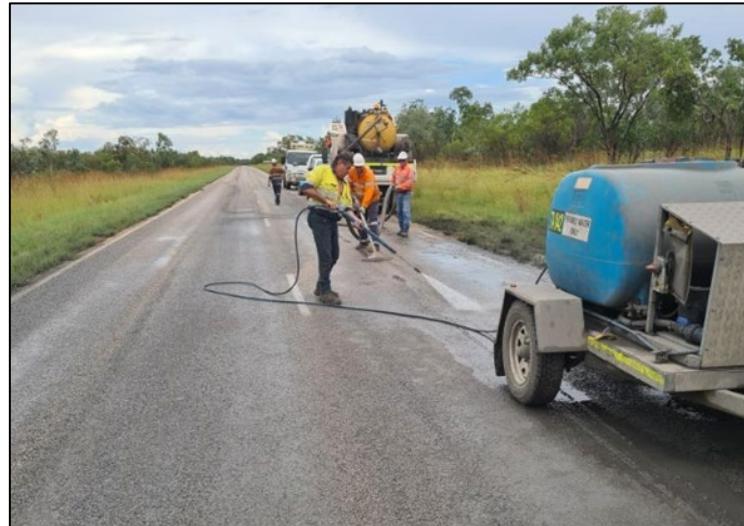
Figure 3: Spill clean-up efforts via pressure cleaner and vacuum truck.

At approximately 12:30 on 24 March 2021, a vacuum truck was deployed to clean-up all of the material on the sealed bitumen (Figure 3). This involved pressure washing the concentrate and simultaneously using a vacuum truck to collect the residue, which was transported back to the BBLF containment ponds.

On the same day, an excavator was used to remove the potentially impacted soil on the roadside that resulted from the incident. All potentially impacted soil was removed and disposed of in Cell 1 of the Tailings Storage Facility.

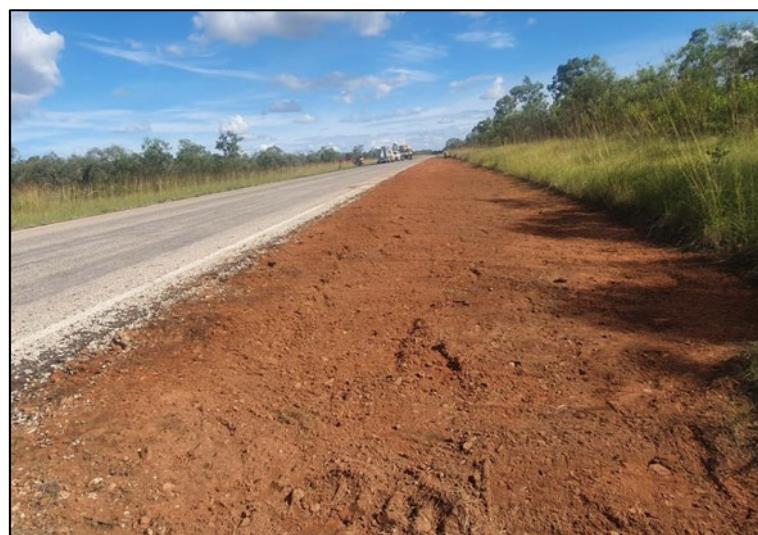
On 27 March 2021, following the completion of the works, MRM personnel inspected the road and could not identify any visible signs of concentrate along the transport route (Figure 4).

Figure 4: Spill location after the completion of clean-up works.

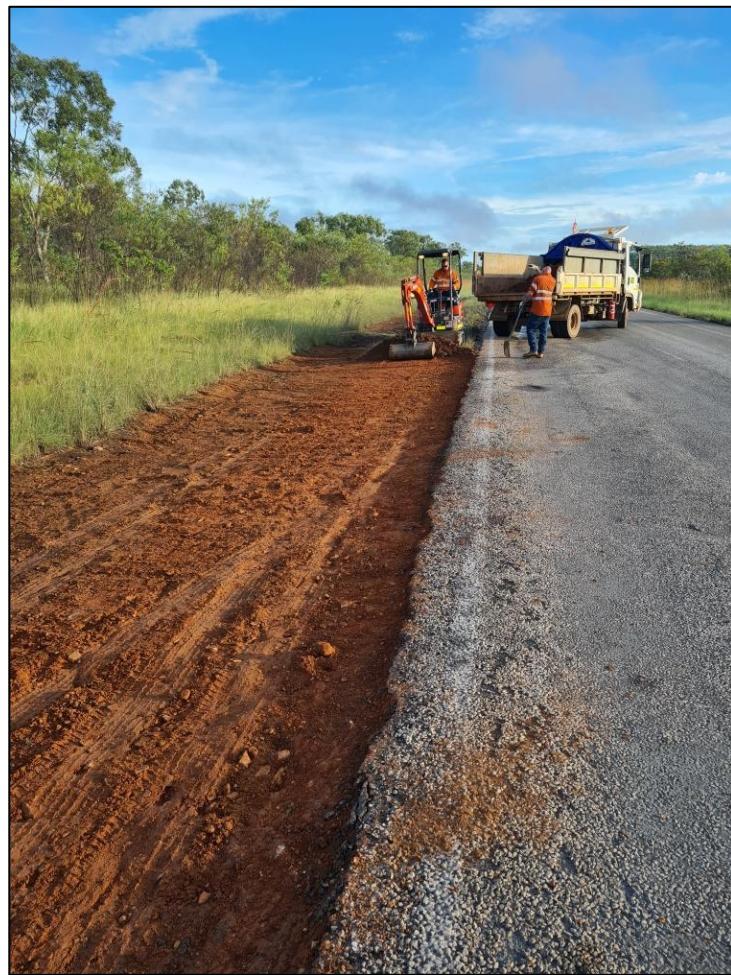
Approximately 200 kg of bulk concentrate was estimated to have been spilt at one location. The majority of the spill was confined to the sealed bitumen area. No potentially sensitive receptors were identified at the spill location (Figure 5).

The potential for material environmental harm is considered to be low due to the majority of the spill being confined to one location, and the timely remedial response. Soil samples were collected at the spill location to determine whether the soil is suitable for the current land-use.

Figure 5: No sensitive receptors identified at the spill location whilst remediation undertaken.

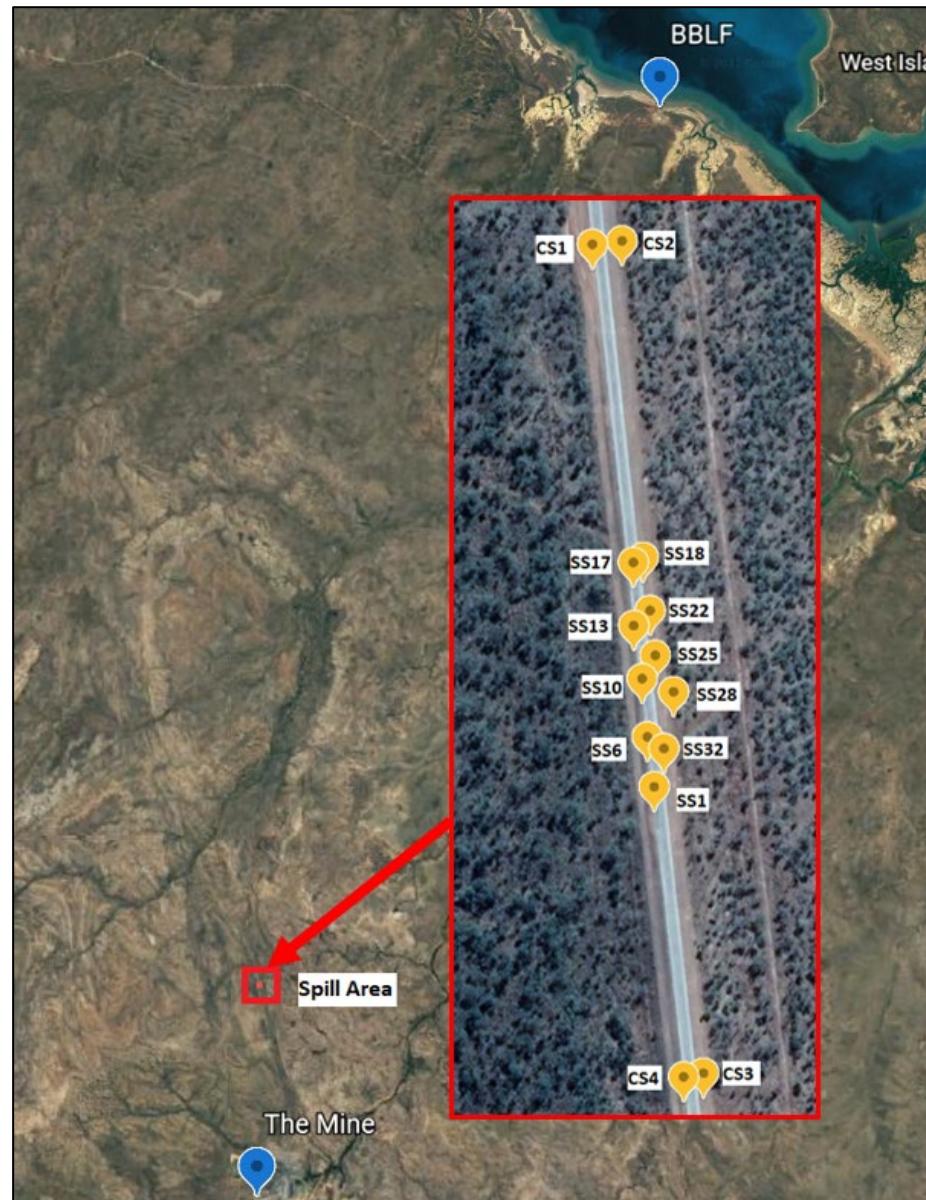
On 29 March 2021, 14 soil samples were collected in total at the spill location (Figure 6) in accordance with *Australian Standard 4482.1-2005: Guide to the investigation and sampling of sites with potentially contaminated soil*.

All soil samples are being analysed for relevant contaminants of concern (i.e. zinc and lead) and results will be compared against the relevant National Environment Protection (Assessment of Site Contamination) Measure 1999 (NEPM, 1999) Guidelines to determine whether the soil is suitable for the current land-use.

Figure 6: Sampling locations at the spill sites between the Mine and BBLF.
