Notice of non-compliance with EPL188-03 – Leachate Breakout Stage 3 and Stage 4 Incident 20/1/2022.

This notification of non-compliance is made to the NT EPA under condition 26, 27 & 29 of the City of Darwin’s Environment Protection Licence (EPL 188-03). The below table provides information to meet the information requirements of condition 29 of EPL 188-03.

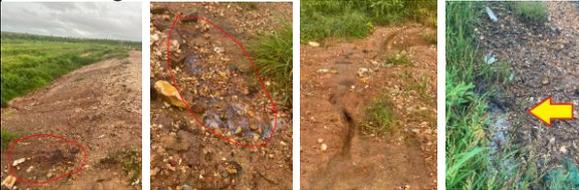
Licence condition	Response from City of Darwin
<p>27 Pollution Hotline Contact Time and Date</p>	<p>The incident was reported to the NTEPA pollution hotline at 1:45pm on the 20th of January 2022. NT Hotline reference number 188115017</p>
<p>29.1 when the non-compliance was detected and by whom.</p>	<p>On Thursday the 20th of January 2022 at 12:40pm Sandrine Ricardo (CoD employee) called Shane Coleman (CoD Waste Manager) to notify that the NT EPA Officers had stopped at the Shoal Bay Weighbridge and notified her that they had found some leachate breakout areas. Stage 4 and Stage 3 were only mentioned by Sandrine.</p>
<p>29.2 the date and time of the non-compliance.</p>	<p>12:30 pm, Thursday the 20th of January 2022.</p>
<p>29.3 the actual and potential causes and contributing factors to the non-compliance.</p>	<p>Recent wet weather has caused the surface to reach saturation point across the landfill batters creating leachate bleed points. The area not having a final cap is also a significant contributing factor for the breakouts.</p>
