SECTION 14 INCIDENT REPORT (*Waste Management and Pollution Control Act*)

Date and Time of Notification:	18 th July 2022, 21:05hrs
Person / Company:	Power and Water Corporation (PWC)
Incident:	Diesel Fuel Spill Palumpa Power Station

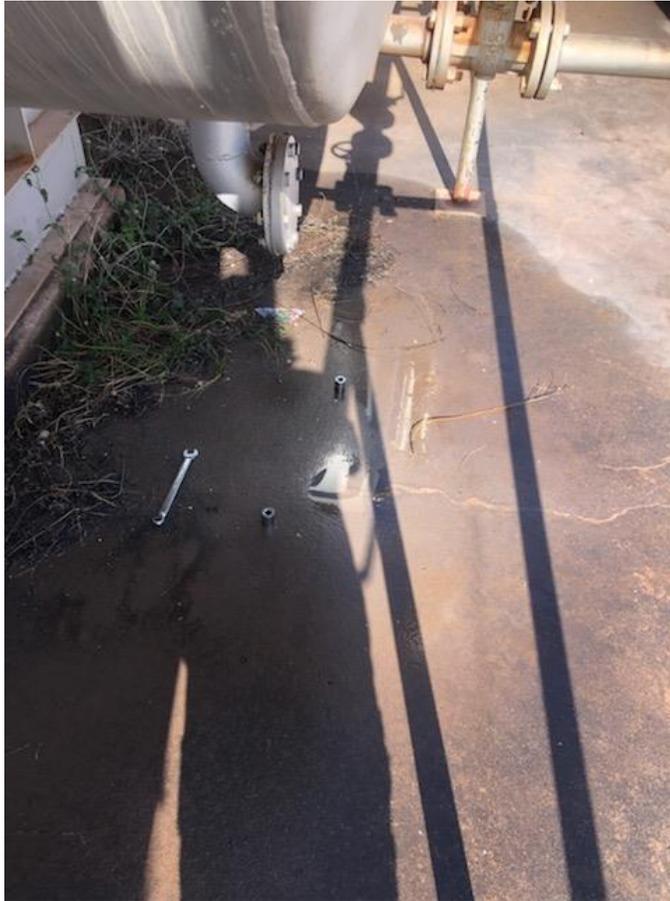
<p>The site's Essential Services Operator (ESO) called the PWC Mechanical Technical Coordinator at 08:14hrs 18 July 2022.</p> <p>iii. The process by which the discharge occurred.</p> <p>Unlawful entry to the power station compound and potential theft of diesel fuel directly from one of the bulk fuel tanks, via a blanked off pipe flange.</p> <p>Secondly, as per advice from the onsite ESO, the fuel bund stormwater outlet valve was closed tight, however it appears that the valve is faulty resulting in diesel exiting the bund into the environment.</p> <p>iv. The reason why the discharge occurred.</p> <p>Unlawful access to the power station's bulk fuel tanks, along with the fuel bund stormwater drainage valve being faulty and allowing diesel to escape.</p>

Pic 1: Bulk fuel tank flange that was tampered with

(c) the date and time of the incident	<p>i. The time and date of commencement and cessation of the discharge.</p> <p>The leak was first detected shortly before 08:14hrs 18 July 2022. The duration of the spill is unknown, but the leak was stopped shortly after 08:14hrs 18 July 2022, once some blanking flange bolts were tightened up.</p> <p>ii. How PWC were notified, or became aware of the discharge.</p>

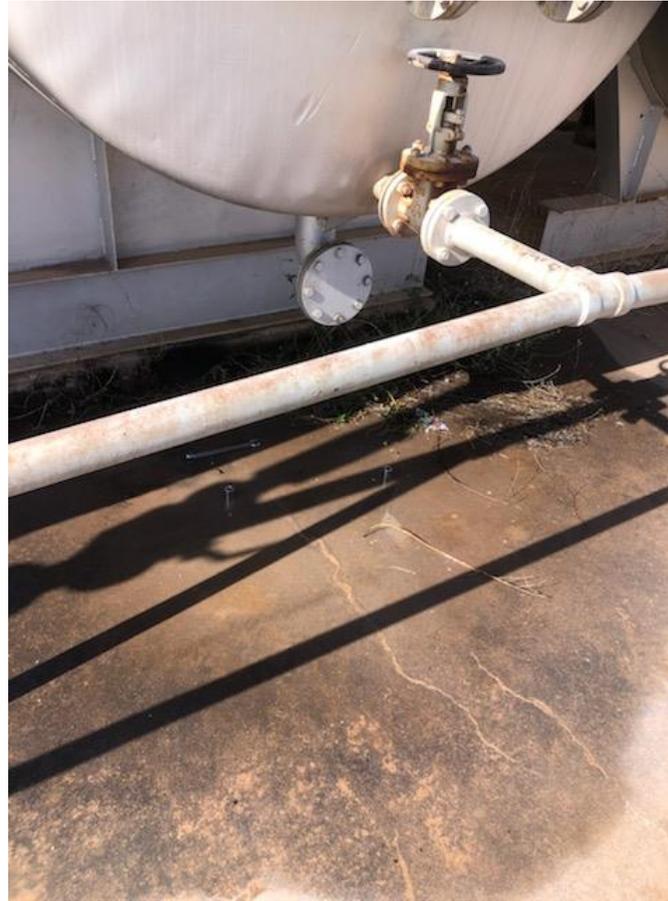
Pic 2: Bulk fuel tank flange

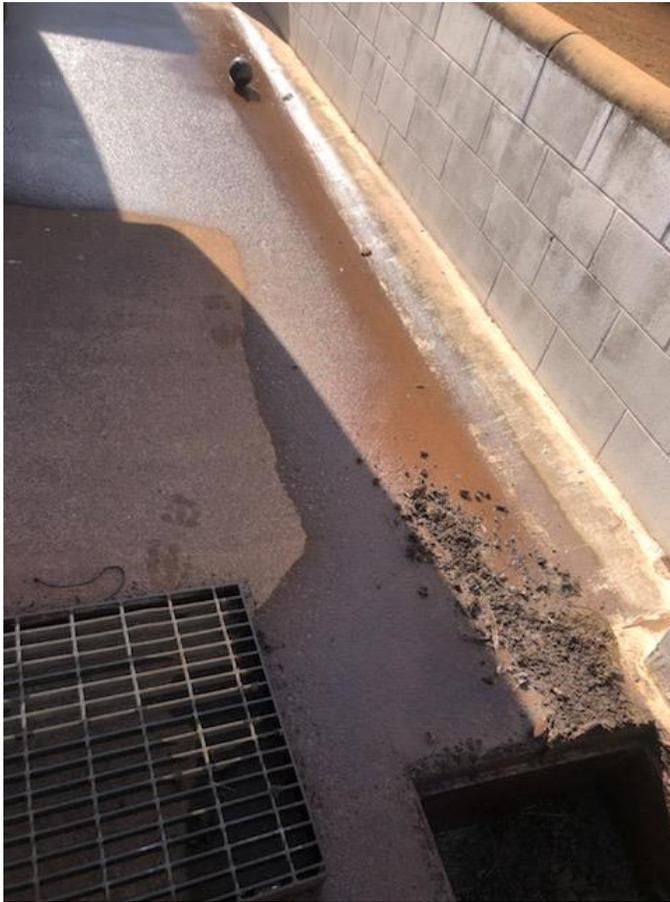
Pic 3: Spill reaching bund sump

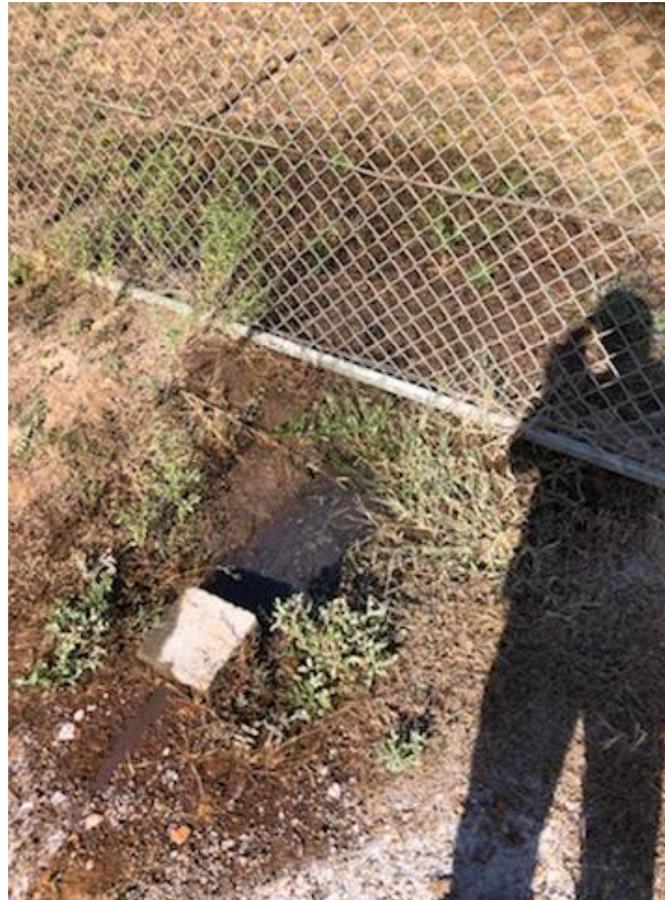
Pic 4: Spill exiting oily water separator pipework
