## SECTION 14 INCIDENT REPORT (*Waste Management and Pollution Control Act*)

<b>Date and Time of Notification:</b>	Wednesday 1 <sup>ST</sup> February 2023, 08:27hrs
<b>Person / Company:</b>	Power and Water Corporation ( <b>PWC</b> )
<b>Incident:</b>	Discharge of sewage from sewerage network (gas trap manhole cover)

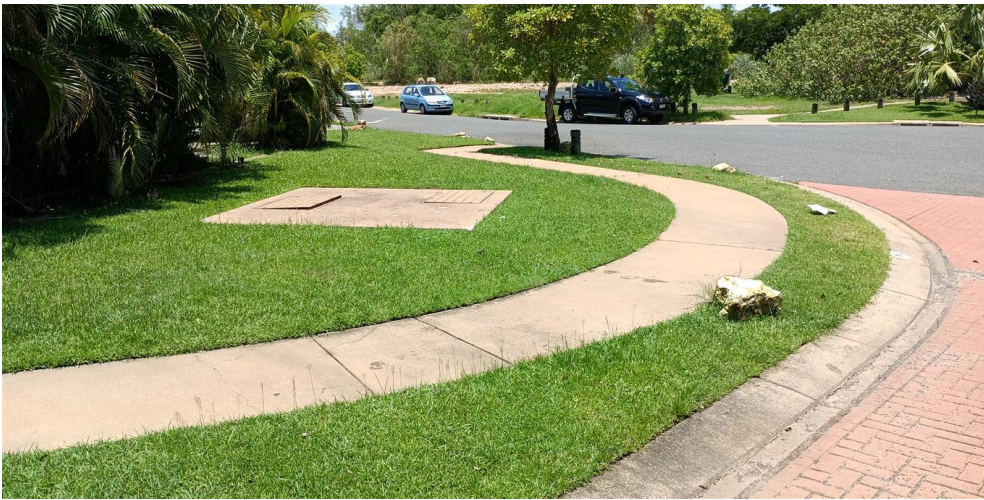
Figure 1. Photograph of the spill site post clean-up, taken 31/01/2023 at 13:12hrs.

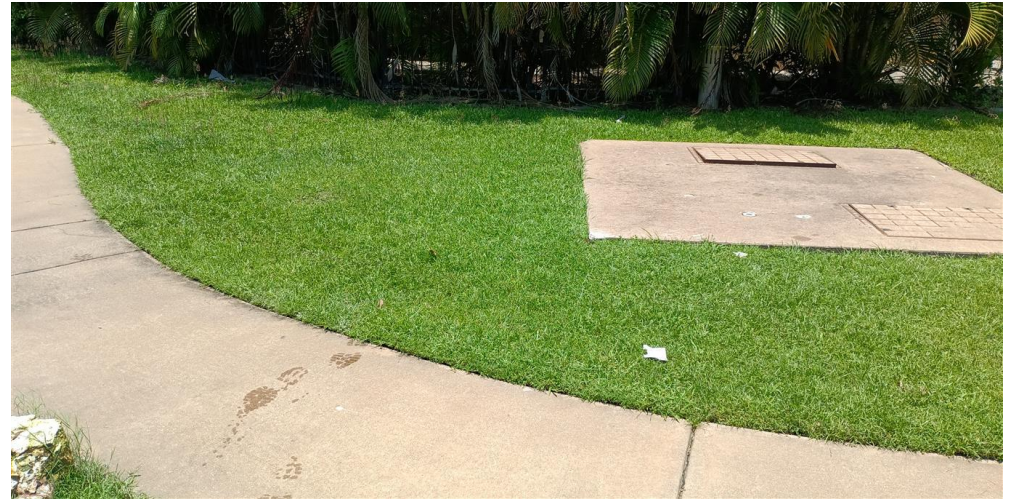
Figure 2. Photograph of the spill site post clean-up, taken 31/01/2023 at 13:12hrs.
