SECTION 14 INCIDENT REPORT (*Waste Management and Pollution Control Act*)

Date and Time of Notification:	Friday 30 th 2023, 15:00hrs
Person / Company:	Power and Water Corporation (PWC)
Incident:	Discharge of sewage from sewerage network – Inspection opening

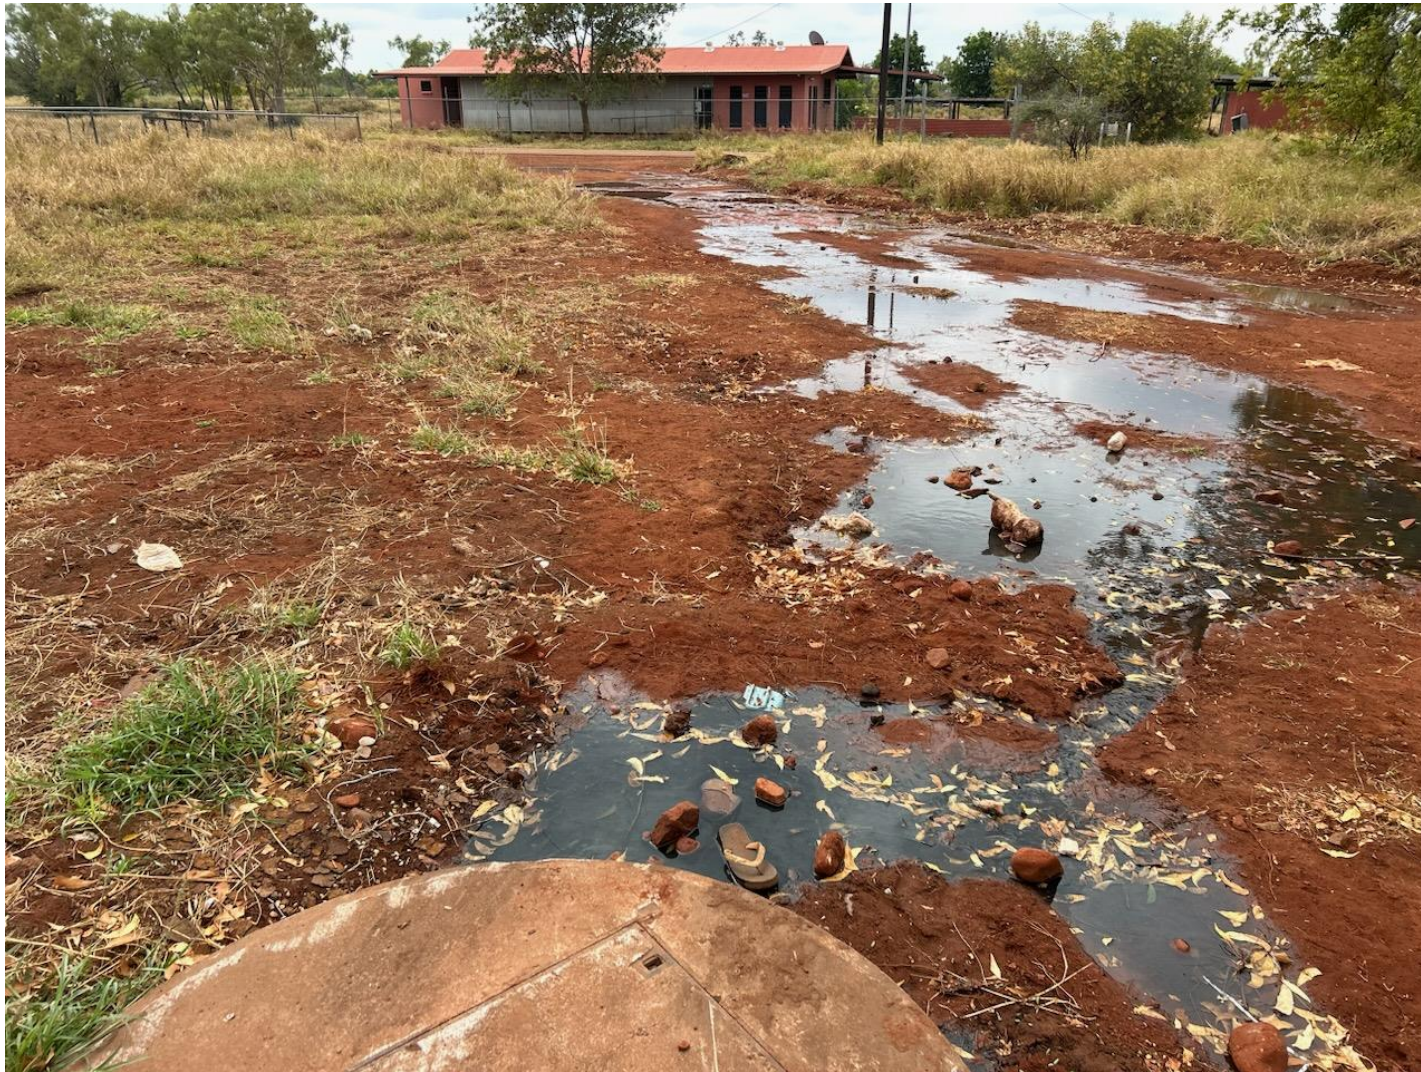
Figure 1 – Showing spill source, path and that there are no gross pollutants present.

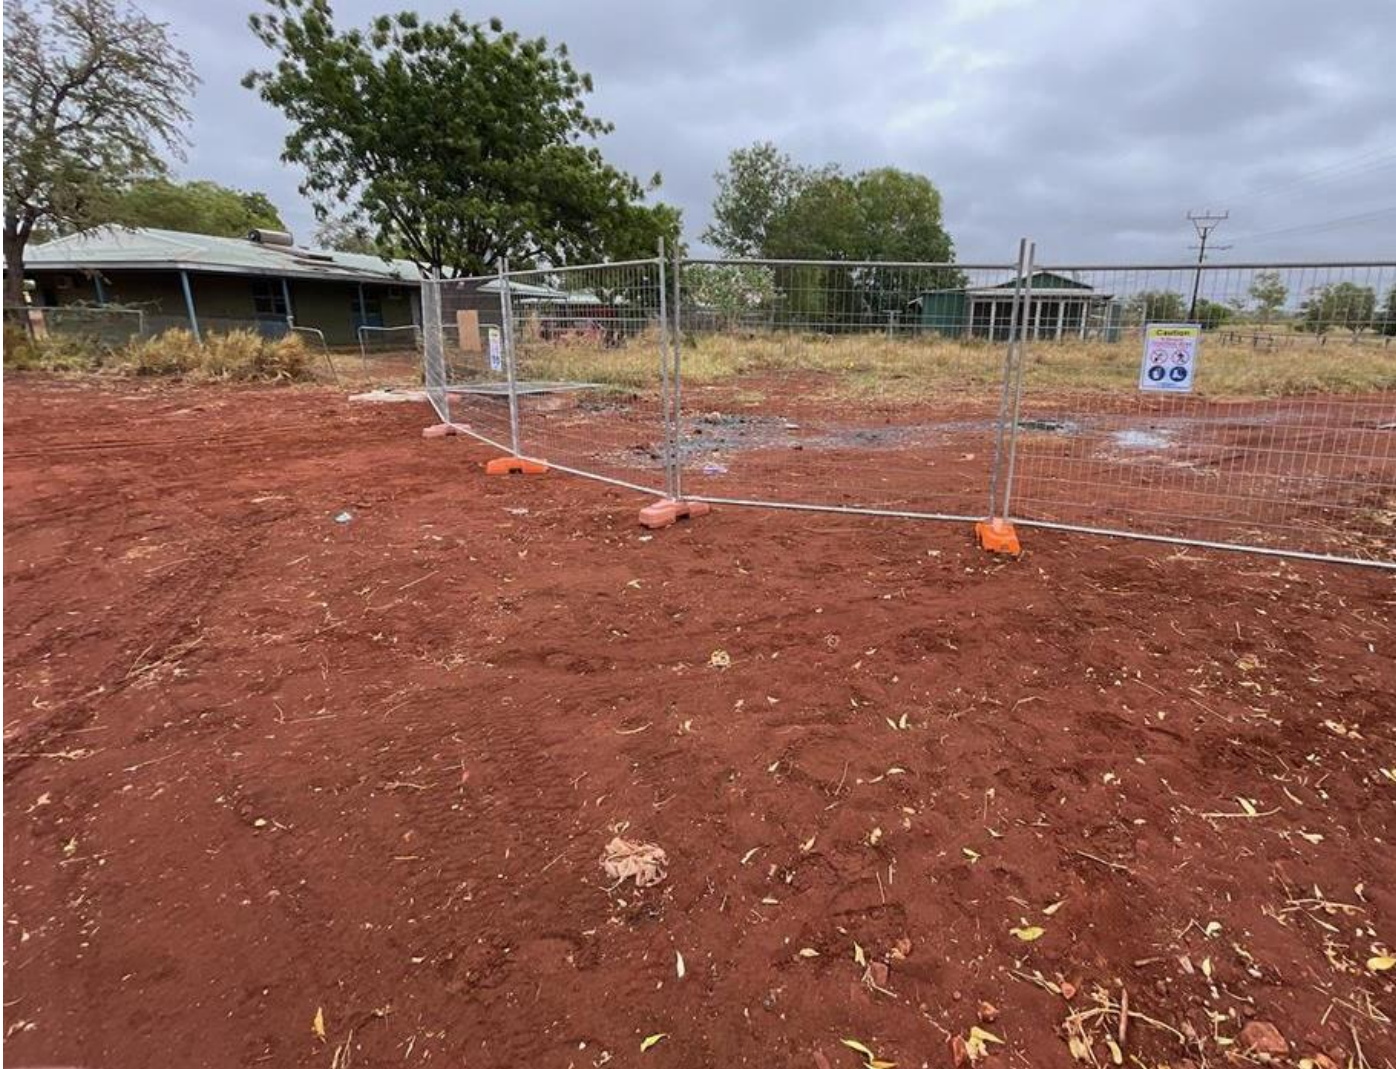
Figure 2 – Showing secure pedestrian fencing erected around the spill, now with appropriate warning signage.

(d) how the pollution has occurred, is occurring or may occur	<p>As per (c) iii & (c) iv.</p>
(e) the attempts made to prevent, reduce, control, rectify or clean up the pollution or resultant environmental harm caused or threatening to be caused by the incident	<p><i>i. Confirmation signage and fencing has been erected, as appropriate.</i></p> <p>The USC worker fenced off the immediate area affected by the spill in less than two hours, as there were fencing panels available from nearby construction works. Temporary hand written warning signage was also fixed to the fence and when the plumbing contractor arrived, purpose specific signage that include pictograms were affixed to the fence panels at key locations advising community members to keep away, see appendix B, figure 2.</p> <p><i>ii. Decontamination of the site as appropriate.</i></p> <p>Clean up consistent with Sewage Spills/Overflow Response Work Instruction as appropriate to the location, and to minimise risk to the environment. The area was inspected for any gross pollutants and it was confirmed that the inspection opening lid prevented these from being part of the spill. The affected area was treated by the USC worker with sodium hypochlorite once the spill has ceased.</p>
