SECTION 14 INCIDENT REPORT (*Waste Management and Pollution Control Act*)

Date and Time of Notification:	Monday 21 August 2023, 12:00hrs
Person / Company:	Power and Water Corporation
Incident:	Discharge of raw sewage from sewer network – manhole in Kalkarindji community

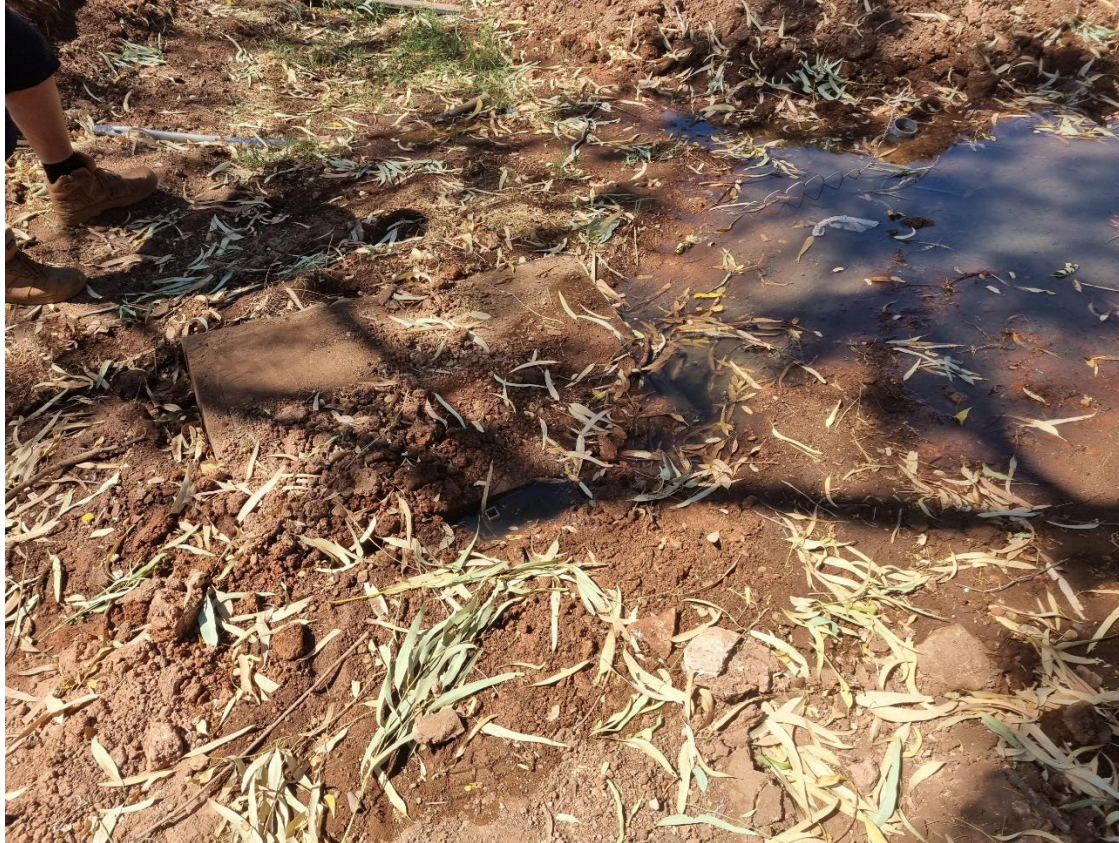
Photo 1 – Damaged manhole lid

(d) how the pollution has occurred, is occurring or may occur	As per (c) iii & (c) iv.
(e) the attempts made to prevent, reduce, control, rectify or clean up the pollution or resultant environmental harm caused or threatening to be caused by the incident	<p><i>i. Signage and fencing has been erected, as appropriate.</i></p> <p>Signed fencing will be erected surrounding the entire affected area. Power and Water contractors are currently onsite resolving the issue.</p> <p><i>ii. Decontamination of the site as appropriate.</i></p> <p>Clean up will be consistent with Power and Water's Sewage Spills/Overflow Response Work Instruction as appropriate to the location. Site will be inspected for any gross pollutants. Blockage will be cleared, affected areas will have ponded water, contaminated soils sucked up via a sucker truck. Manhole will be repaired, and ensure affected areas are cleaned and disinfected.</p>

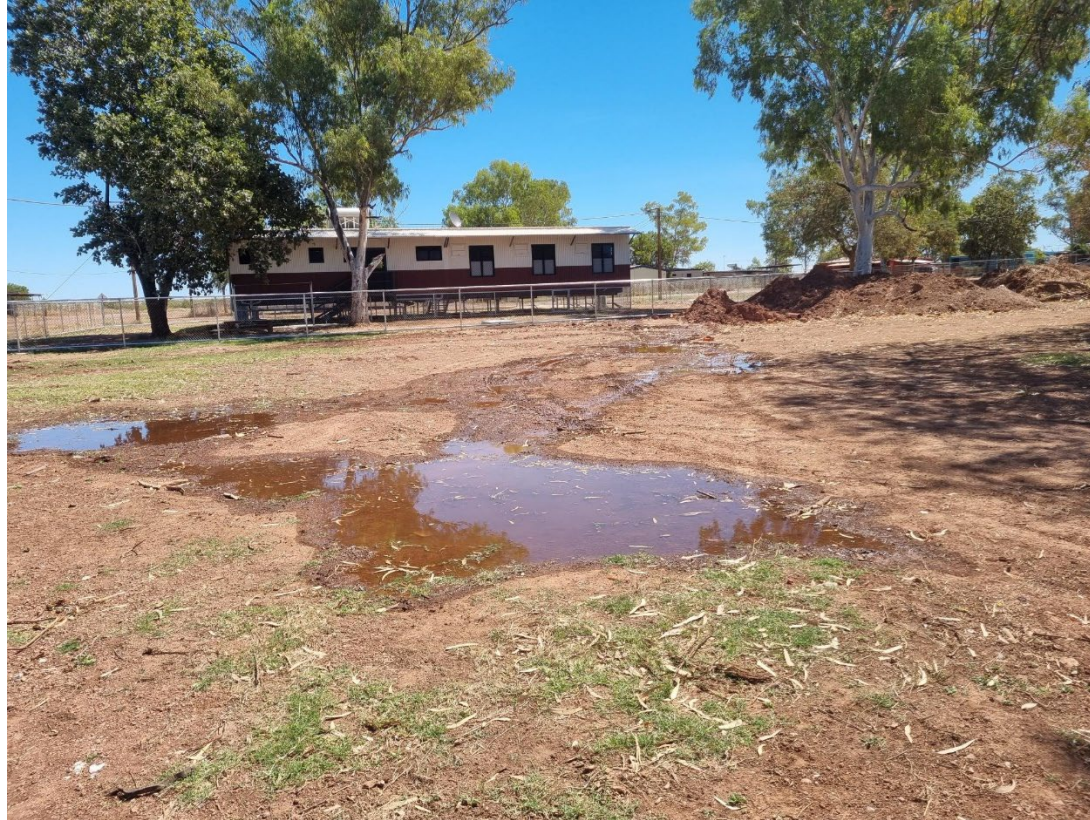
<p><i>iii. Volume of the waste that was discharged.</i></p> <p>The volume of waste discharged is unknown as manholes are not telemetered. It is estimated to be approximately 5000 litres.</p> <p>Contractors have been engaged by Power and Water staff to resolve the situation.</p>	Bacteriological				Sample Date	Location	E. coli (MPN/100 mL)	Enterococci (MPN/100 mL)	19/04/2023	Pond 1 Inlet	7330	200
Bacteriological													
Sample Date	Location	E. coli (MPN/100 mL)	Enterococci (MPN/100 mL)										
19/04/2023	Pond 1 Inlet	7330	200										
<p>(b) the place where the incident occurred</p>	<p><i>i. Description of the PWC asset from which the discharge occurred.</i></p> <p>A damaged manhole has subsequently caused the sewage to backup and discharge from a manhole. Its believed the manhole has been hit by machinery, moving the lid and allowing dirt and other debris to block the manhole causing it to fill and overflow. The damage is believed to have occurred by external contractors in the area – however what/who caused the damage to the manhole is not specifically known.</p> <p>Power and Water contractors are currently onsite resolving the issue.</p> <p><i>ii. GPS coordinates of the discharge point from the PWC asset, and the final coordinates of the final discharge point.</i></p> <p>Discharge Point 1: 130.8314772E, 17.4484995S</p> <p>The discharge starts at point 1 and has pooled in the general area.</p>

Photo 2 – General overflow area
