Date and Time of Notification:	Monday 25 th March 2024, 15:28hrs
Person / Company:	Power and Water Corporation
Incident:	Discharge of fully treated effluent from Alice Springs Ponds to Ilparpa Swamp

Alice Springs Ponds

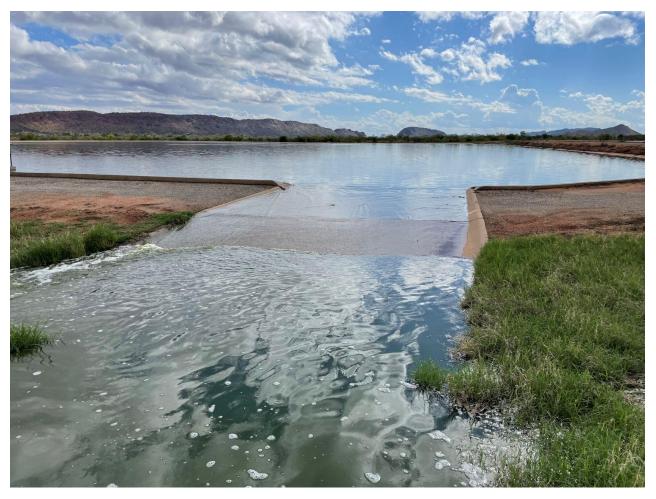
Image 1: Discharge from Pond C3. Historical image used.

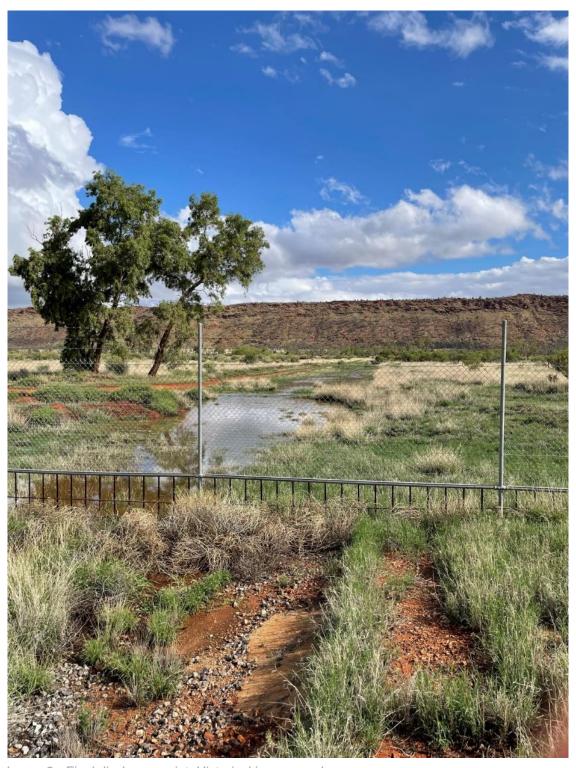
Image 2: Final discharge point. Historical image used.

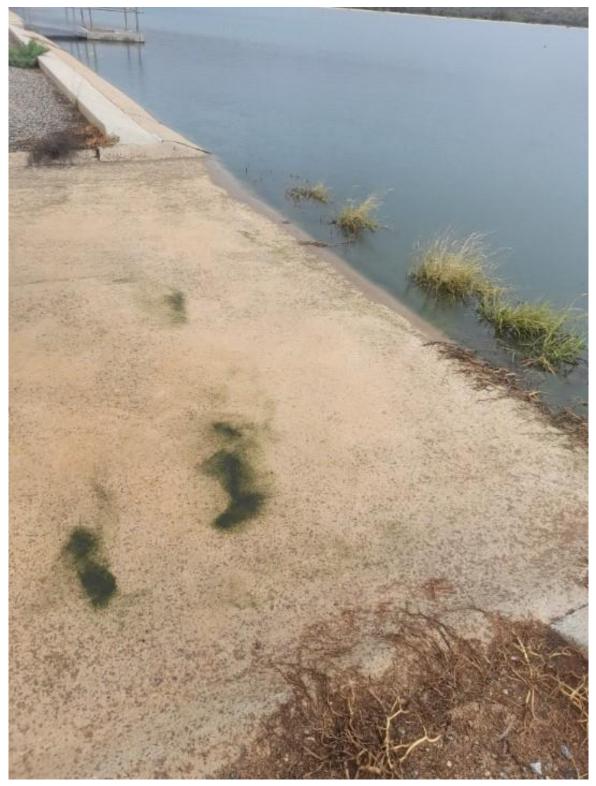
Image 3: Emergency discharge spillway at pond C3, showing that the overflow has ceased. Taken 26/03/2024.
