SECTION 14 INCIDENT REPORT (*Waste Management and Pollution Control Act*)

Date and Time of Notification:	23 rd August 2024
Company:	Groote Eylandt Mining Company Pty. Ltd. (GEMCO)
Incident:	Vegetation impacts in proximity to GEMCO's mining operation.
(a) the incident causing or threatening to cause pollution	Vegetation in proximity to GEMCO's mining operation may have been adversely affected by dieback in connection with GEMCO's site dewatering.
(b) the place where the incident occurred	Area of vegetation adjacent to GEMCO's tailings storage facility 15 (i.e. TSF15) (Figure 1), extending off lease (Figure 2) and entering the surveyed Mamagiyaliyamanja cultural heritage site boundary (Figure 3).
(c) the date and time of the incident	A site inspection with the Anindilyakwa Land Council (ALC) and Traditional Owners on Thursday 15/8/2024 (approximately 11:30) has confirmed vegetation impacts.

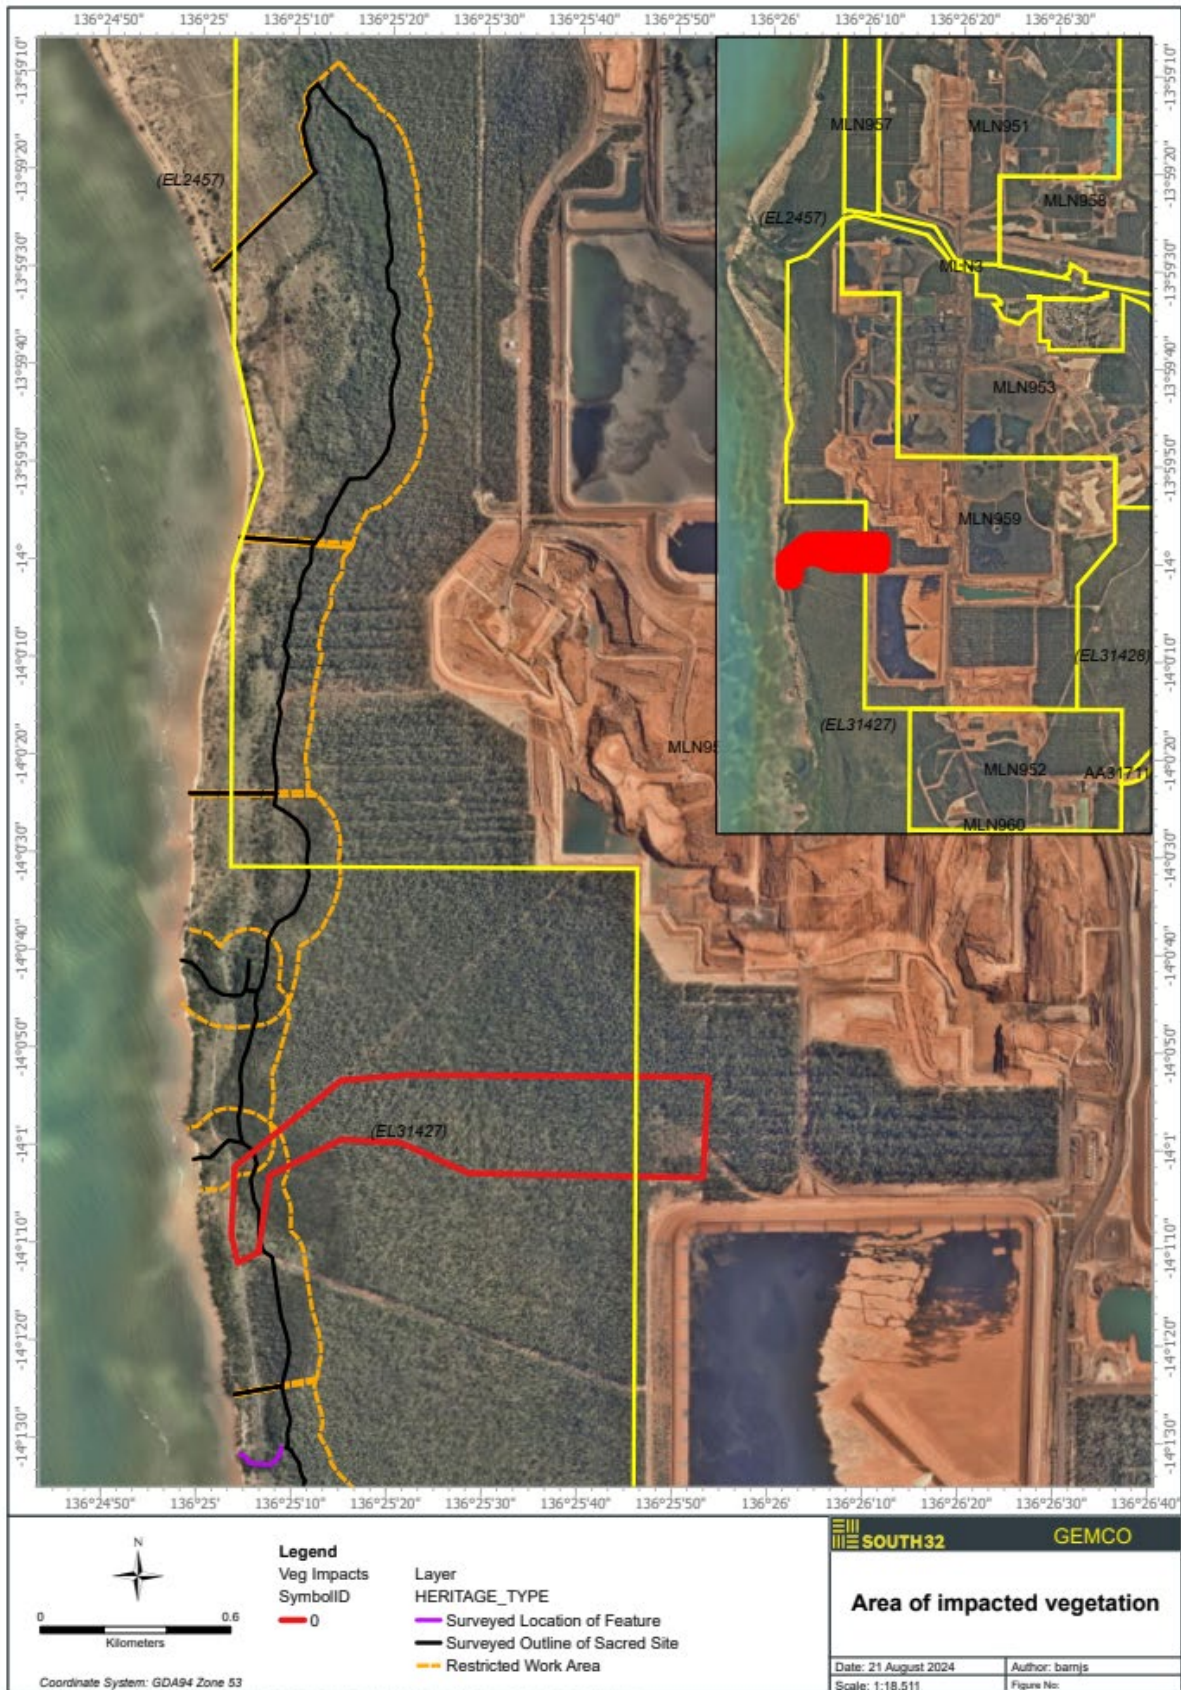
<p>(d) how the pollution has occurred, is occurring or may occur</p>	<p>GEMCO has for some years conducted a program of releasing excess water from quarry areas within its mine site. This activity is approved by the Anindilyakwa Land Council (ALC) and through GEMCO's Mine Management Plan approved by the Department of Industry, Tourism and Trade (DITT).</p> <p>As part of that program, GEMCO conducts regular monitoring of water quality to ensure any water release is within the approved (by DITT) water quality criteria. Additionally, GEMCO have in place an adaptive management monitoring program to assess vegetation health and modify water release accordingly.</p> <p>Tropical Cyclone Megan impacted Groote Eylandt on the 15th-16th of March 2024 during which approximately 700mm of rainfall was received across the mine site in a 36 hour period. This resulted in around 26GL of additional water being held within GEMCO's mining voids. Since March, GEMCO has been executing a controlled release of excess quarry water from mining areas and tailings facilities in order to ensure their safe operation and to bring the mine back into operation in a controlled manner.</p> <p>In the course of regular environmental monitoring drone surveys, it has come to our attention that vegetation off-lease appears to have been affected. Regular water quality monitoring indicates the dewatered mine water is of good quality and within GEMCO's trigger limits as outlined within its Mine Management Plan. Any vegetation impacts are believed to be due to soil saturation.</p> <p>The site inspection with the ALC and Traditional Owners on Thursday 15/8/2024 has indicated that the cultural fabric of the Mamagiyaliyamanja heritage site has not been impacted.</p>

Figure 1: Area of vegetation die-back

<p>(e) the attempts made to prevent, reduce, control, rectify or clean up the pollution or resultant environmental harm caused or threatening to be caused by the incident</p>	<p>Water discharge into the area ceased as soon as potential vegetation impacts were observed.</p> <p>Consultations are ongoing with the ALC in terms of any future remediation activities.</p>
<p>(f) the identity of the person notifying the NT EPA</p>	<p>Michael Smith Manager Technical Services GEMCO Mining Pty. Ltd.</p>

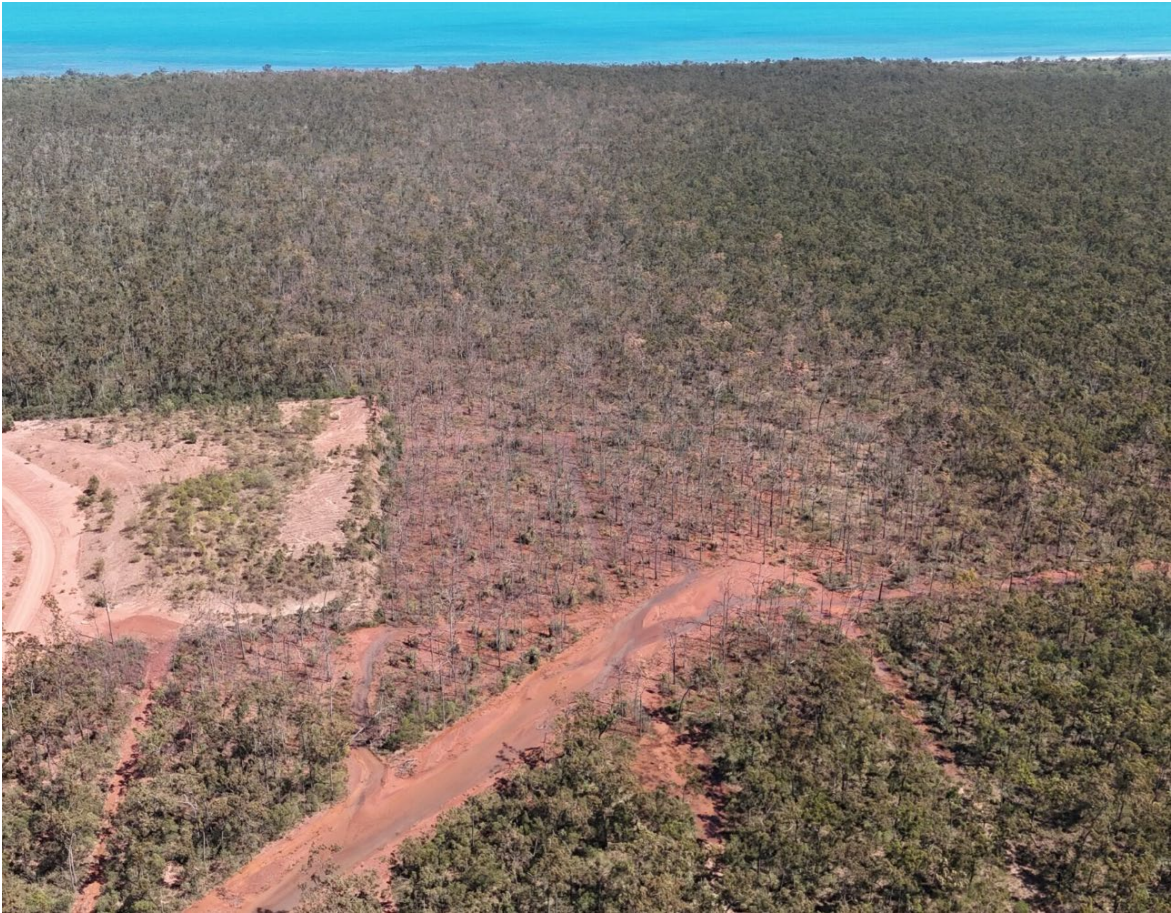
Figure 2: Drone footage of vegetation die-back (East to West perspective)

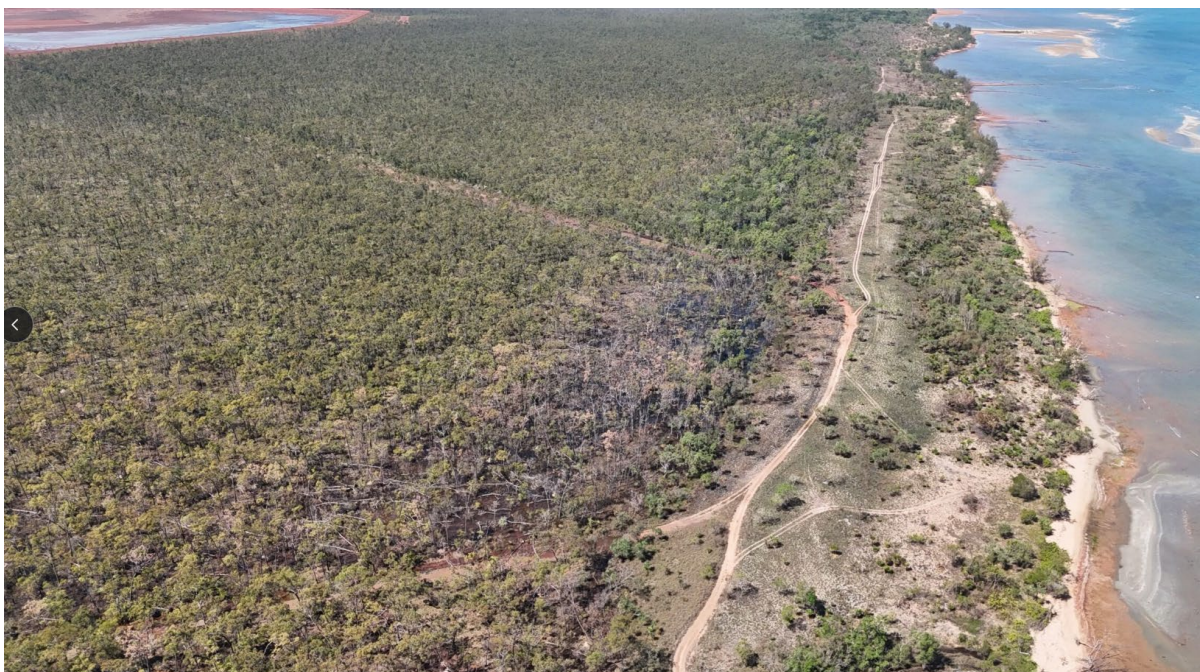
Figure 3: Drone footage of vegetation die-back (within cultural heritage buffer and area)
