SECTION 14 INCIDENT REPORT (*Waste Management and Pollution Control Act*)

Date and Time of Notification:	Wednesday 8 January 2025 14:57hrs
Person / Company:	Power and Water Corporation
Incident:	Discharge of diluted effluent from Ludmilla Sewage Pumping Station (SPS), due to wet weather events.

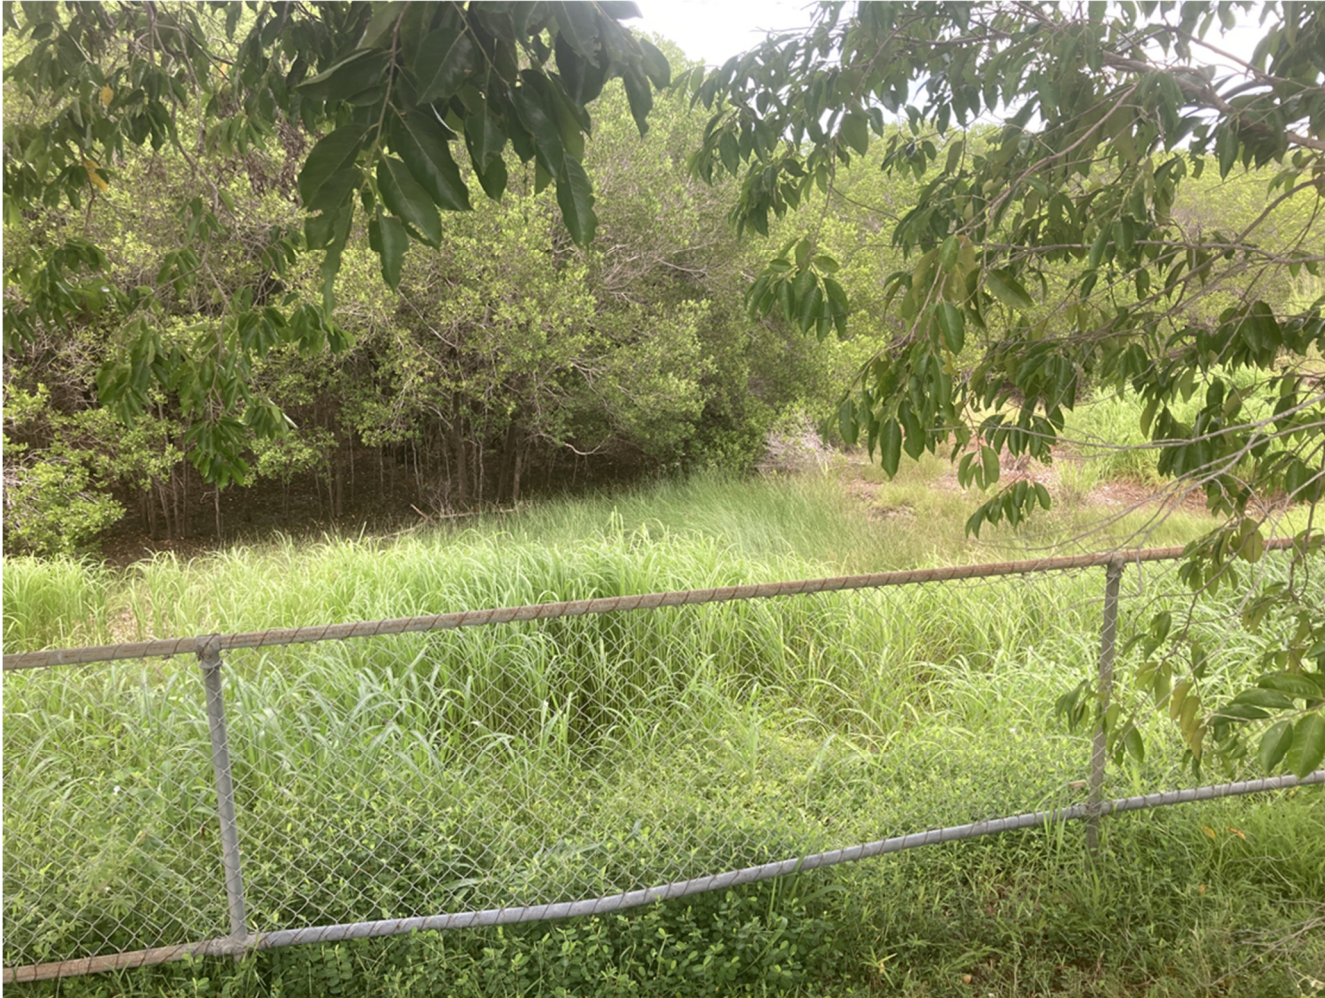
Ludmilla SPS Emergency Discharge Point, Historical Photo dated 21 January 2021
