## SECTION 14 INCIDENT REPORT (*Waste Management and Pollution Control Act*)

| <b>Incident:</b> | Overflow of treated effluent at Alpururulam (Lake Nash) waste stabilisation ponds due to wet weather. |

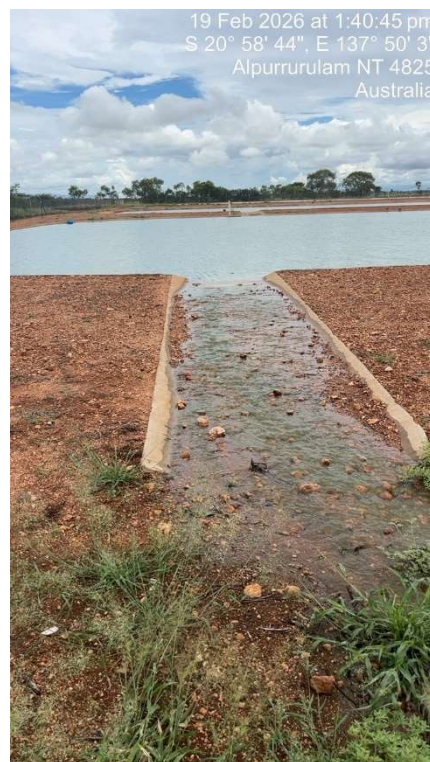
| | <p>The overflow was first observed at 08:00 on 19 February 2026. Power and Water became aware of the overflow at around 15:00 on 19 February 2026.</p> <p>Estimated that overflow ceased on around 28 or 29 February 2026 [communication from Utility Support Contract Worker (USCW)].</p> <p>Please note. Future overflows of treated effluent from Lake Nash waste stabilisation ponds may be likely pending forecasted wet weather.</p> <p><i>ii. How PWC were notified, or became aware of the discharge.</i></p> <p>The relief USCW onsite alerted Power and Water staff (based in Alice Springs) who subsequently informed Environmental Services (located in Darwin).</p> <p><i>iii. The process by which the discharge occurred.</i></p> <p>Wet weather events in the lead up to the overflow have caused ponds to exceed capacity with the addition of rainfall. Increasing pond levels, from the addition of rainfall, exceeded pumping capacity to the irrigation area. As per engineering design, treated effluent started to leave the waste stabilisation ponds via the emergency overflow channel (Figure 2 &amp; 3) as a safety measure to reduce drastic environmental damage - if the waste stabilisation ponds were to be fully compromised.</p> <p><i>iv. The reason why the discharge occurred.</i></p> <p>As per (c) iii.</p> |

Figure 2 – Emergency overflow channel

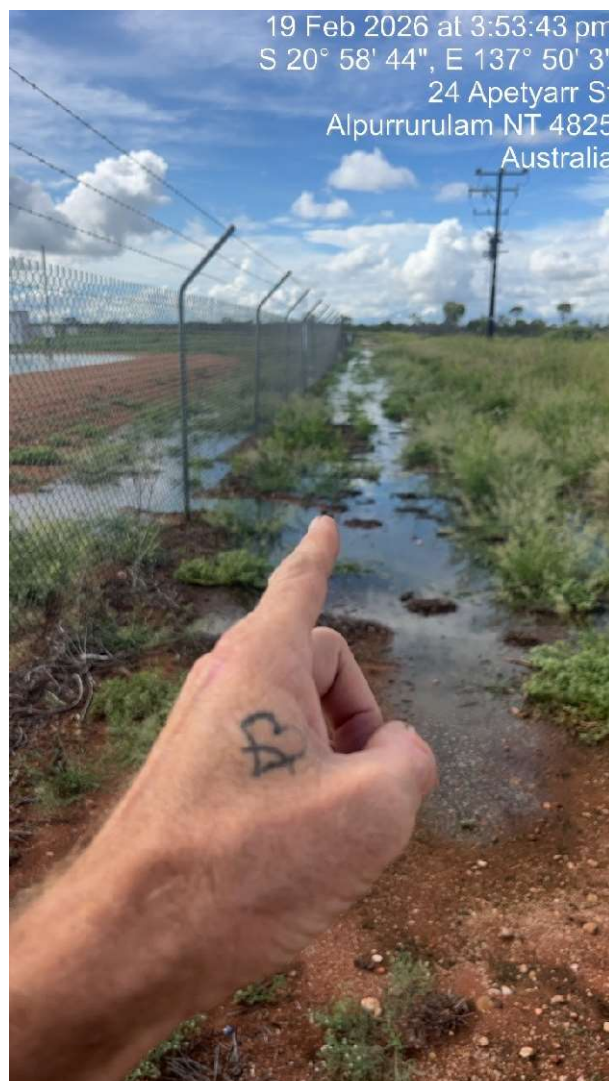
| <b>(a) the incident causing or threatening to cause pollution</b> | <p><i>i. Description of the waste that was discharged.</i></p> <p>Treated effluent (no gross pollutants).</p> <p><i>ii. Indicative wastewater quality for the discharge.</i></p> <p>We do not have any analysis results from the site for treated wastewater quality. Please note the discharge is from the emergency overflow channel located in the final pond (pond 3). Treated effluent from pond 3 has normally undergone a complete treatment cycle before transferring to the irrigation area. Recent, and ongoing, wet weather events across central Australia has meant the addition of rainfall caused the ponds to exceed holding capacity.</p> <p><i>iii. Volume of the waste that was discharged.</i></p> <p>No telemetric monitoring occurs at the site of discharge. Estimated volume is approximately 450kL.</p> |

Figure 3 – Discharge path

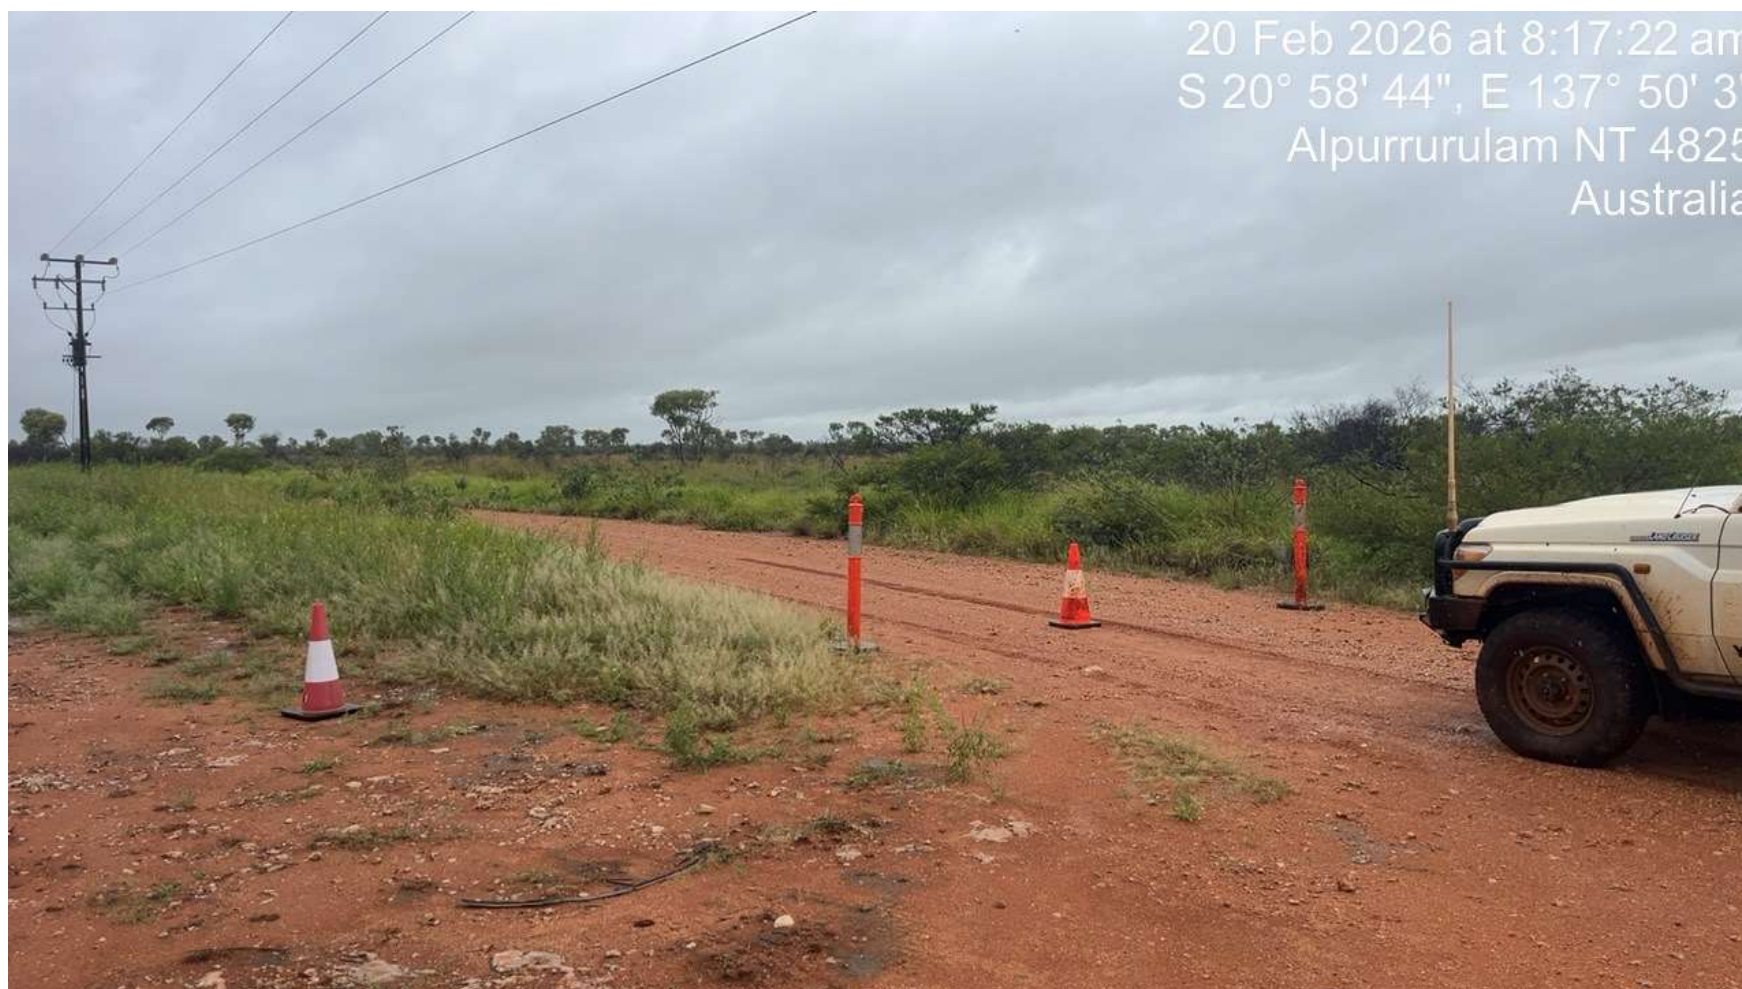
Figure 4 – Temporary barricade at discharge area

| <b>(e) the attempts made to prevent, reduce, control, rectify or clean up the pollution or resultant environmental harm caused or threatening to be caused by the incident</b> | <p><i>i. Confirmation signage and fencing has been erected, as appropriate.</i></p> <p>Temporary barricades have been placed at the discharge area to deter any potential access by the public (Figure 4).</p> <p><i>ii. Decontamination of the site as appropriate.</i></p> <p>Clean up will be consistent with Sewage Spills/Overflow Response Work Instruction as appropriate to the location, and to minimise risk to the Environment.</p> |
