SECTION 14 INCIDENT REPORT (*Waste Management and Pollution Control Act*)

Date and Time of Notification:	Tuesday 19 th of November IR received 7.47 am
Person / Company:	Gary O'Hearn Paspaley Pearls Properties PTY LTD
Incident:	Diesel fuel spill

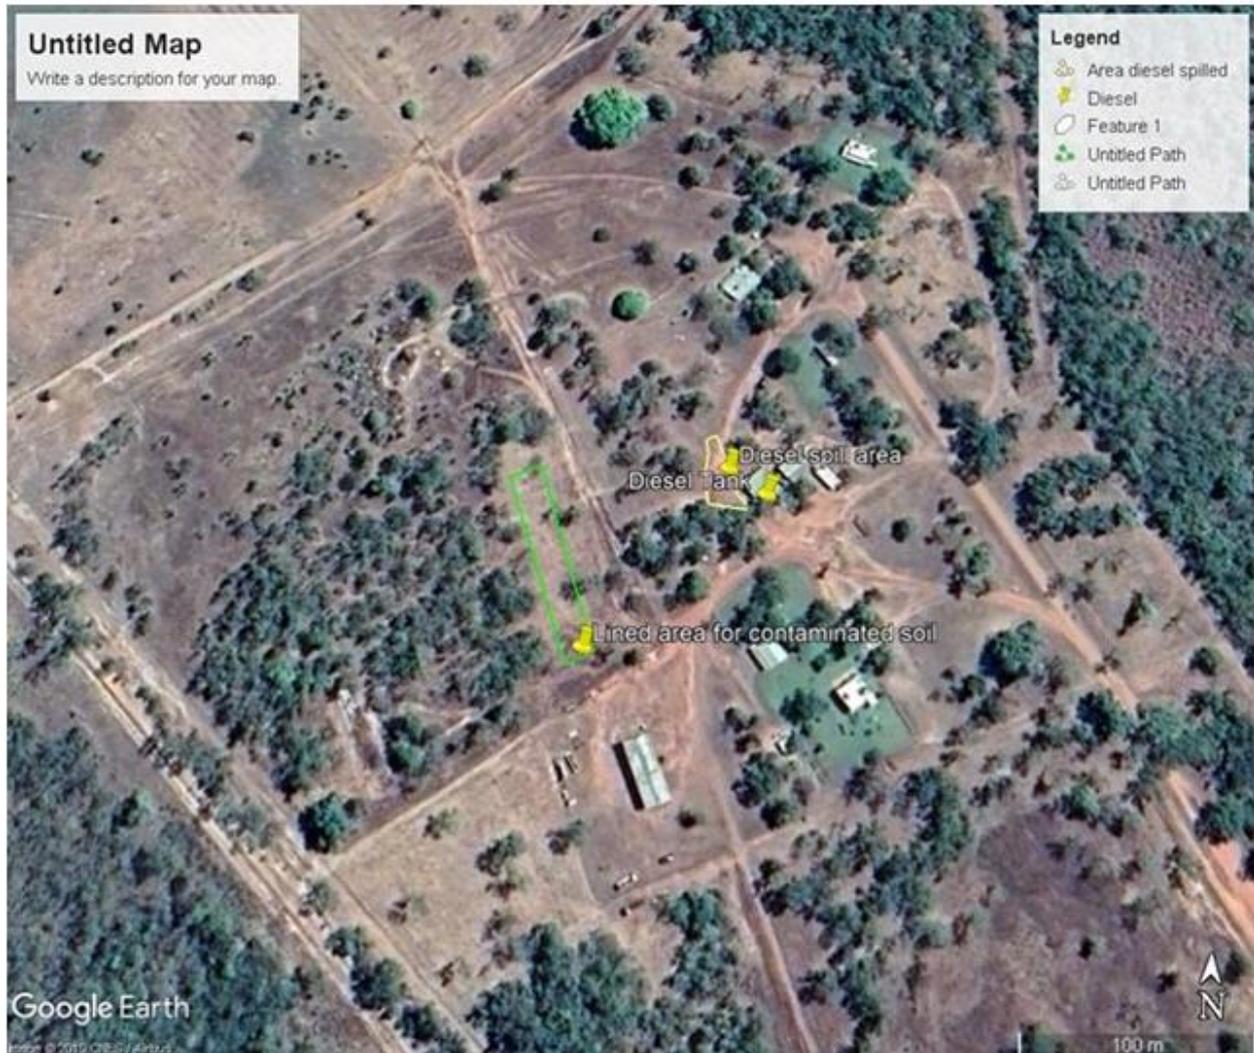
Map of Northern Territory Portion 2708, which depicts:

(b) the place where the incident occurred	Melaleuca Station is comprised of Northern Territory Portions 4458 and 2708. Attached is a map of Northern Territory Portion 2708, which depicts: <ul style="list-style-type: none"> • the location of the incident; and • the bund into which soil impacted with diesel will be remediated (remediation site).

- the location of the incident; and
- the bund into which soil impacted with diesel will be remediated (**remediation site**)
